# **Inspection and Assessment Report**

## **Cloddach Bridge, Elgin**

**March 2022**

REPORT TITLE: Inspection for Assessment Report

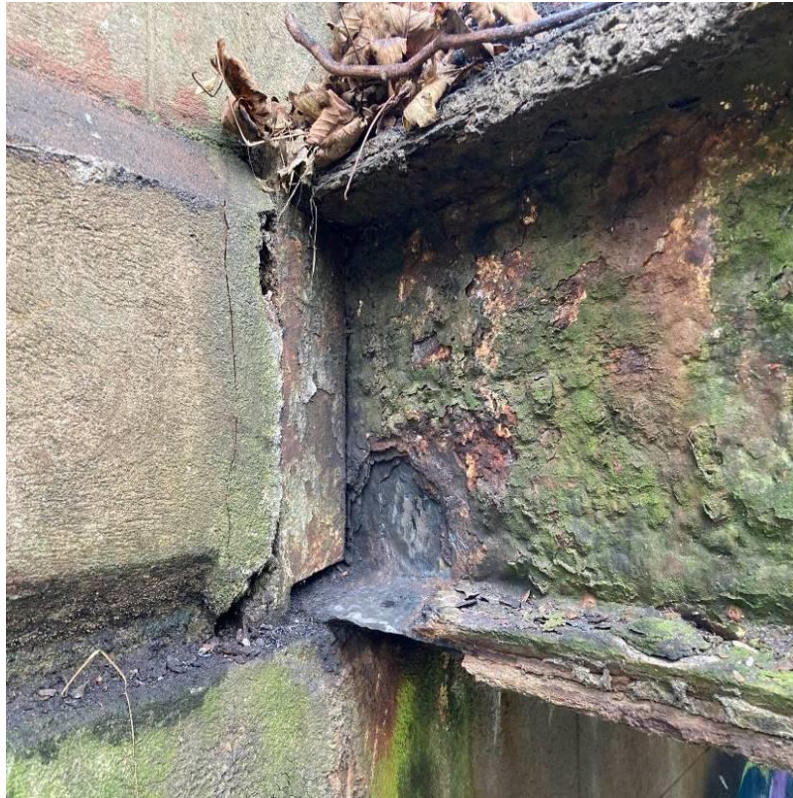
- There is widespread corrosion, delamination and layered rust build-up to entire length of exposed web and flange of PB1 and PB7 over all three spans as noted on defect schedule (Photograph 1, 2 & 3).

**Photograph 1: Widespread corrosion, delamination and layered rust build-up to entire length of exposed web and flange of PB1 & PB7 over all three spans.**

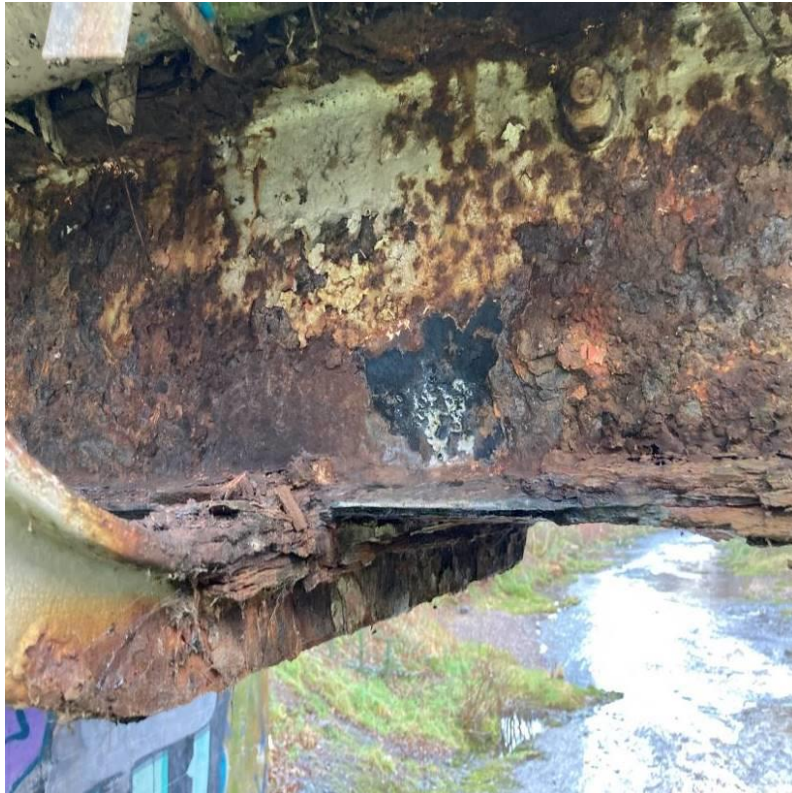
**Photograph 2: Widespread corrosion, delamination and layered rust build up to entire length of exposed web and flange of PB1 & PB7 over all three spans.**

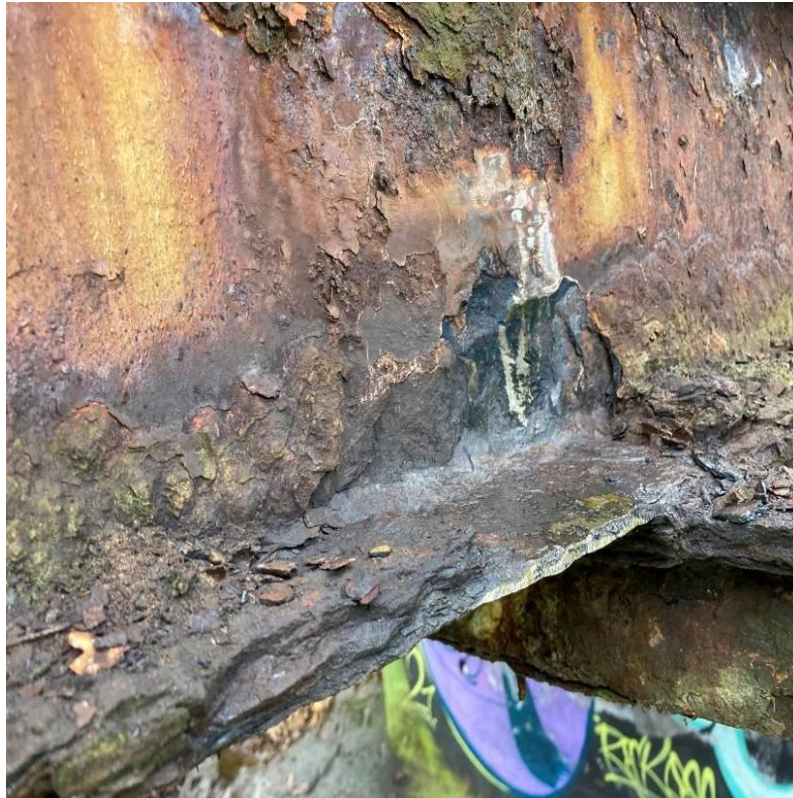
**Photograph 3: Widespread corrosion, delamination and layered rust build up to entire length of exposed web and flange of PB1 & PB7 over all three spans.**

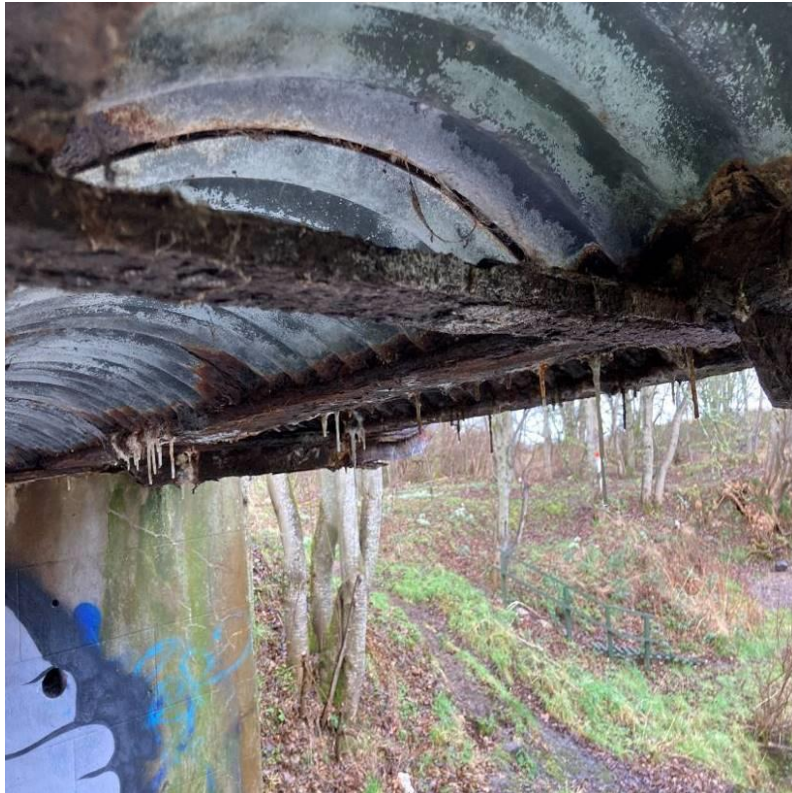
- There is widespread corrosion delamination and layered rust build-up to entire length of visible bottom flange of PB2 and PB6 over all three spans (Photograph 4).

**Photograph 4: Widespread corrosion, delamination and layered rust build up to entire length of visible bottom flange of PB2 & PB6 over all three spans.**

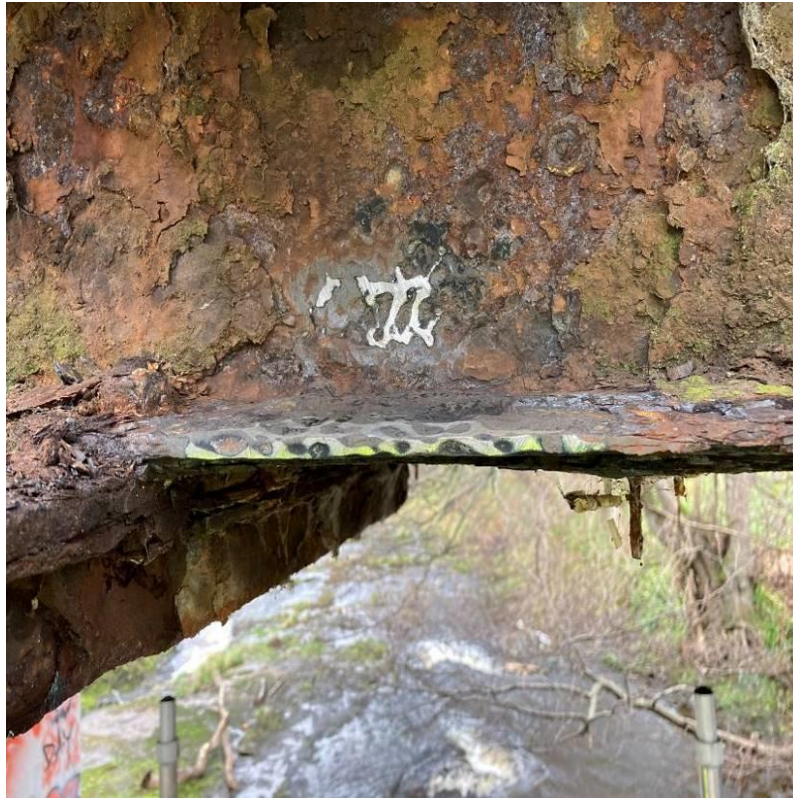
**Photograph 5: Visible section loss to flange of PB1 & PB7 over all three spans. Flange measuring 4-6mm at toe and, on average, 12.4mm at quarter points of overall flange width.**

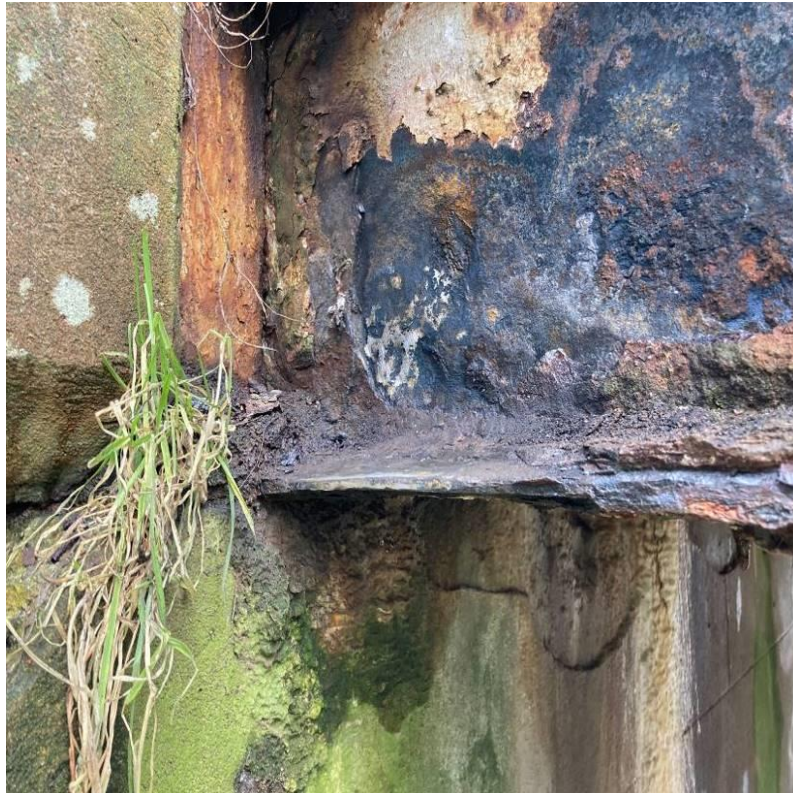
**Photograph 6: Widespread corrosion, delamination and layered rust build up to entire length of exposed web and flange of PB1 & PB7 over all three spans.**

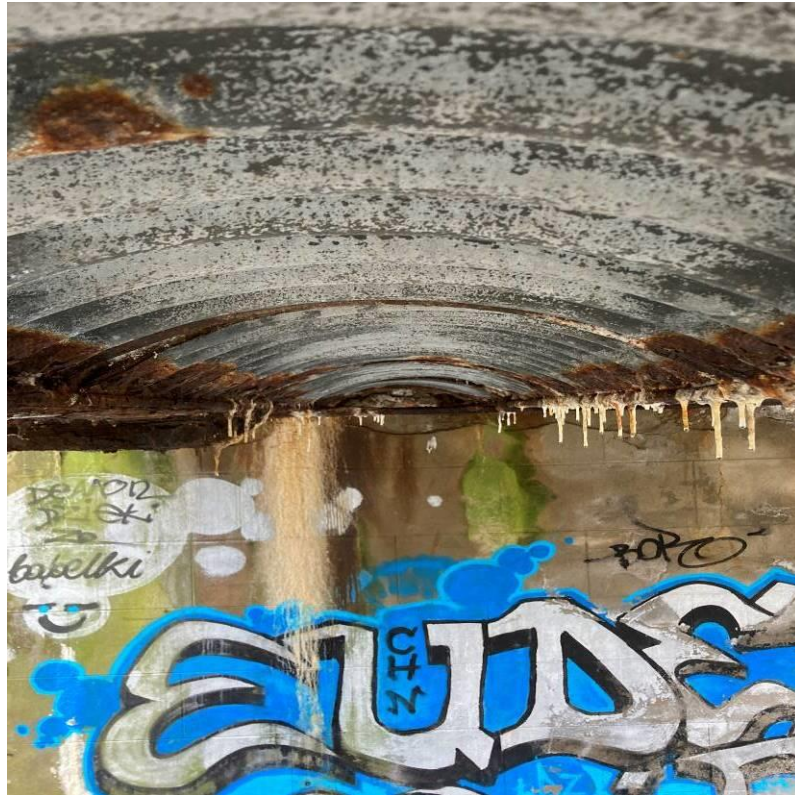
**Photograph 7: Widespread calcite stalactites to bottom flange of PB1 – PB7 indicating extensive water ingress through deck structure. Typical localised surface rust at junction between corrugated steel shuttering and steel beam bottom flange.**

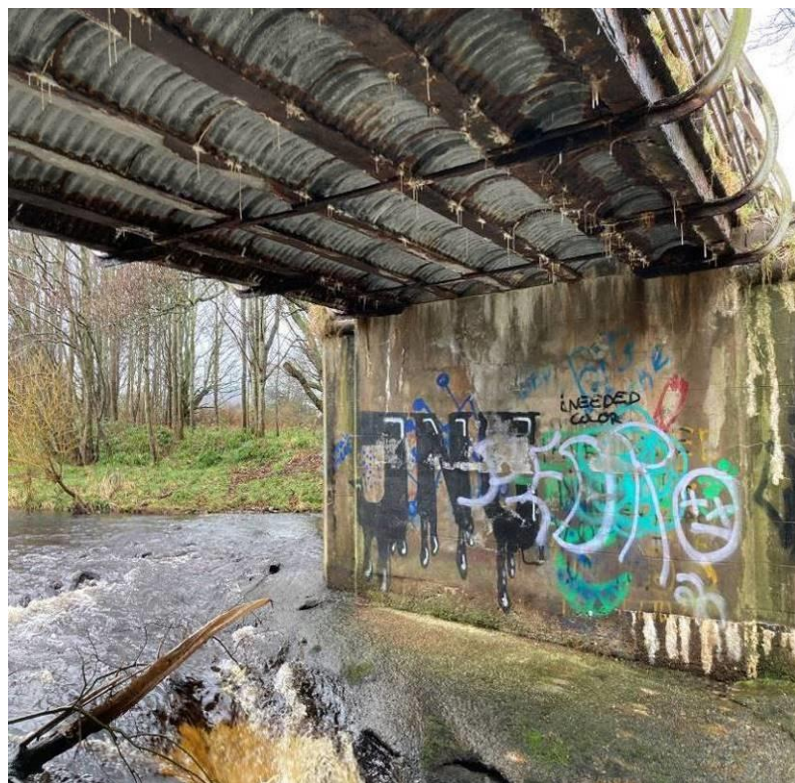
**Photograph 8: Widespread calcite stalactites to bottom flange of PB1 – PB7 indicating extensive water ingress through deck structure.**

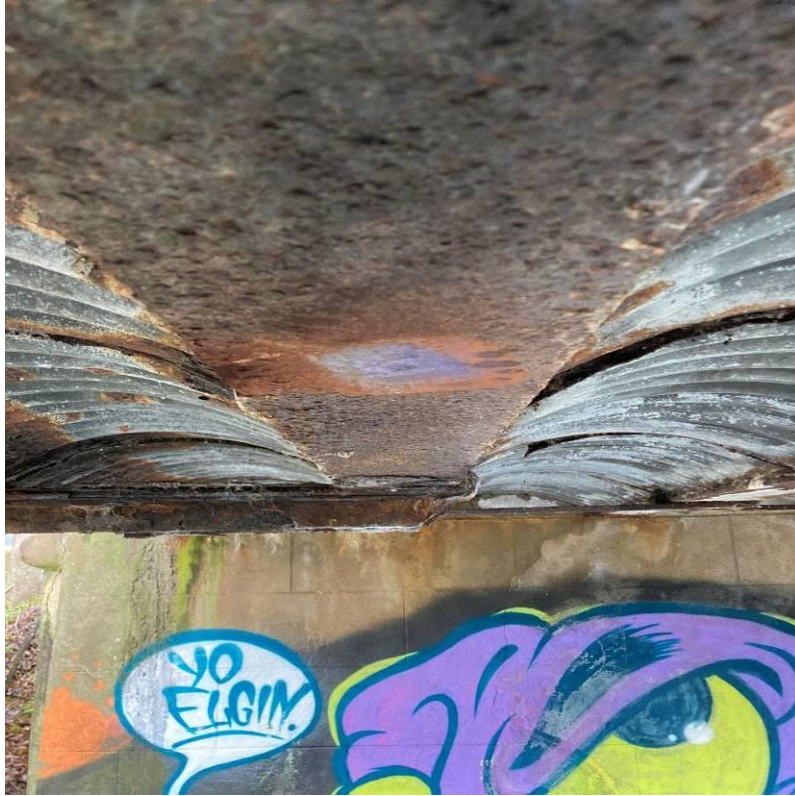
- There is general moderate surface rust and pitting to soffit of bottom flange of internal beams (Photograph 9).
- The flaking paint to soffit of bottom flange of PB4 – PB6 in Span 1. Is indicative of condition where paint coating was only partially intact throughout all three spans. No paint coating was generally visible to PB1 and PB7 as rust layering and delamination was too extensive (Photograph 10 & 11).

**Photograph 9: Typical defect to internal beams - moderate surface rust and pitting to soffit of bottom flange (PB6, Span 1 shown).**

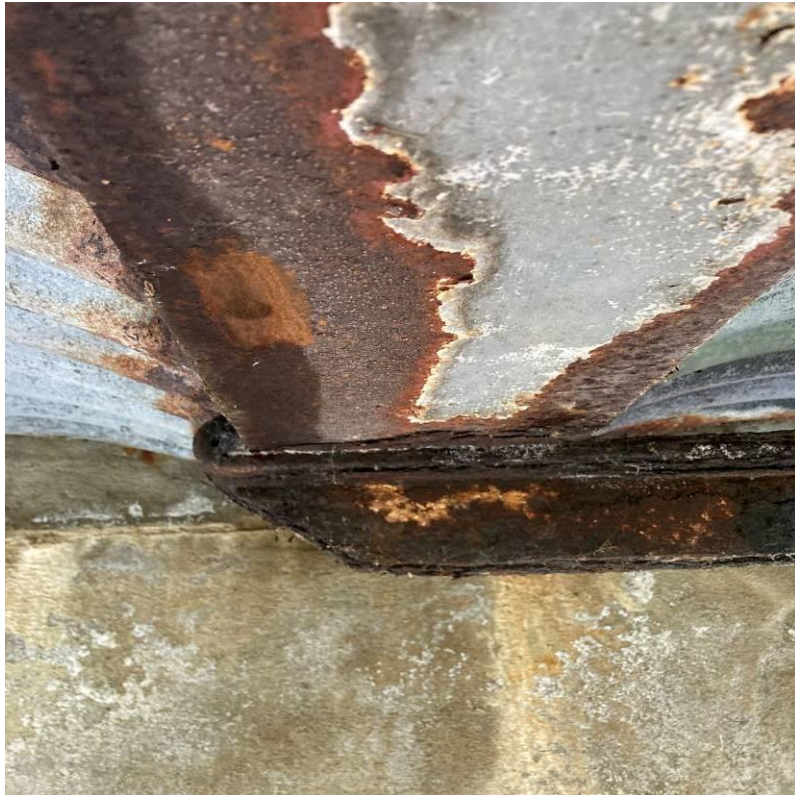
**Photograph 10: Flaking paint to soffit of bottom flange of PB4-PB6 in Span 1. Indicative of condition where paint coating was partially intact throughout all three spans.**

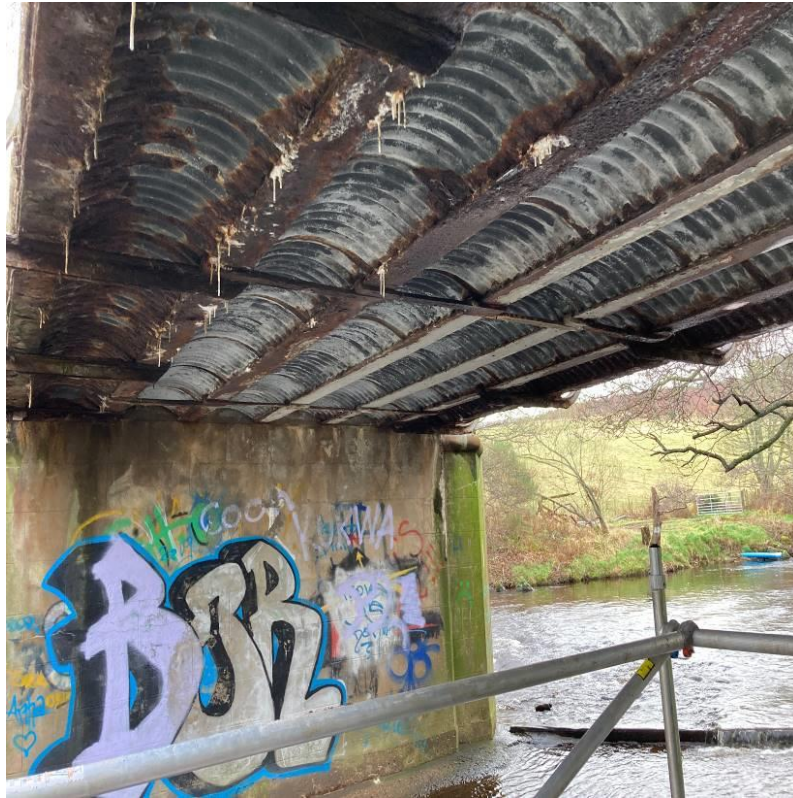
**Photograph 11: Flaking paint to soffit of bottom flange of PB4-PB6 in Span 1. Indicative of condition where paint coating was partially intact throughout all three spans.**

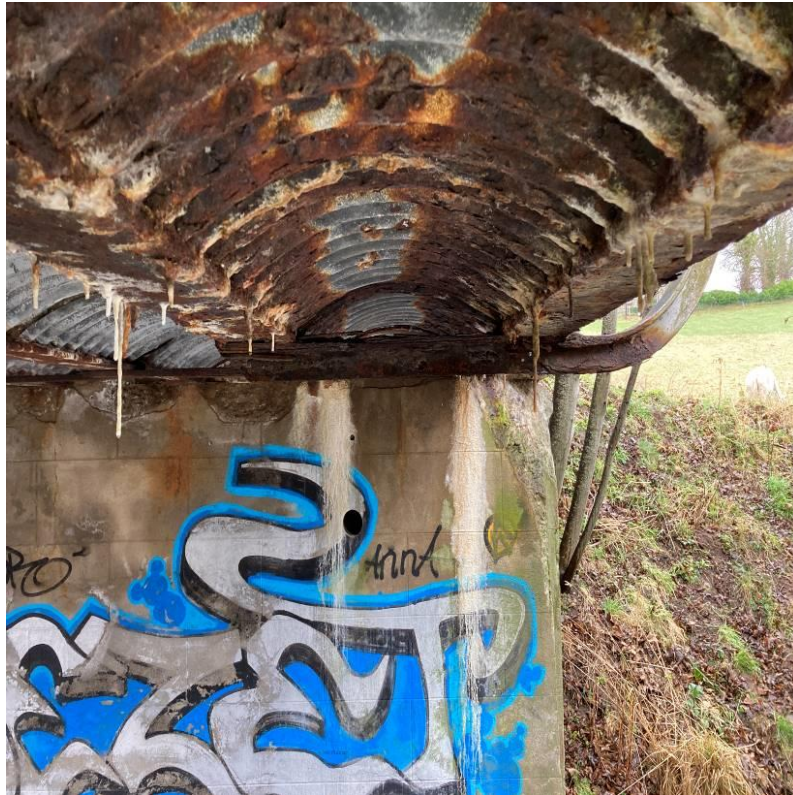
**Photograph 12: Surface rust, delamination and corrosion to the corrugated steel shuttering forming the soffit of the structure. Predominant in arches between PB1 - PB2 and PB6 - PB7.**

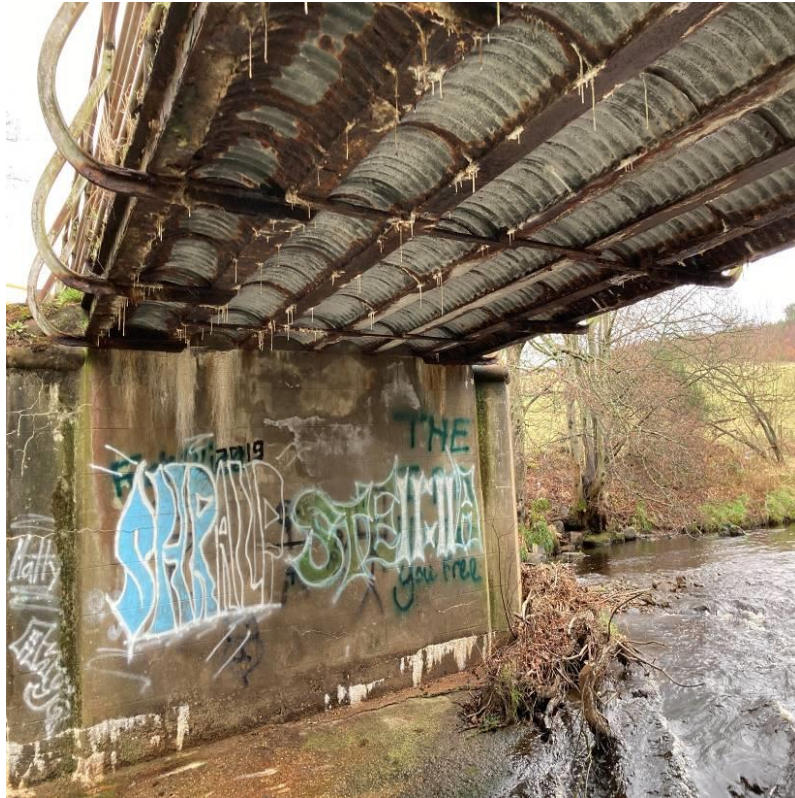
**Photograph 13: Surface rust, delamination and corrosion to the corrugated steel shuttering forming the soffit of the structure. Predominant in arches between PB1 - PB2 and PB6 - PB7.**

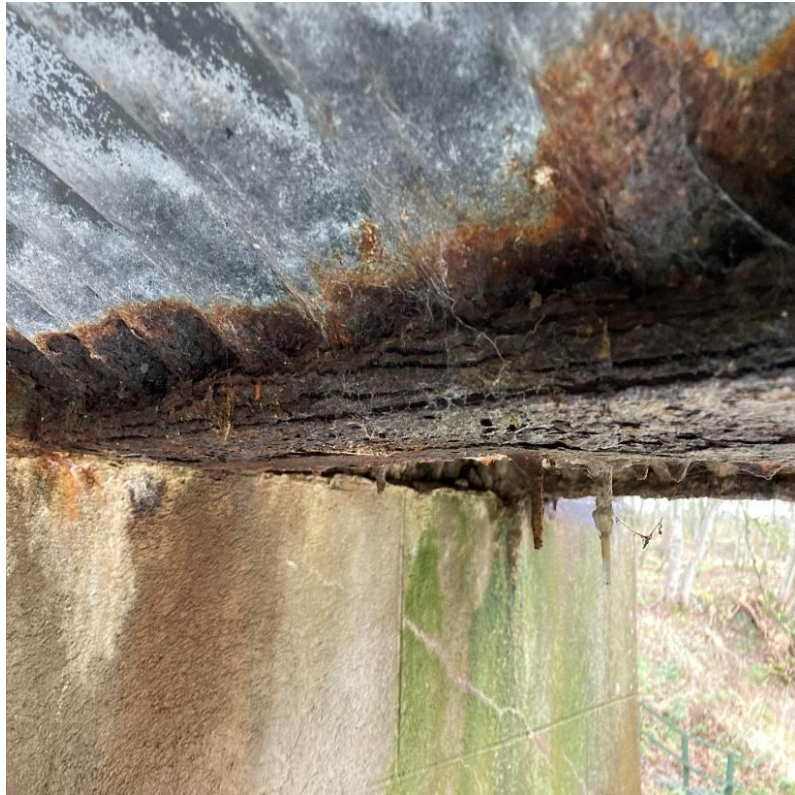
**Photograph 14: Typical localised surface rust at junction between corrugated steel shuttering and steel beam bottom flange.**

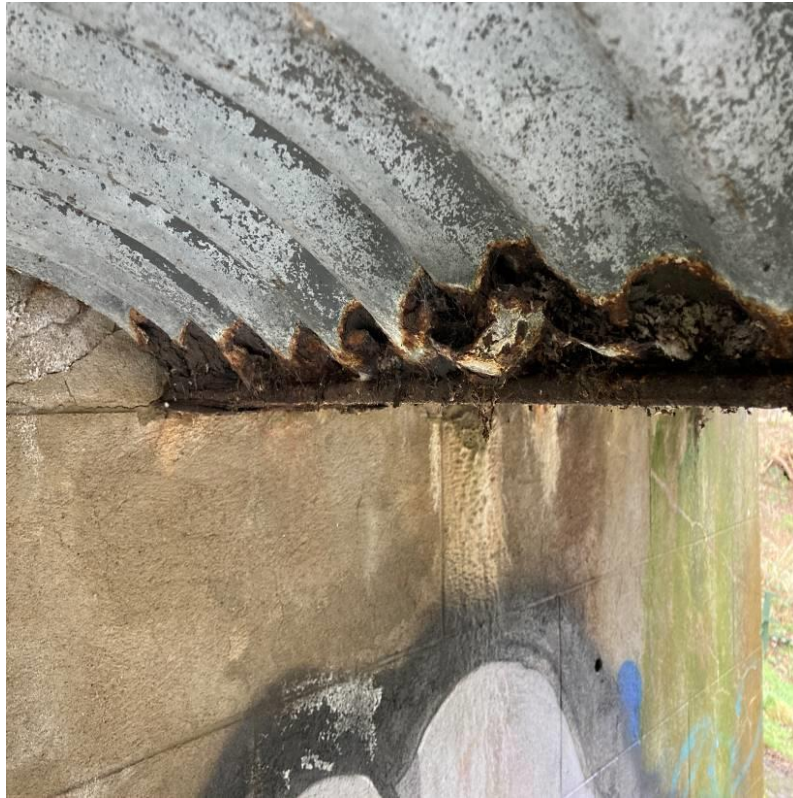
**Photograph 15: Localised failure of corrugated steel shuttering at junction with PB3 within Span 1.**

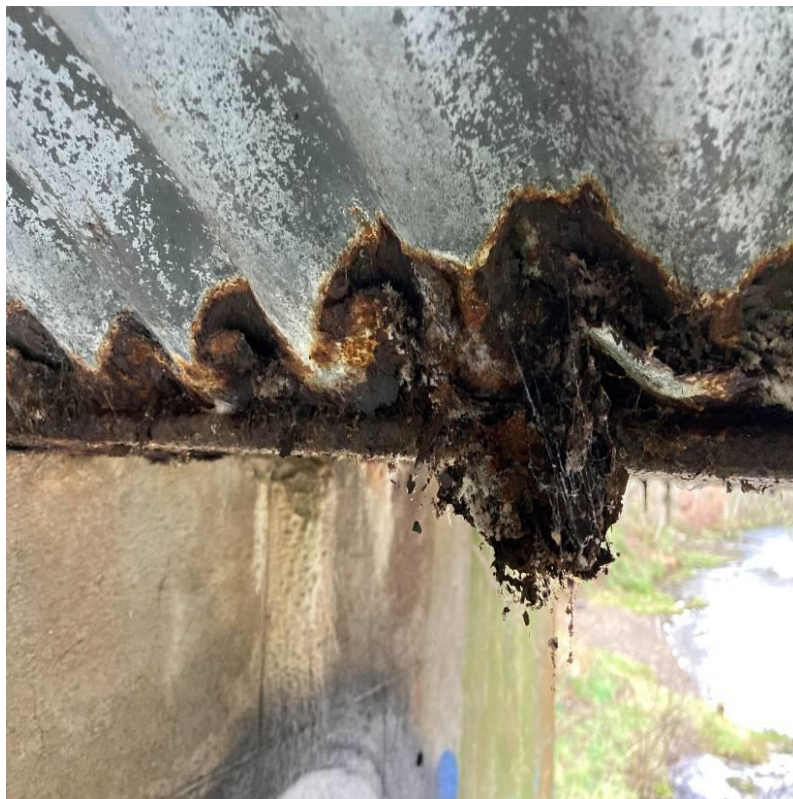
**Photograph 16: Localised failure of corrugated steel shuttering at junction with PB3 within Span 1.**

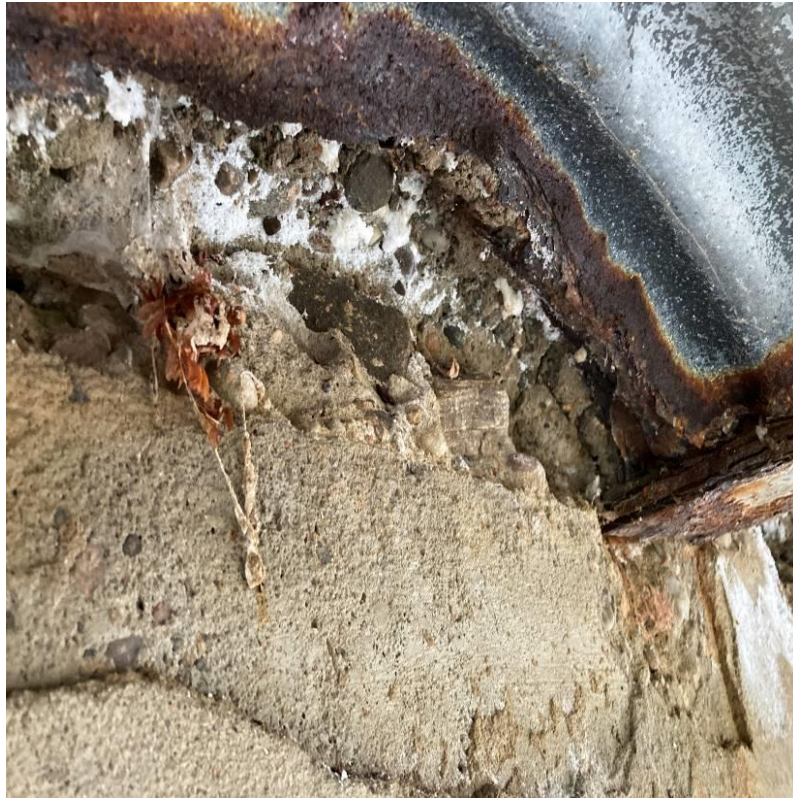
- There is surface rust, delamination and corrosion to the corrugated steel shuttering to the soffit of the structure. This is widespread through the structure but predominantly found between PB1 – PB2 and PB6 – PB7 within each span (Photograph 12 & 13).
- Typical localised surface rust is present at the junction between the corrugated steel shuttering and primary steel beam bottom flange. This rust is also prevalent throughout the entire structure (Photograph 7 & 14).
- Localised failure of corrugated steel shuttering was observed at junction with PB3 within Span 1 (Photograph 15 & 16).
- The mass concrete to the jack arched slab is honeycombed with visible areas of rounded river gravel aggregate indicating the poor quality of the original concrete. (Photograph 17).

**Photograph 17: Mass concrete jack arched slab visible with rounding river gravel aggregate indicating a low grade concrete mix.**

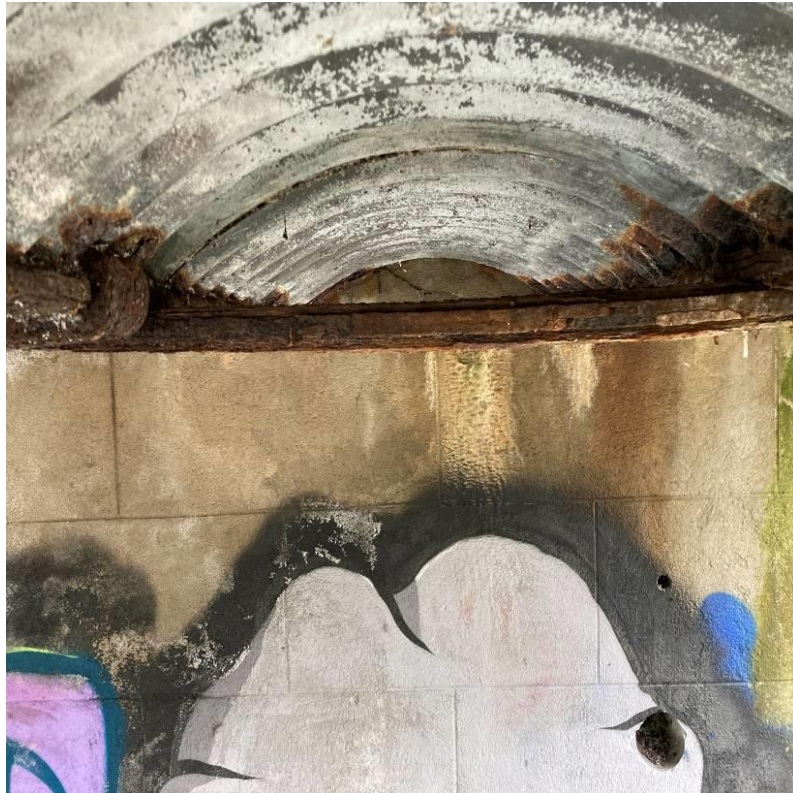
- There is typical layered surface rust and delamination to all transverse ties. Areas with extensive corrosion were measured to be approximately 30mm deep with true section depth taken as 10mm within less corroded areas (Photograph 18).

**Photograph 18: Typical layered surface rust and delamination to all transverse ties.**

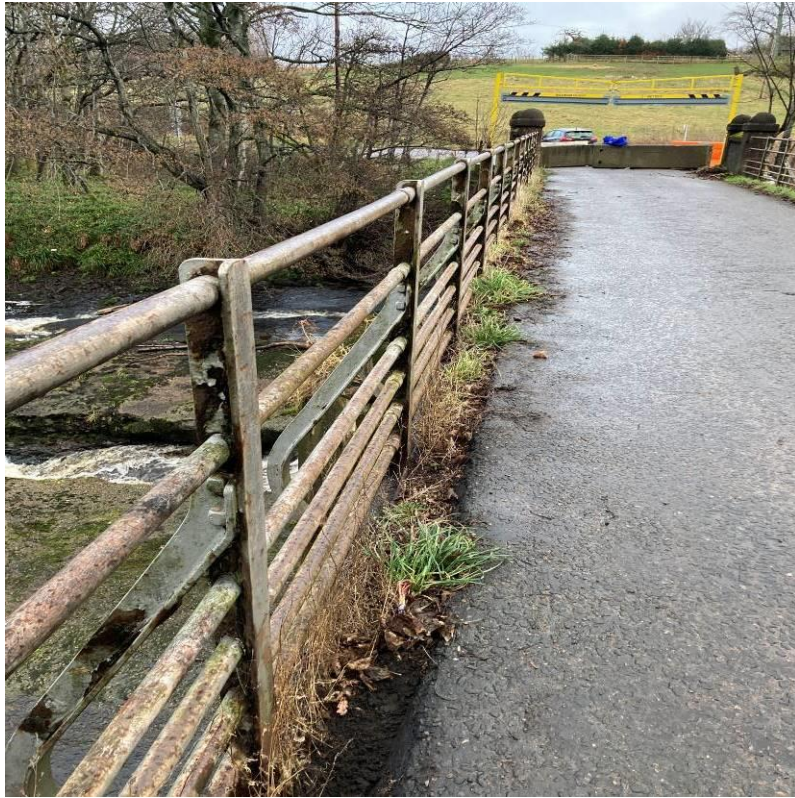
- Typical weathering with surface rust and failure of coating system to parapet rails and upstands has been noted (Photograph 19 & 20).
- Typical cracks are propagating from the junction between the steel parapet rails and the mass concrete approach wing walls (Photograph 21).
- There is widespread hairline cracking to approach wing walls (Photograph 22 & 23).

**Photograph 19: Typical weathering, surface rust and failure of coating system to parapet rails and upstands.**

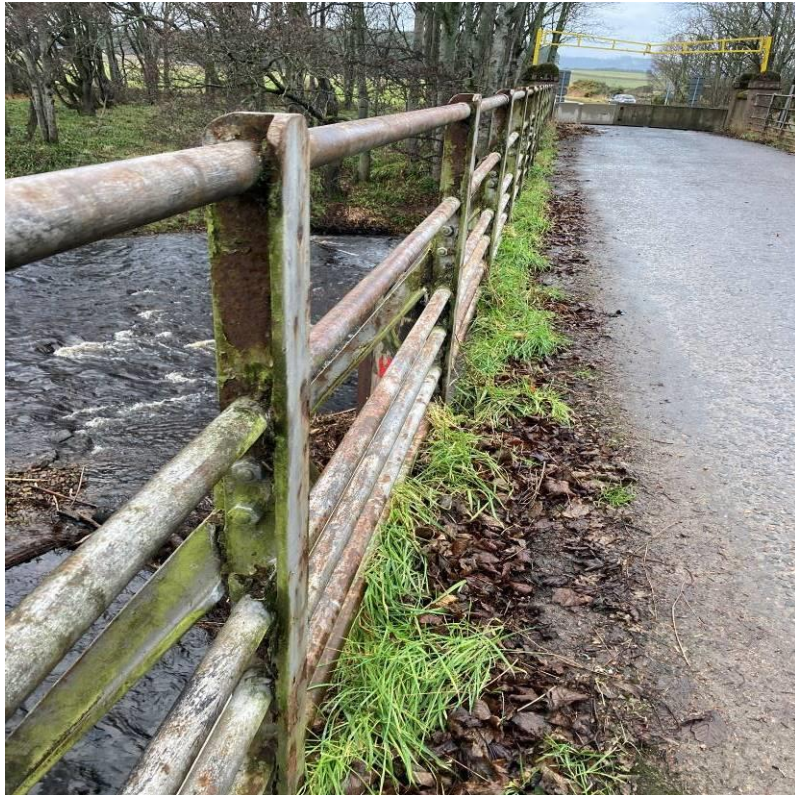
**Photograph 20: Typical weathering, surface rust and failure of coating system to parapet rails and upstands.**

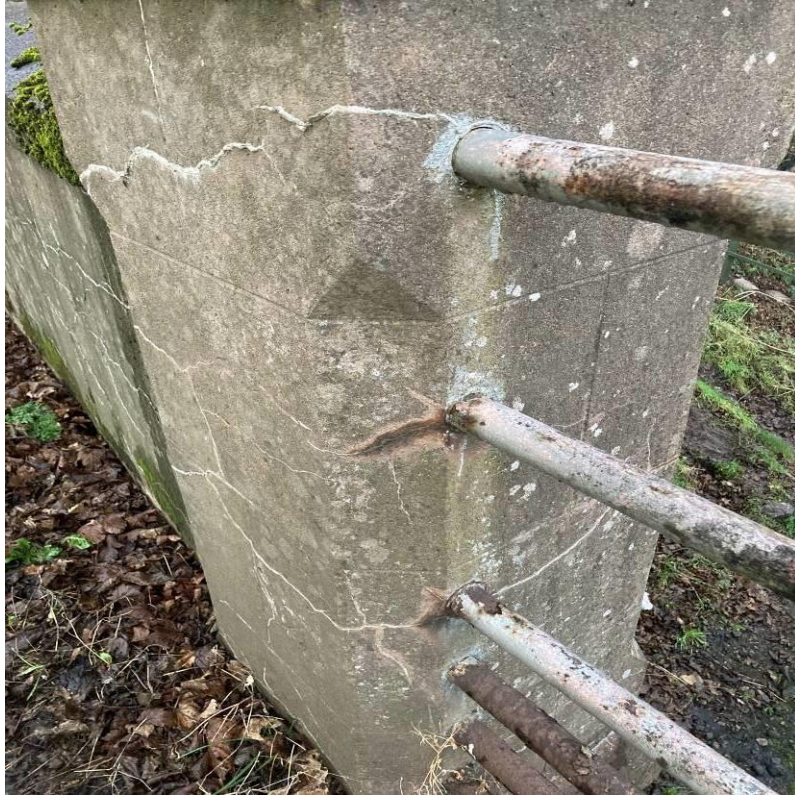
**Photograph 21: Typical cracks propagating from the junction between the steel parapet rails and mass concrete approach wing walls.**

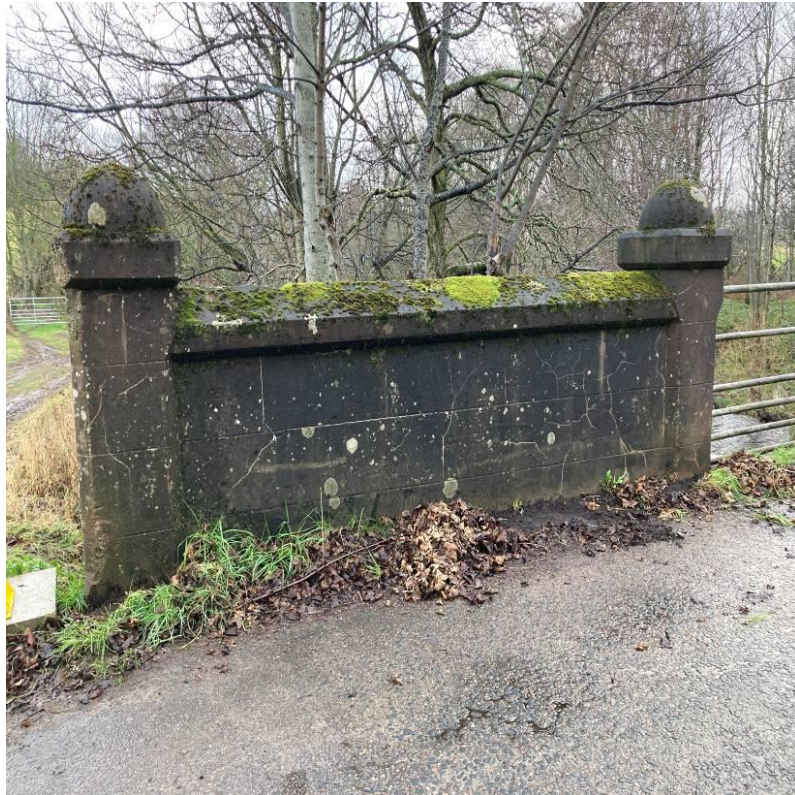
**Photograph 22: Typical widespread hairline cracking to approach wing walls.**

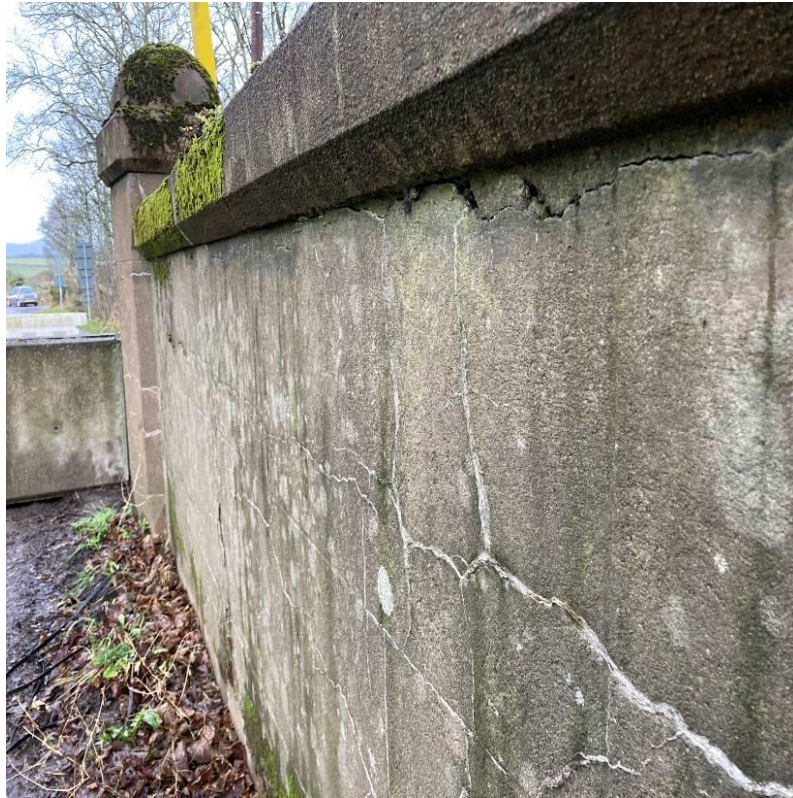
**Photograph 23: Typical widespread hairline cracking to approach wing walls.**

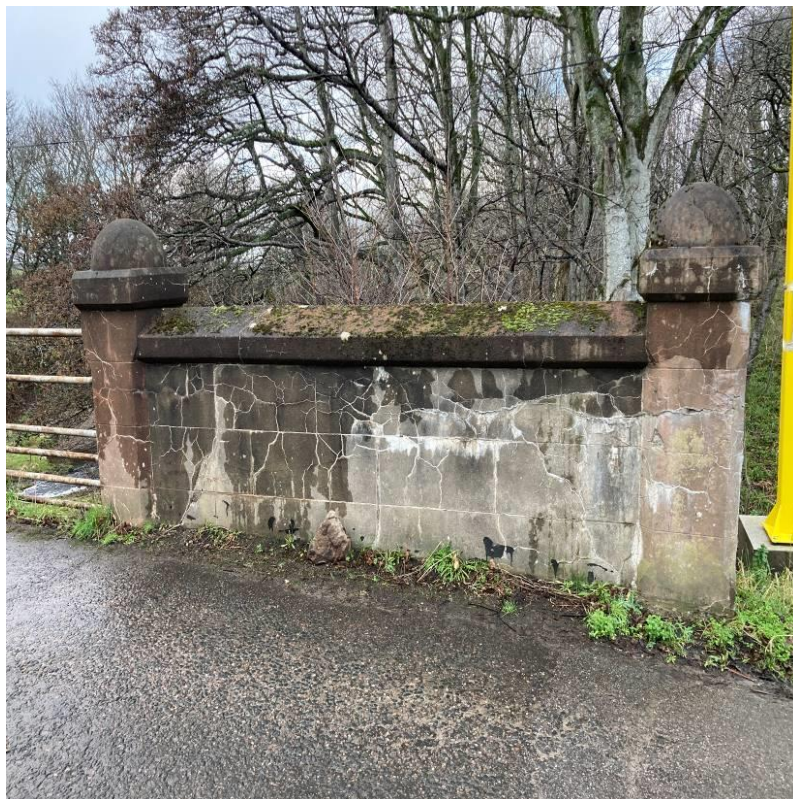
- There is evidence of vehicle collision to north-east approach wing wall with spalled concrete and widespread cracking to wall and cope (Photograph 24 & 25).
- A band of vegetation growth was observed within the drainage channel to the carriageway edge (Photograph 26 & 27).
- Typical drainage outlets are situated to north and south of bridge at mid-point of each span. One of the drainage outlets was cleared for the photograph but the remaining outlets were generally blocked by silt and vegetation throughout structure (Photograph 28).
- There is widespread corrosion, delamination and layered rust build-up to lower section of parapet brace member. A paint coating is visible to the upper section but appears to stop and is not visible to lower section (Photograph 29, 30 & 31).
- Vegetation is present due to nesting birds resting on parapet brace to east and west of Span 2 (Photograph 32).

**Photograph 24: Evidence of vehicle collision to north-east approach wing wall with spalled concrete and widespread cracking to wall and cope.**

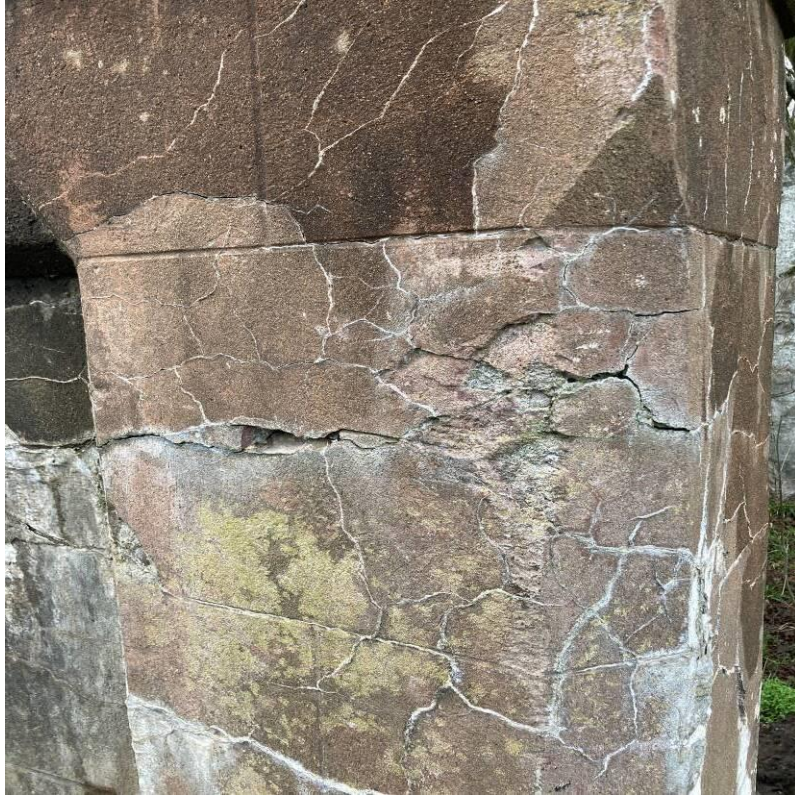
**Photograph 25: Evidence of vehicle collision to north-east approach wing wall with spalled concrete and widespread cracking to wall and cope.**

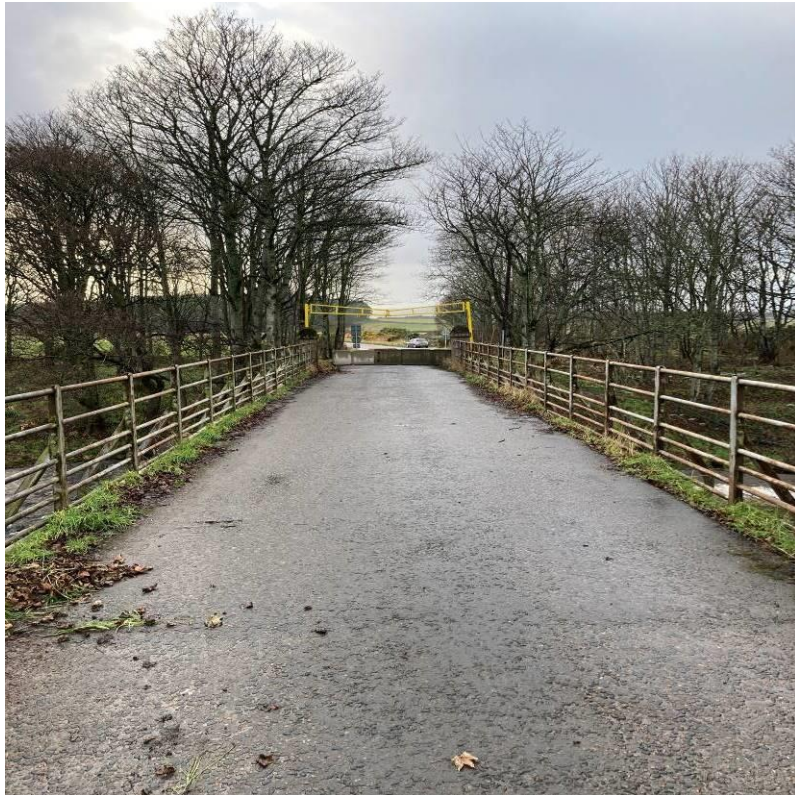
**Photograph 26: Typical band of vegetation growth within drainage channel to carriageway edge.**

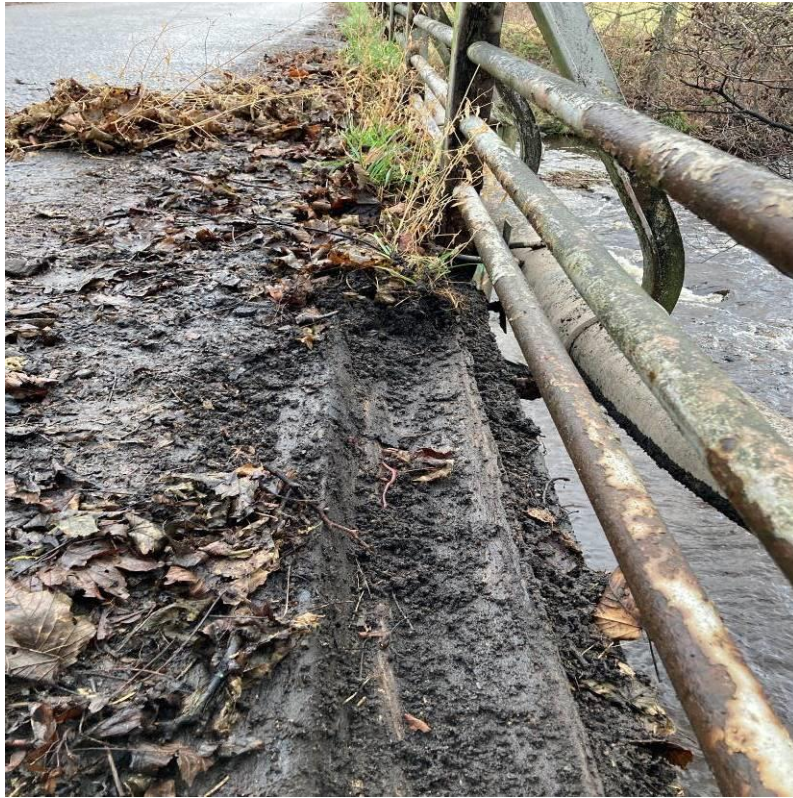
**Photograph 27: Typical band of vegetation growth within drainage channel to carriageway edge.**

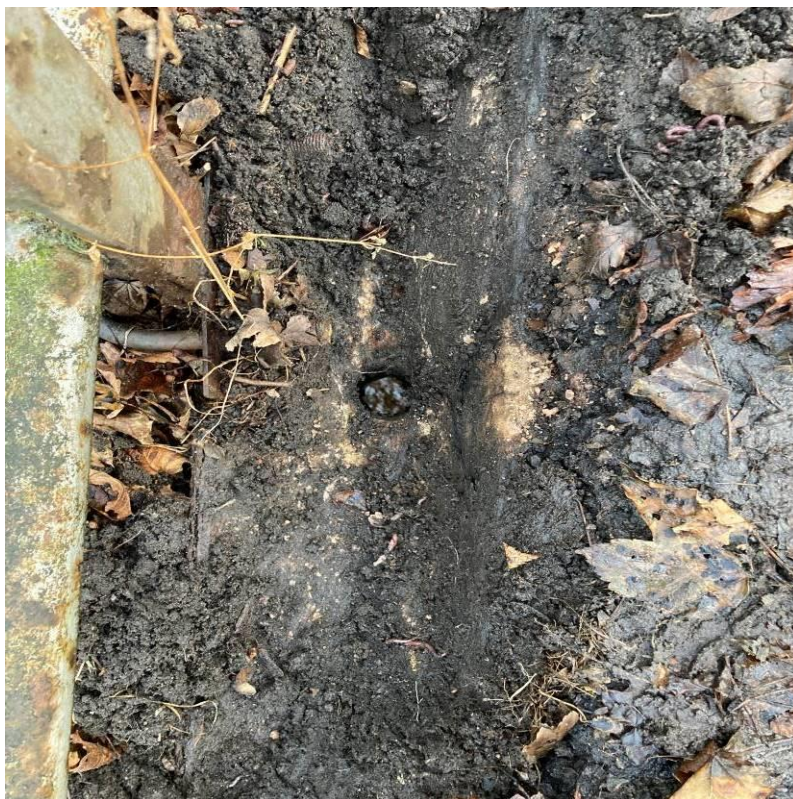
**Photograph 28: Typical drainage outlet situated to north and south of bridge at mid-point of each span. Typically blocked by silt and vegetation.**

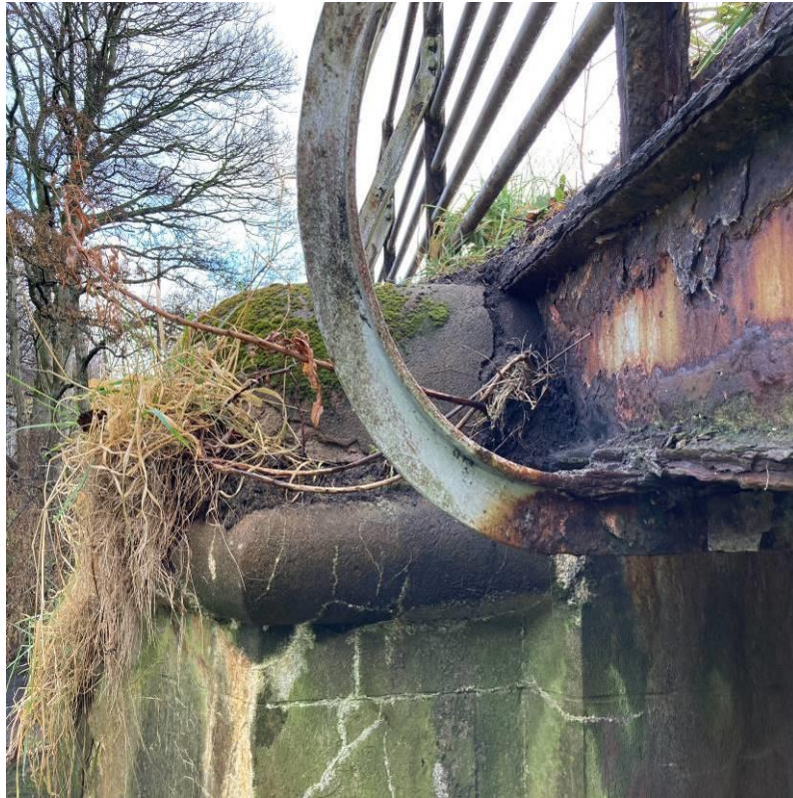
**Photograph 29: Widespread corrosion, delamination and layered rust build-up to lower section of parapet brace member. Paint coating visible to upper section stops and is not visible to lower section.**

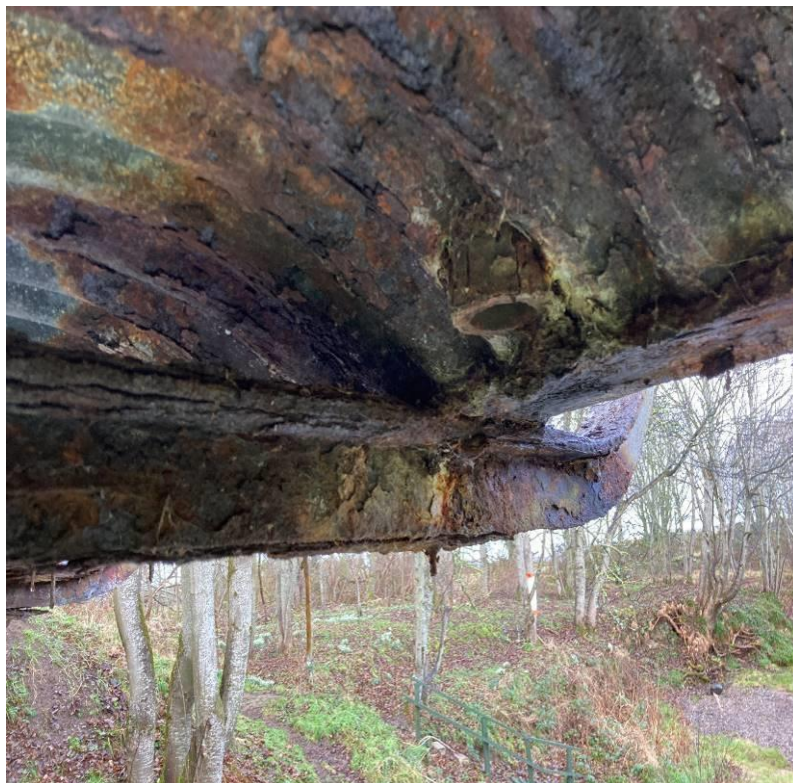
**Photograph 30: Widespread corrosion, delamination and layered rust build-up to lower section of parapet brace member.**

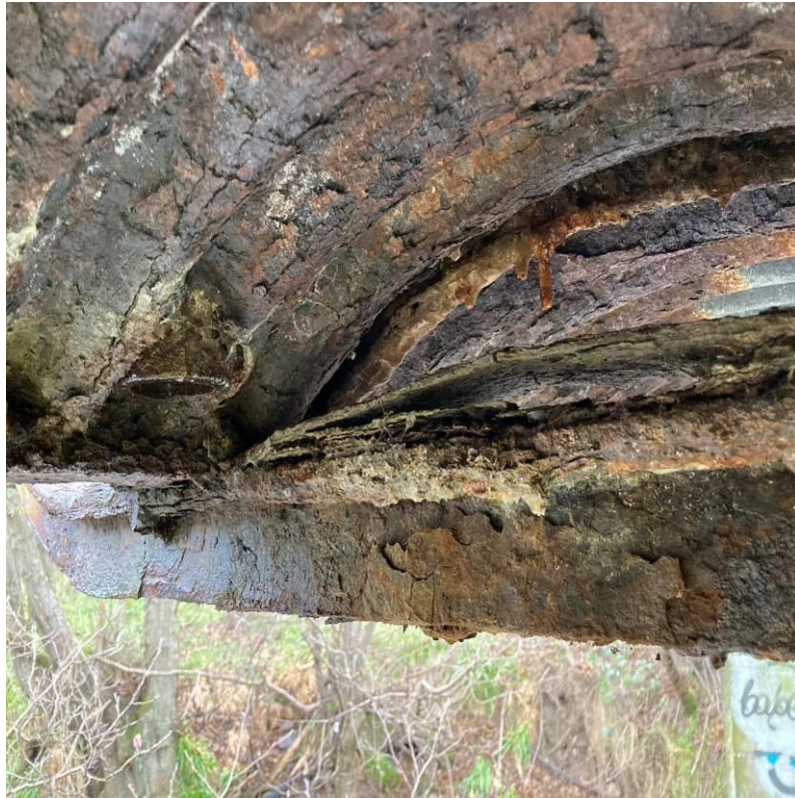
**Photograph 31: Widespread corrosion, delamination and layered rust build-up to lower section of parapet brace member.**

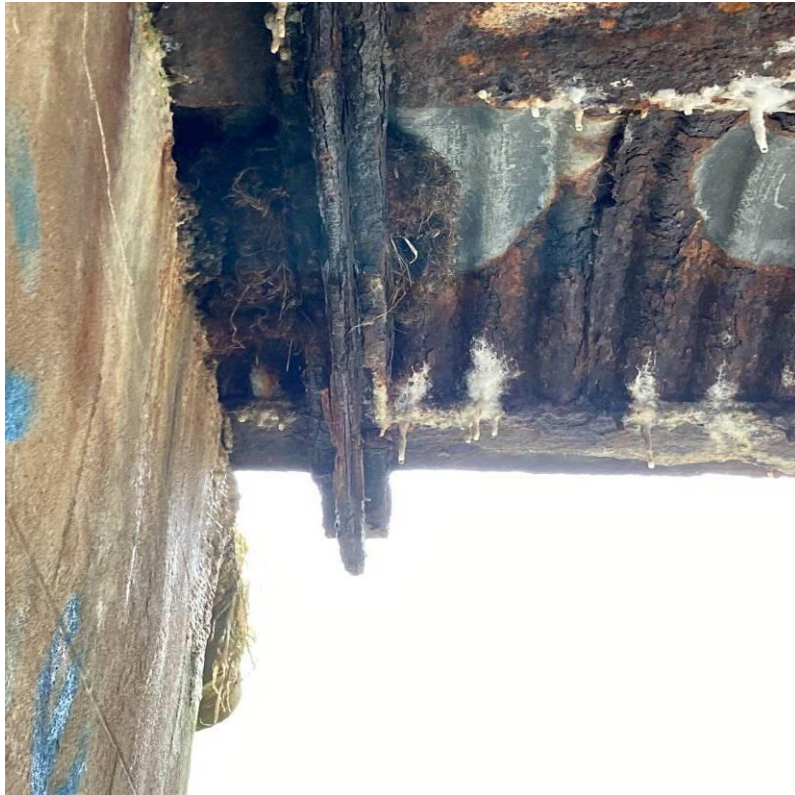
**Photograph 32: Vegetation due to nesting birds resting on parapet brace to east and west of Span 2.**

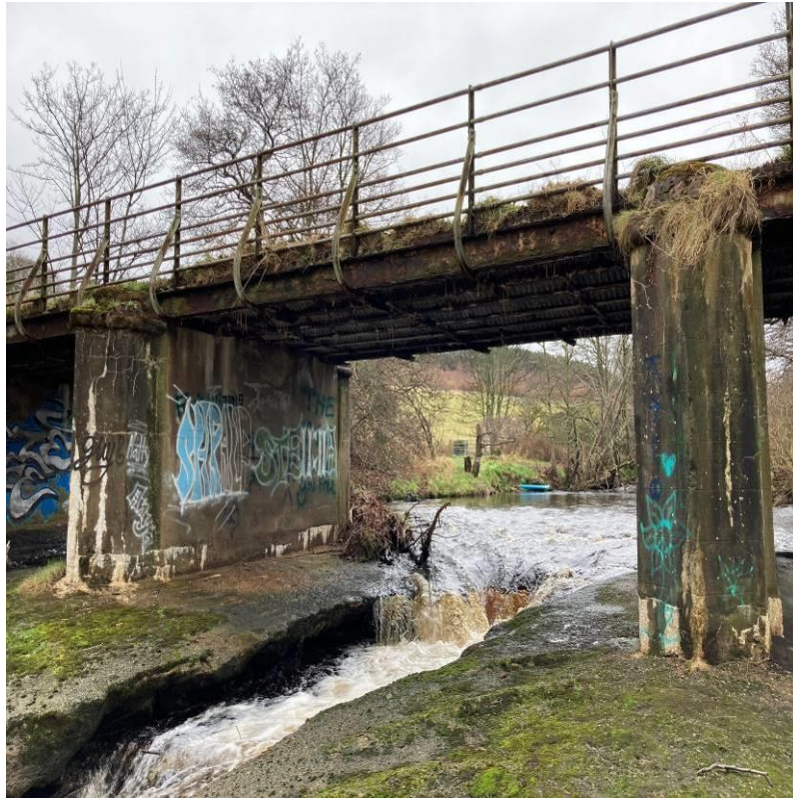
**Photograph 33: Visible cut in concrete invert below Span 2 with fast flowing water. Extent of scour below invert unclear. Accumulation of vegetation to upstream cutwater of Pier 2.**
