# **Inspection and Assessment Report**

## **Cloddach Bridge, Elgin**

**March 2022**

REPORT TITLE: Inspection for Assessment Report

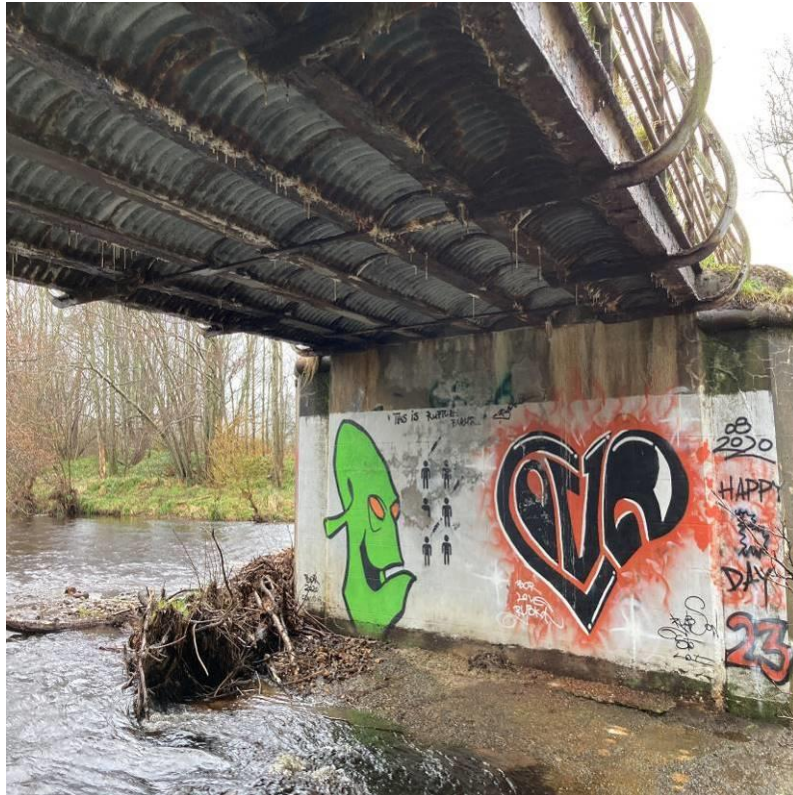
**Photograph 34: Accumulation of vegetation to upstream cutwater of Pier 2.**

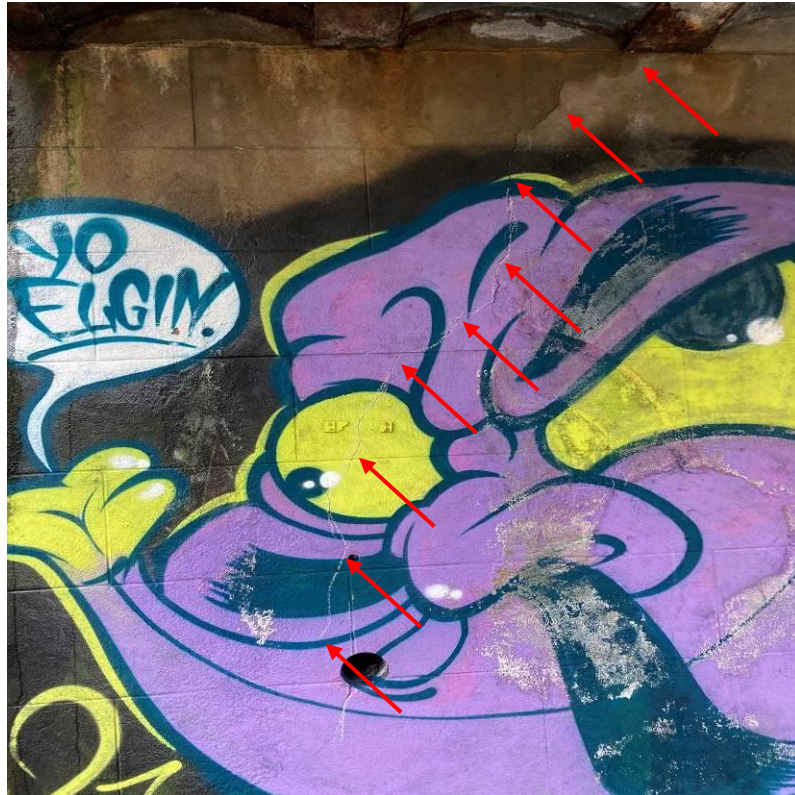
- Graffiti is present along the entire face of both west and east abutments.
- A vertical crack emanating from the support position of PB5 to approximately 950mm above invert level to west abutment. The crack width was measured to be approximately 1mm (Photograph 35).

- A historic crack monitor was identified across vertical crack which is in a state of disrepair. There is no evidence of when crack monitor was installed (Photograph 35).

**Photograph 35: Vertical crack emanating from the support position of PB5 to approximately 950mm above invert level to west abutment. Crack width measured to be approximately 1mm. Historic crack monitor in state of disrepair.**

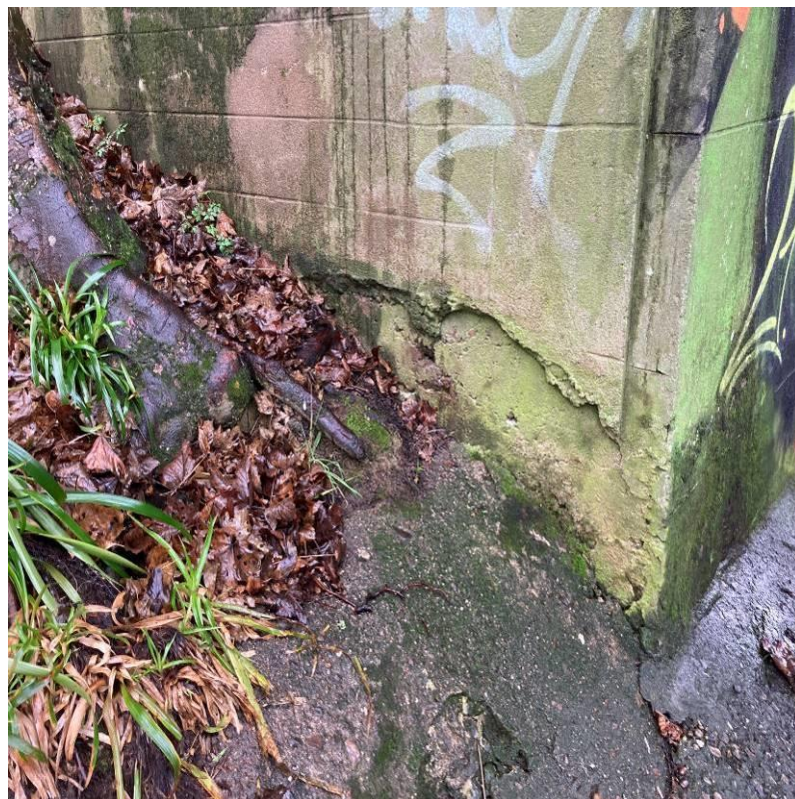
- There is significant scour to the render at base of west abutment (Photograph 36).
- Damp and algae staining is present to the face of the west abutment below the support positions of PB1 & PB7 (Photograph 37).

**Photograph 36: Typical scour to render at base of west abutment.**

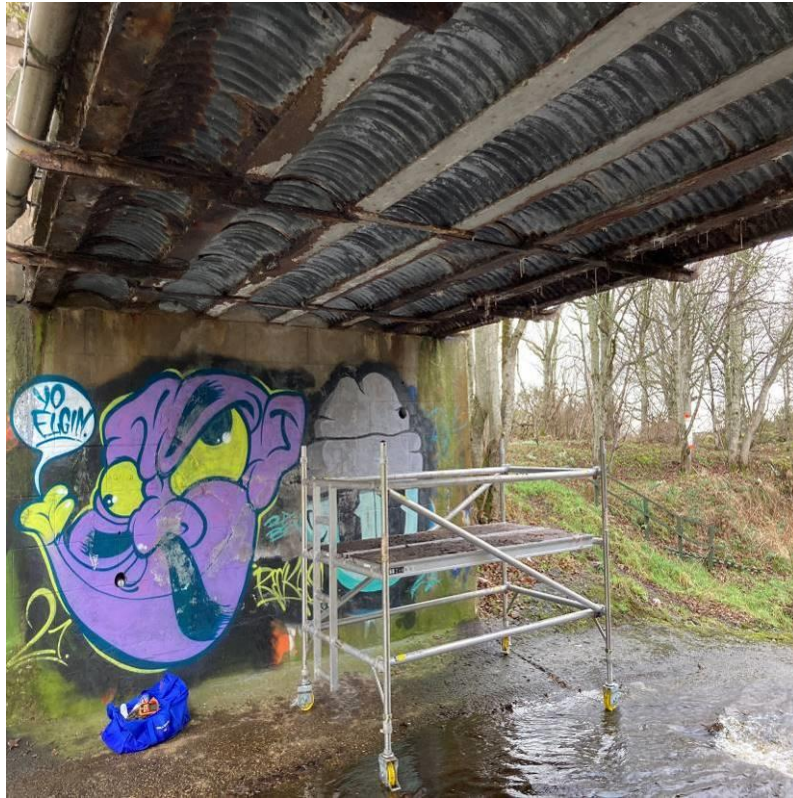
- Two 100mm diameter cores were identified to face of west abutment extending approximately 700mm back into structure (Photograph 37).
- There is significant calcite and algae staining to the face of east abutment below the support positions of steel beams (Photograph 38 & 39).

**Photograph 37: Damp and algae staining to face of west abutment below support position of PB1 and PB7. Two 100mm diameter cores noted to face of abutment extending 700mm back into structure.**

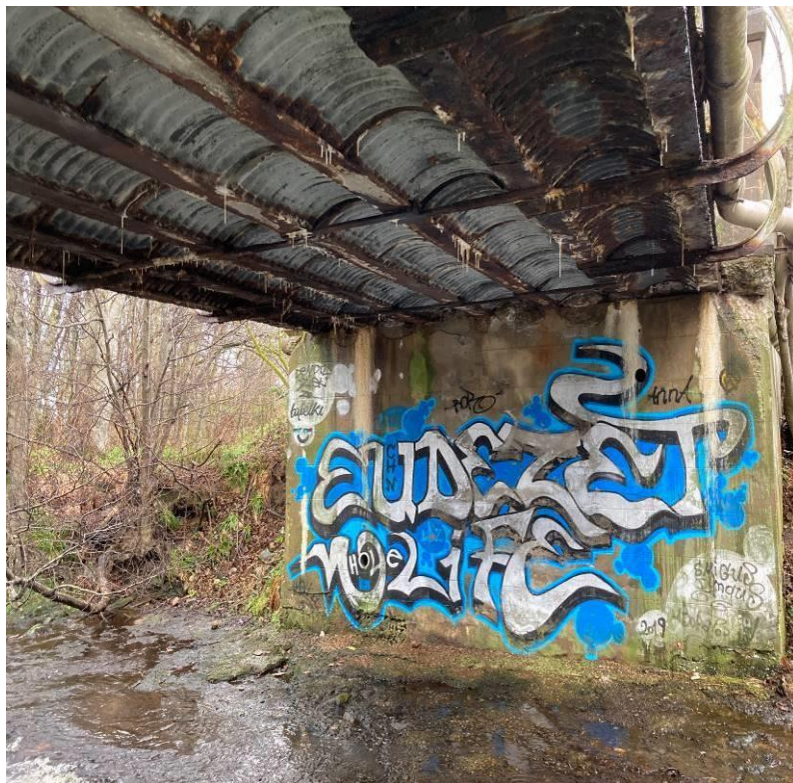
**Photograph 38: Significant calcite and algae staining to face of east abutment below support positions of steel beams.**

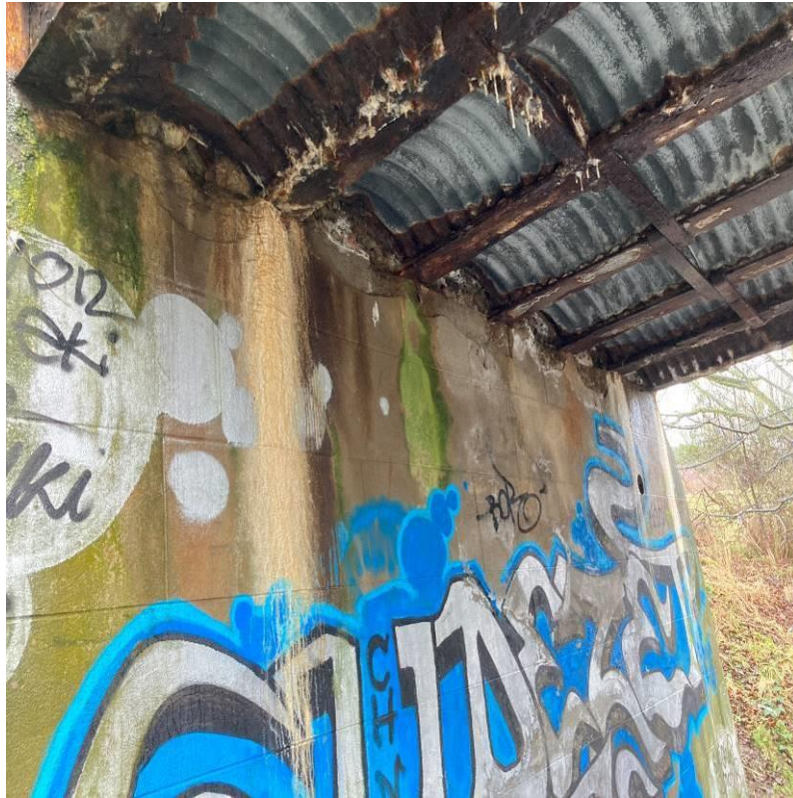
**Photograph 39: Significant calcite and algae staining to face of east abutment below support positions of steel beams.**

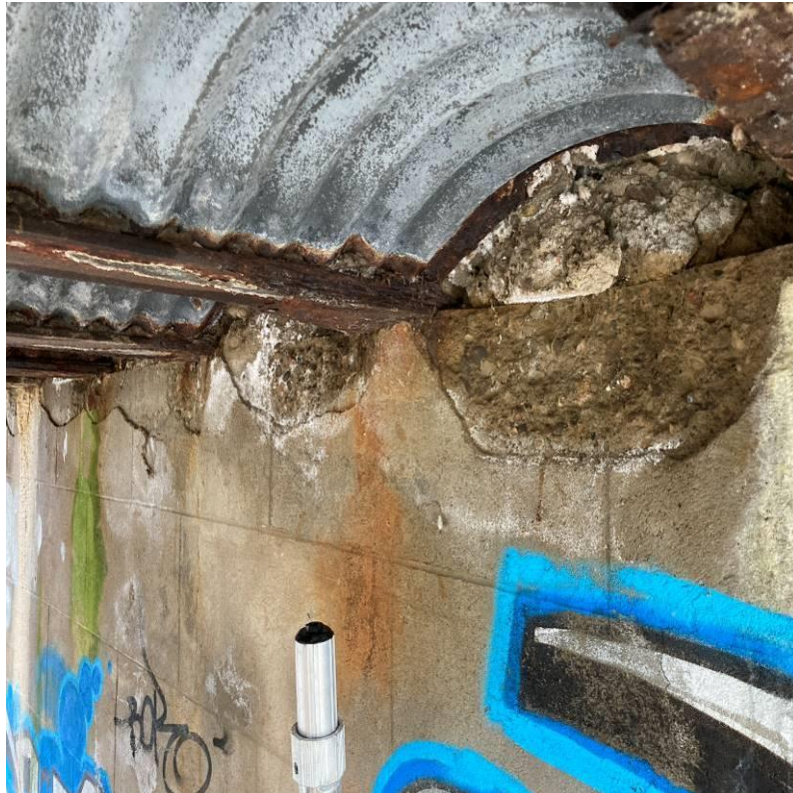
- Significant concrete spalling is present along top of east abutment between beams in each bay. The aggregate is exposed and loose when disturbed (Photograph 40).
- There is a significant concrete spalled area to south-east corner of east abutment leaving approach wing wall above partially unsupported (Photograph 41 & 42).
- There is scour to render at base of east abutment with exposed aggregate (Photograph 43).
- Typical mature vegetation growth is present to the east and west abutment (Photograph 44 & 45).

**Photograph 40: Significant concrete spalling along top of east abutment between beams in each bay. Aggregate exposed and loose when disturbed.**

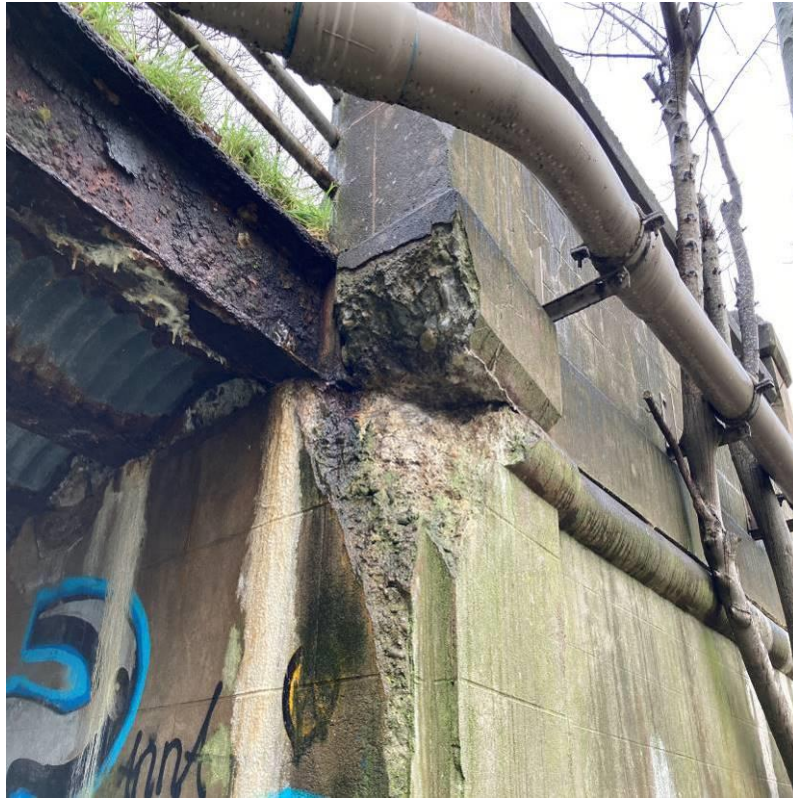
**Photograph 41: Significant concrete spalling to south-east corner of east abutment leaving approach wing wall partially unsupported.**

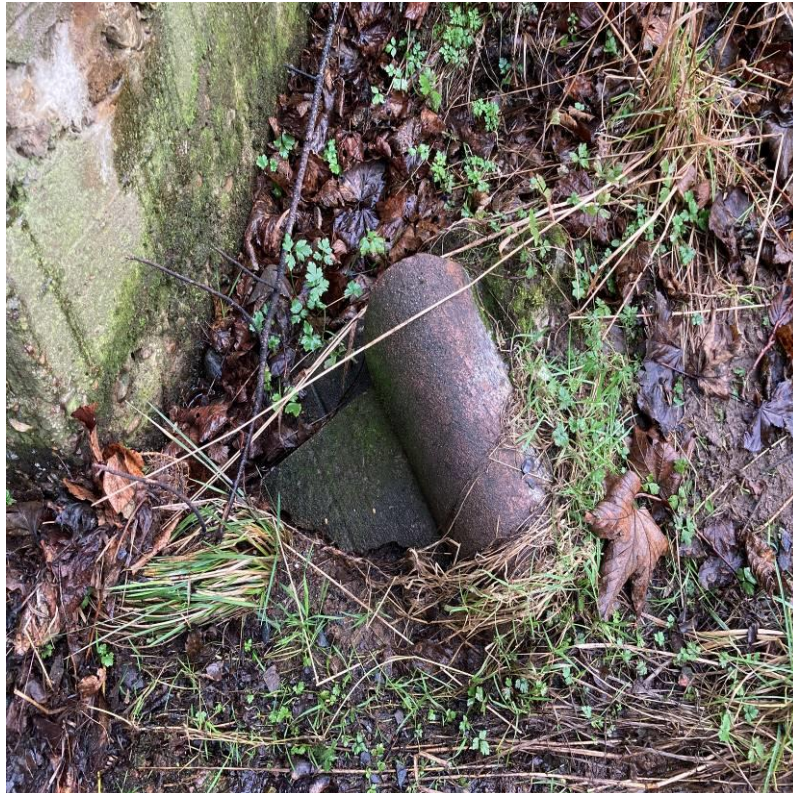
**Photograph 42: Significant concrete spalled to south-east corner of east abutment leaving approach wing wall partially unsupported.**

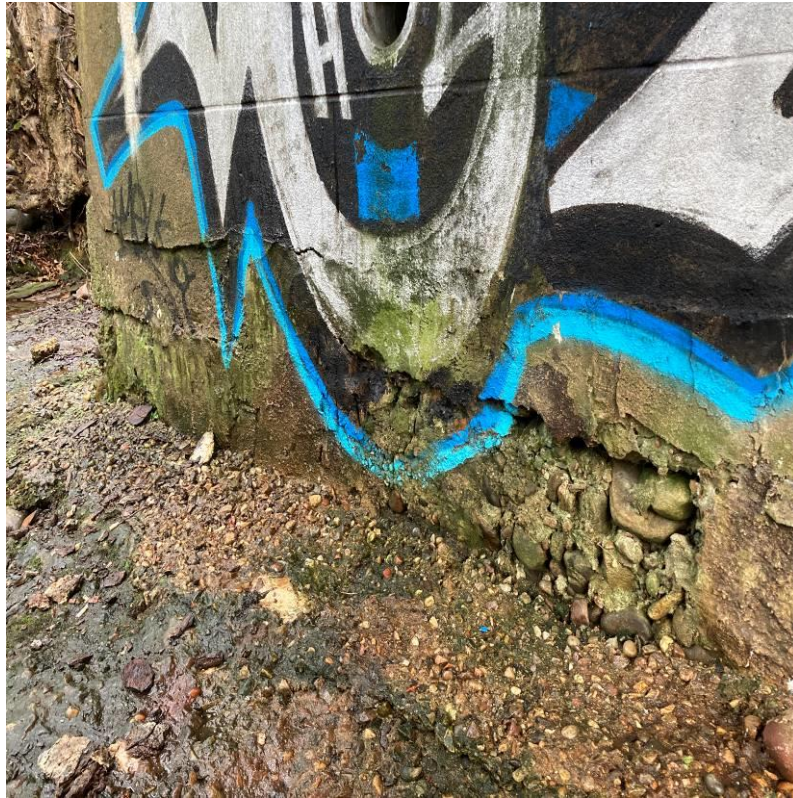
**Photograph 43: Typical scour to base at base of east abutment with exposed aggregate.**

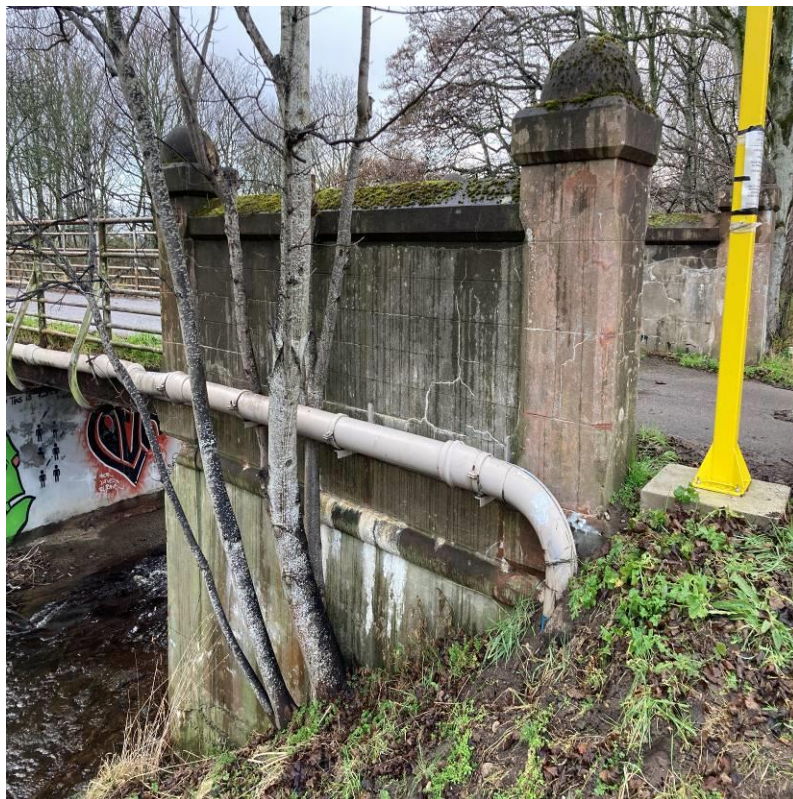
**Photograph 44: Typical mature vegetation growth to east and west abutment.**

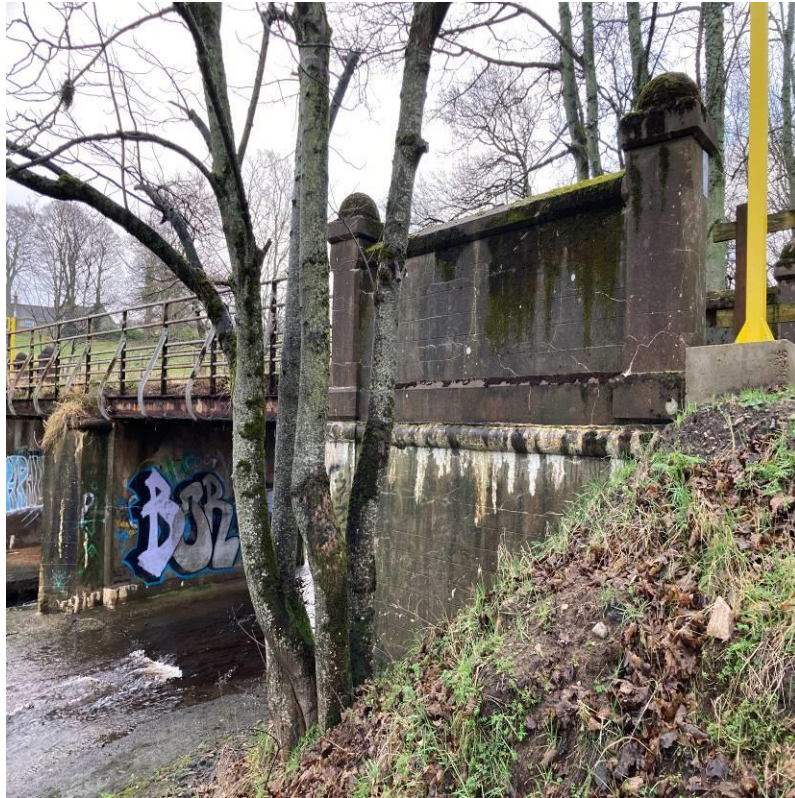
**Photograph 45: Typical mature vegetation growth to east and west abutment.**

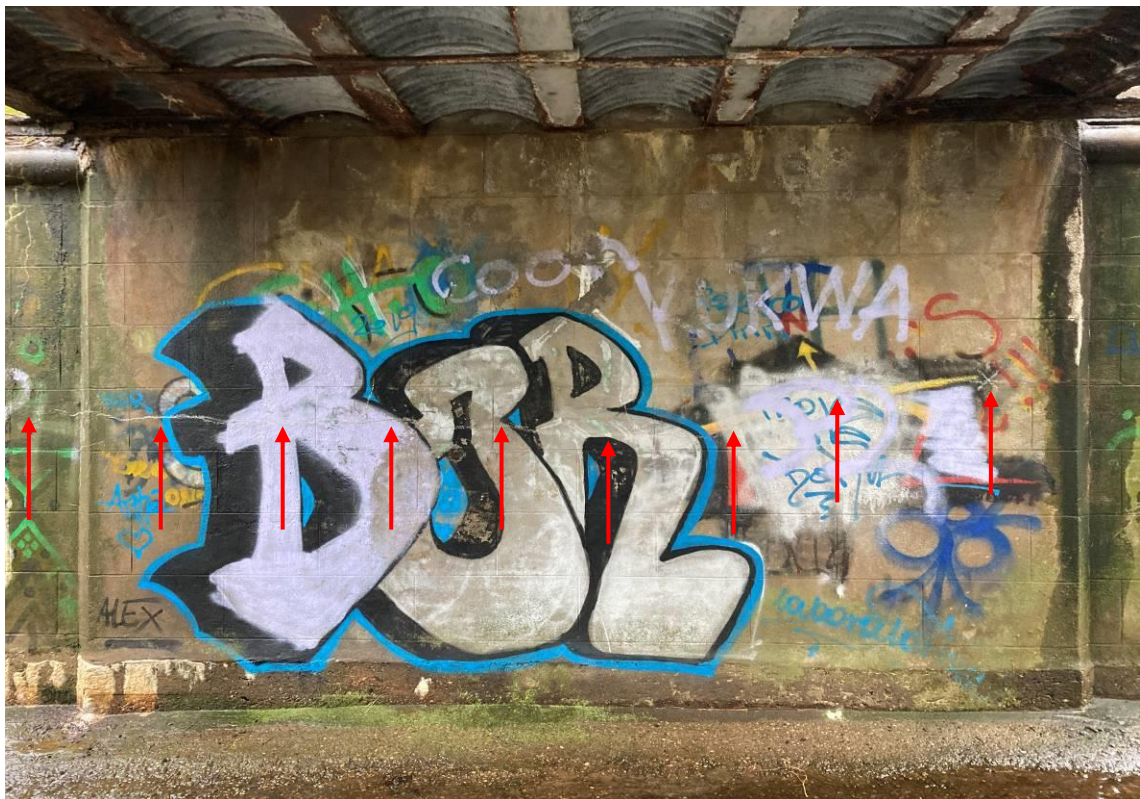
**Photograph 46: Horizontal crack propagating full width of western face of Pier 1. Height of crack varies between 1.3m and 1.6m above invert level. Width of crack varies along length but is less than 1mm at all times.**

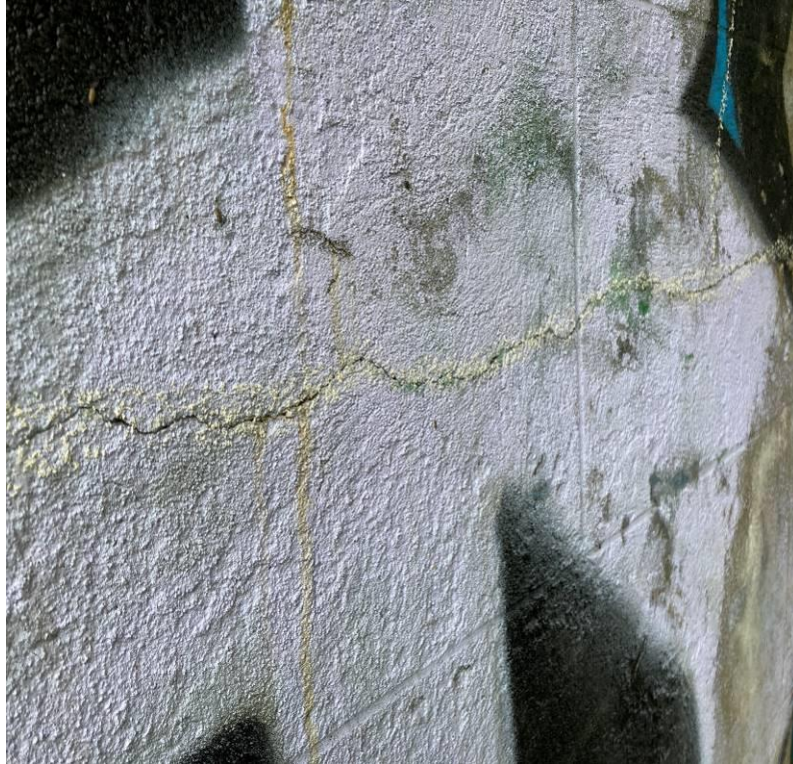
**Photograph 47: Horizontal crack propagating full width of western face of Pier 1. Height of crack varies between 1.3m and 1.6m above invert level. Width of crack varies along length but is less than 1mm at all times.**

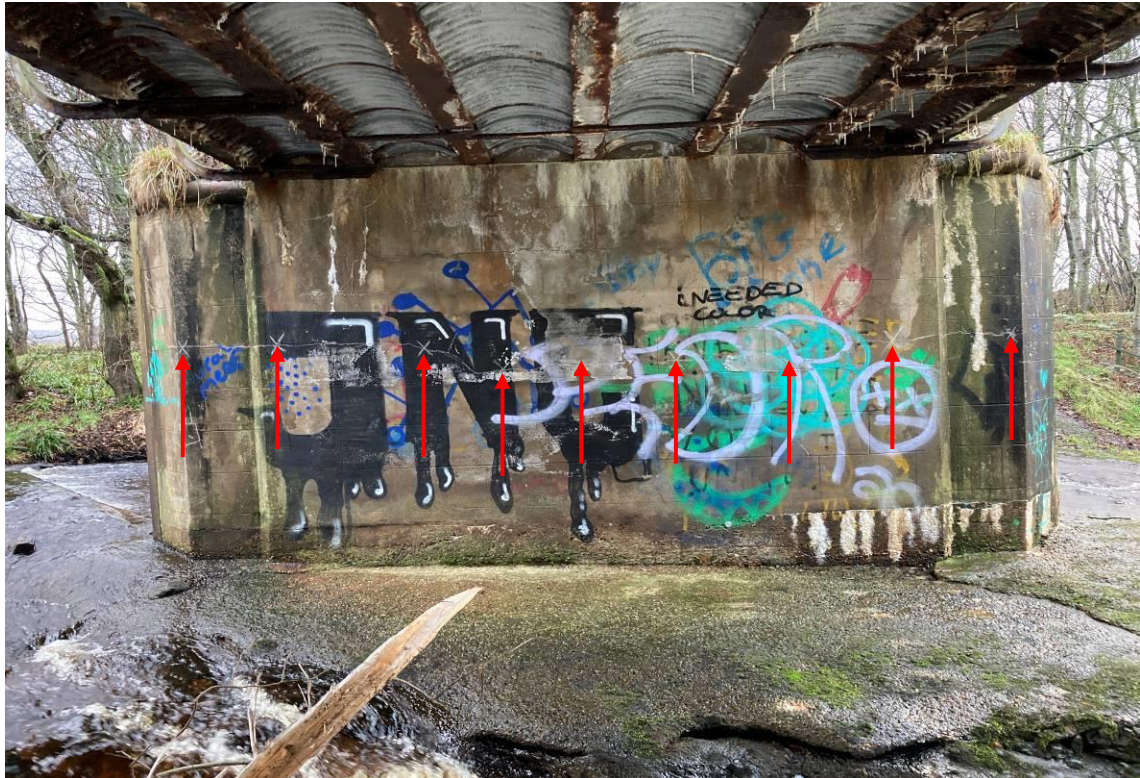
**Photograph 48: Horizontal crack propagating full width of eastern face of Pier 1. Height of crack varies between 1.3m and 1.6m above invert level. Width of crack varies along length but is less than 1mm at all times. Typical calcite staining to face of Pier 1 and Pier 2.**

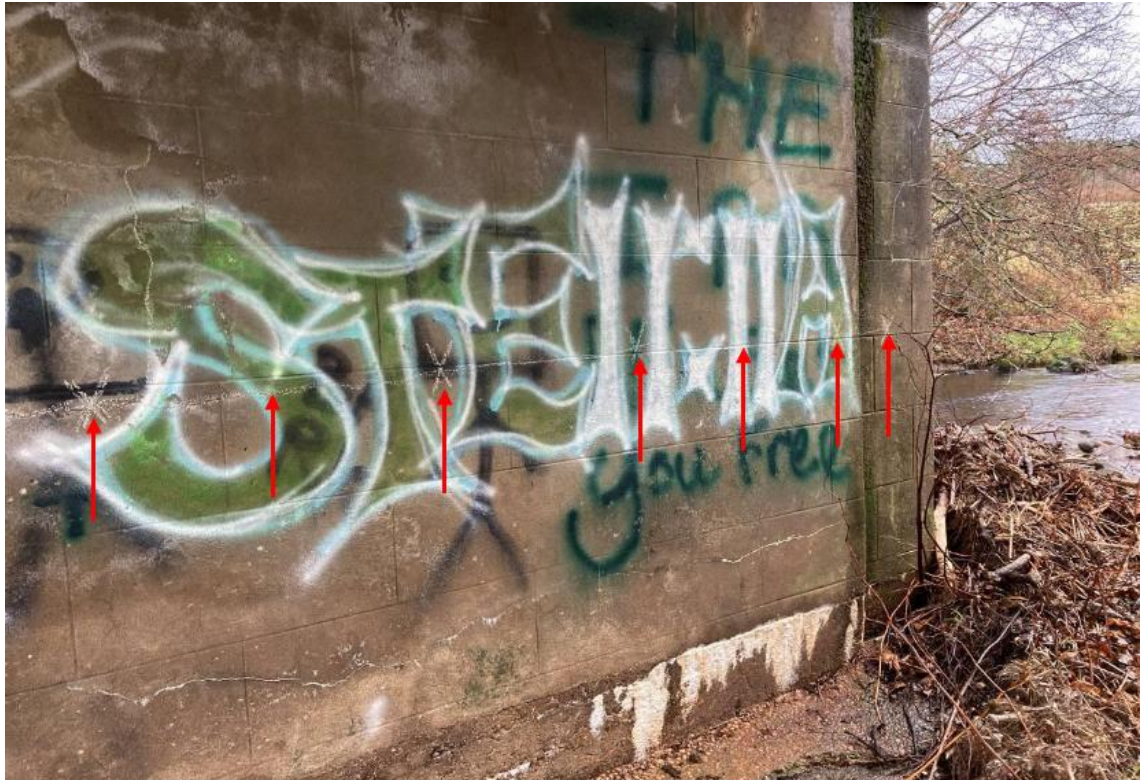
**Photograph 49: Horizontal crack propagating full width of western face of Pier 2. Height of crack varies between 1.3m and 1.6m above invert level. Width of crack varies along length but is less than 1mm at all times.**

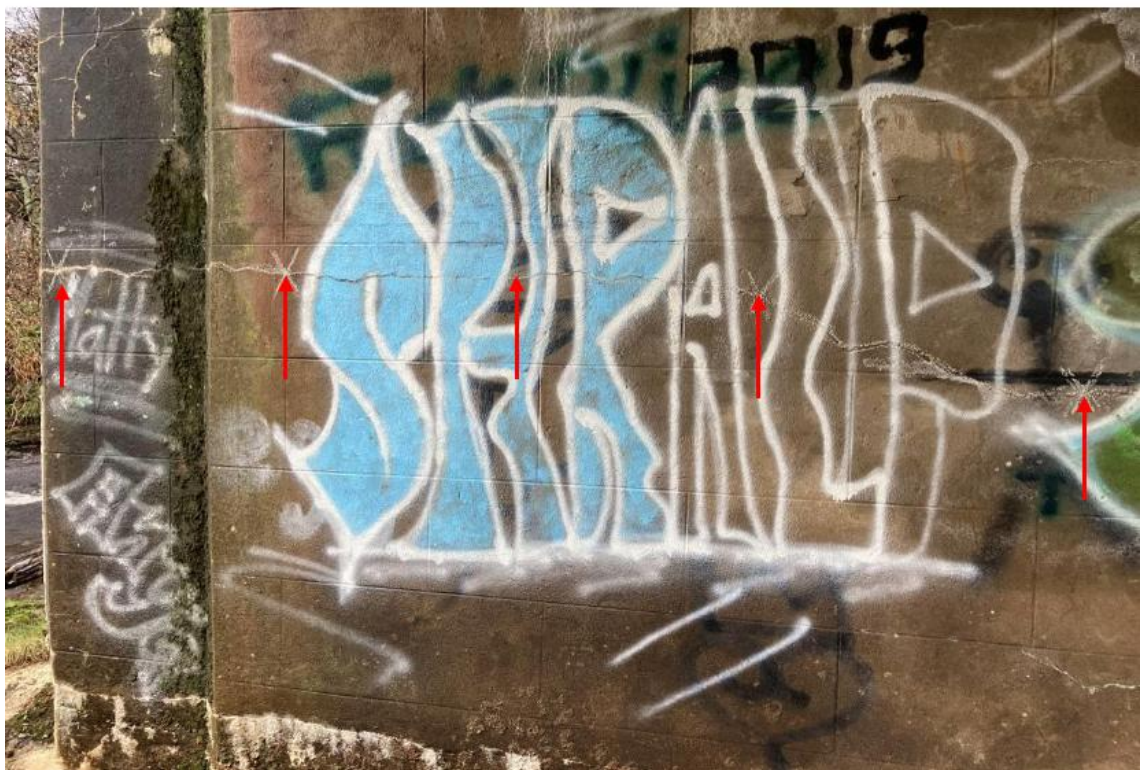
**Photograph 50: Horizontal crack propagating full width of western face of Pier 2. Height of crack varies between 1.3m and 1.6m above invert level. Width of crack varies along length but is less than 1mm at all times.**

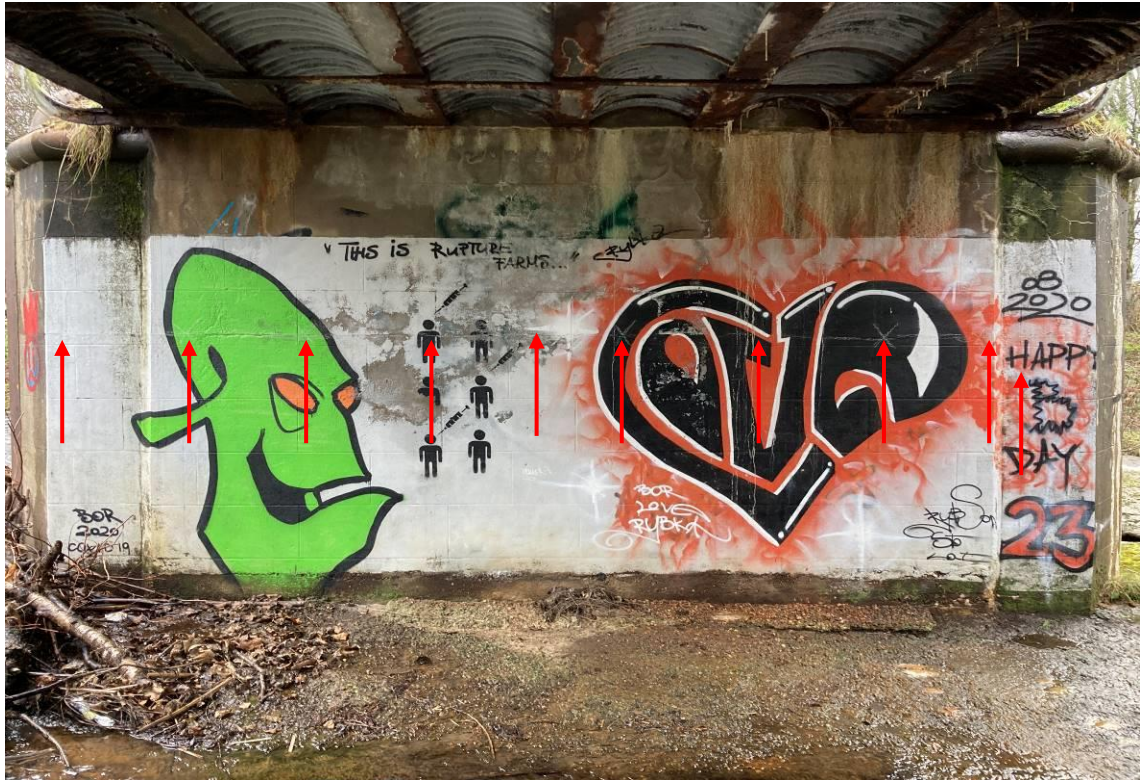
**Photograph 51: Horizontal crack propagating full width of eastern face of Pier 2. Height of crack varies between 1.3m and 1.6m above invert level. Width of crack varies along length but is less than 1mm at all times. Typical calcite staining to face of Pier 1 and Pier 2.**

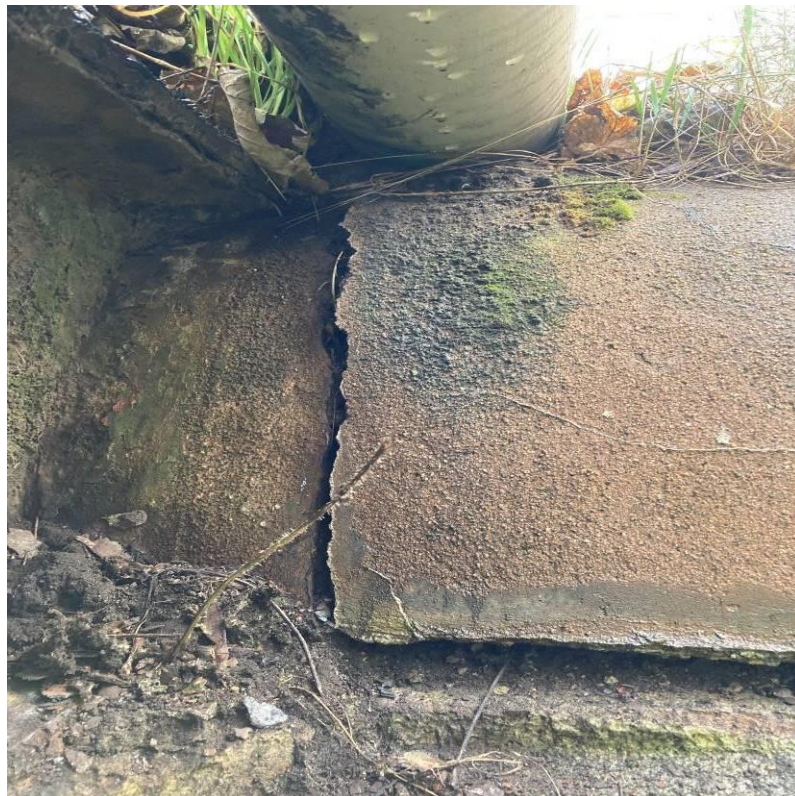
- Graffiti is present to both faces of each intermediate pier.
- There is a horizontal crack propagating full width of both the western and eastern face of Pier 1. The height of the crack varies between 1.3m and 1.6m above invert level. The width of the crack varies along length but is less than 1mm at all times (Photograph 46, 47 & 48).
- A horizontal crack propagates the full width of both western and eastern face of Pier 2. The height of crack varies between 1.3m and 1.6m above invert level. The width of crack varies along the length but is less than 1mm at all times (Photograph 49, 50 & 51).
- Typical calcite staining is present to faces of both Pier 1 and 2 below support positions of steel beams (Photograph 48 & 51).
- Typical concrete spalling and cracking with vegetation growth is present to the decorative cutwater capping (Photograph 52 & 53).

**Photograph 52: Typical concrete breakout and cracking with vegetation growth to decorative cutwater capping.**

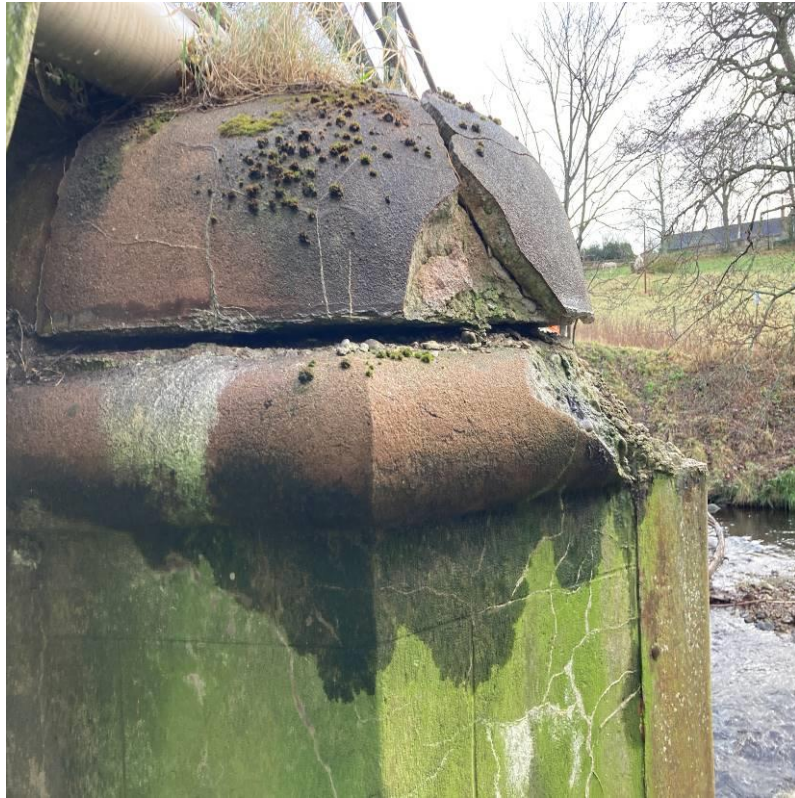
**Photograph 53: Typical concrete breakout and cracking with vegetation growth to decorative cutwater capping.**
