Inspection and Assessment Report

Cloddach Bridge, Elgin

March 2022

CLIENT: The Moray Council
REPORT TITLE: Inspection for Assessment Report
PROJECT REFERENCE: 140163F – Cloddach Bridge, Elgin

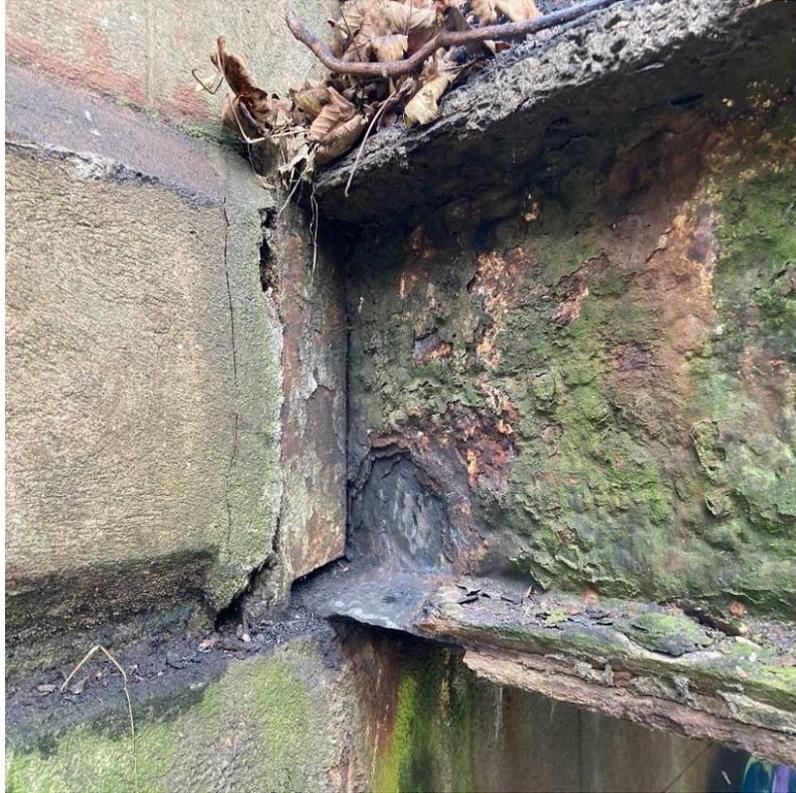
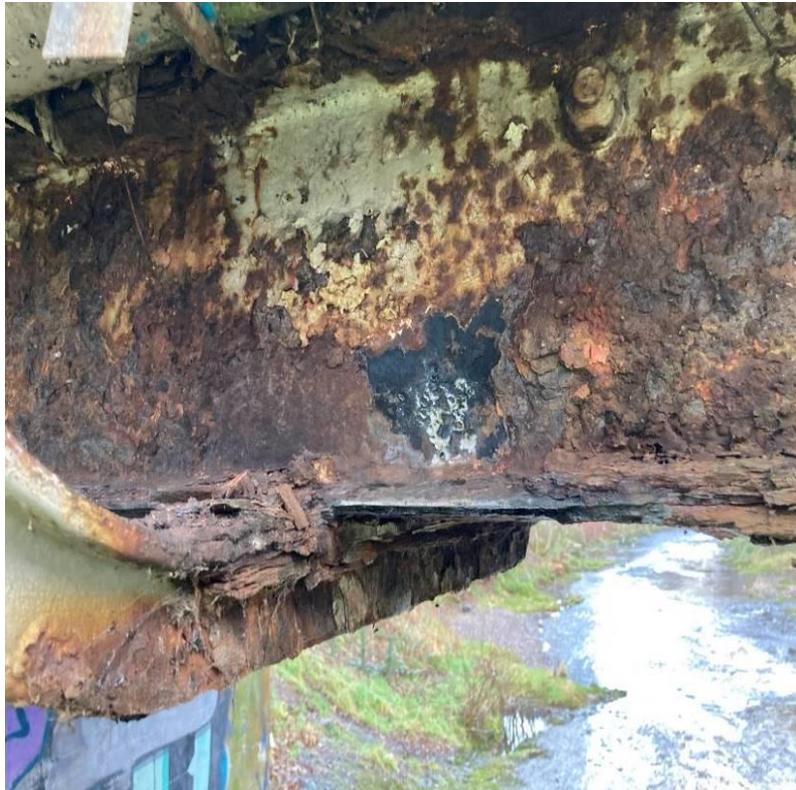
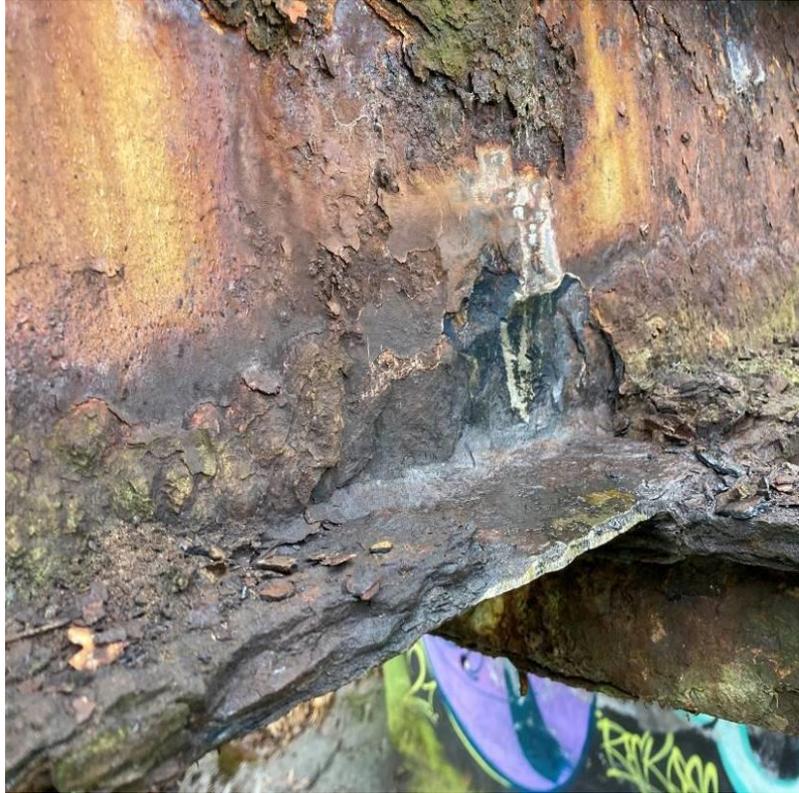
- There is widespread corrosion, delamination and layered rust build-up to entire length of exposed web and flange of PB1 and PB7 over all three spans as noted on defect schedule (Photograph 1, 2 & 3).

Photograph 1: Widespread corrosion, delamination and layered rust build-up to entire length of exposed web and flange of PB1 & PB7 over all three spans.

Photograph 2: Widespread corrosion, delamination and layered rust build up to entire length of exposed web and flange of PB1 & PB7 over all three spans.

Photograph 3: Widespread corrosion, delamination and layered rust build up to entire length of exposed web and flange of PB1 & PB7 over all three spans.

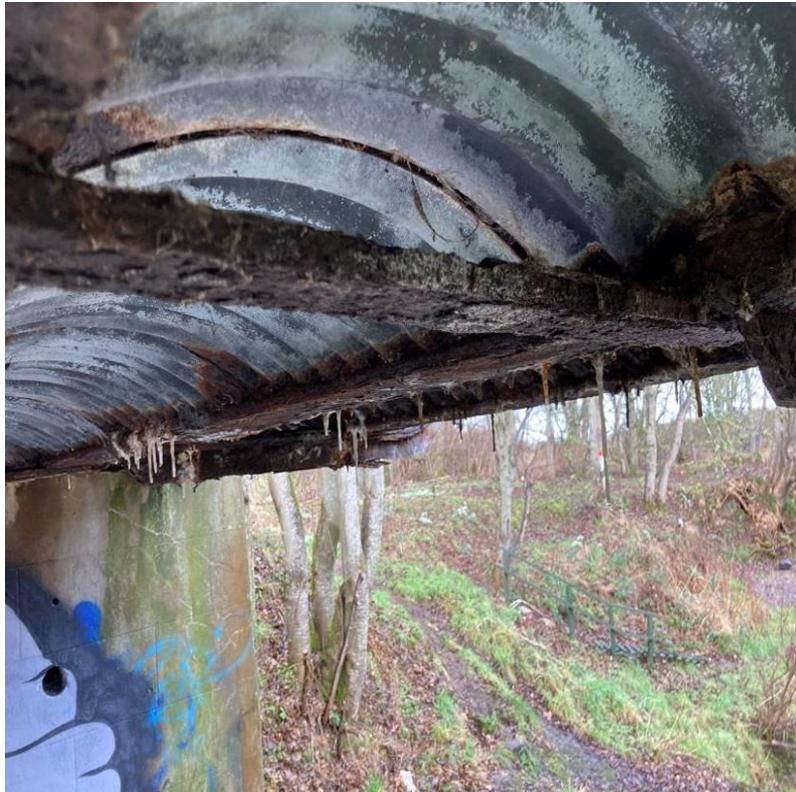
- There is widespread corrosion delamination and layered rust build-up to entire length of visible bottom flange of PB2 and PB6 over all three spans (Photograph 4).

Photograph 4: Widespread corrosion, delamination and layered rust build up to entire length of visible bottom flange of PB2 & PB6 over all three spans.

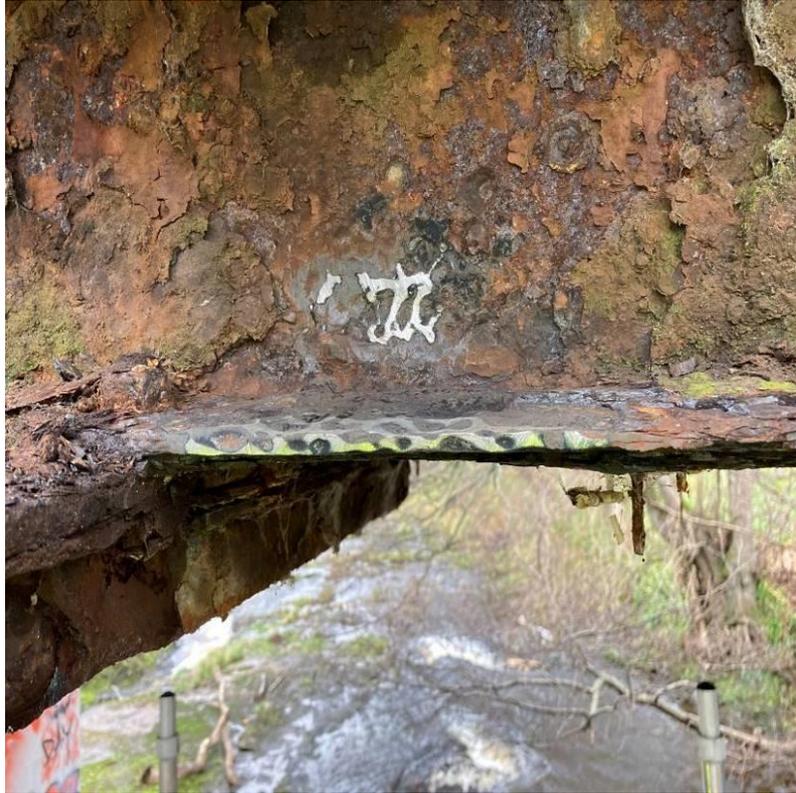
Photograph 5: Visible section loss to flange of PB1 & PB7 over all three spans. Flange measuring 4-6mm at toe and, on average, 12.4mm at quarter points of overall flange width.

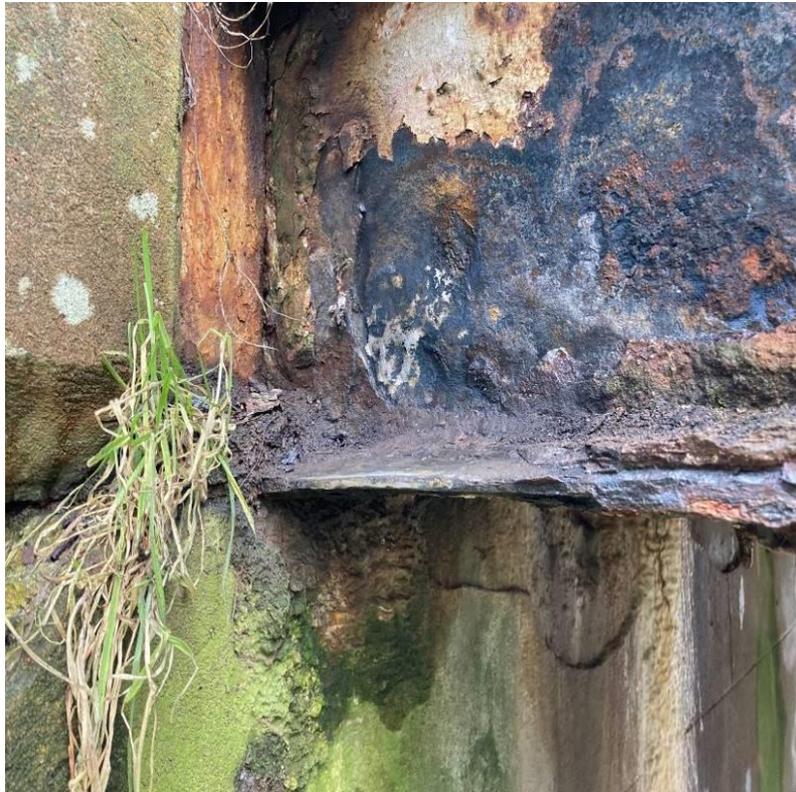
Photograph 6: Widespread corrosion, delamination and layered rust build up to entire length of exposed web and flange of PB1 & PB7 over all three spans.

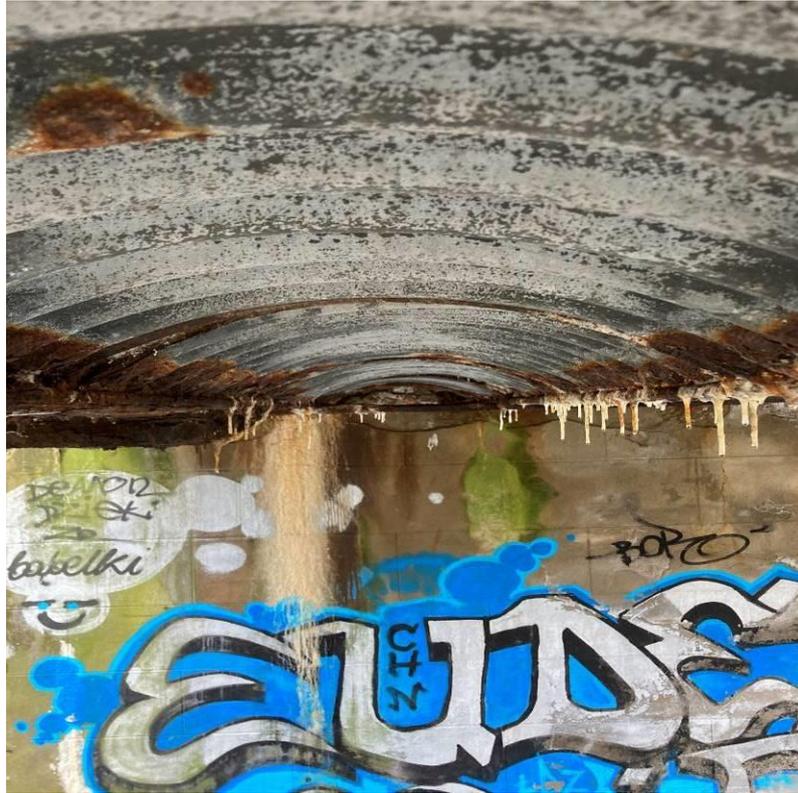
Photograph 7: Widespread calcite stalactites to bottom flange of PB1 – PB7 indicating extensive water ingress through deck structure. Typical localised surface rust at junction between corrugated steel shuttering and steel beam bottom flange.

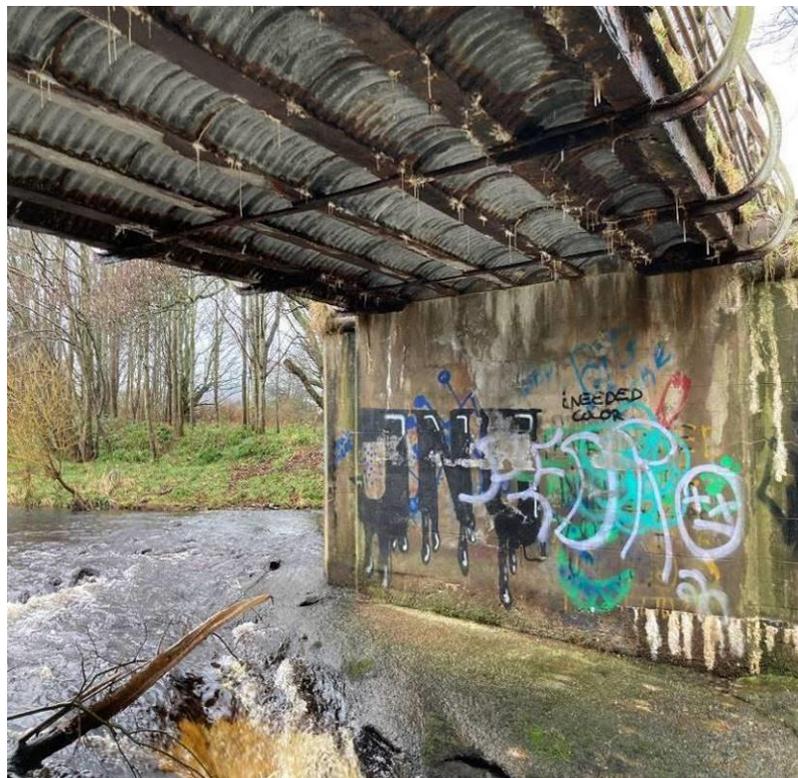
Photograph 8: Widespread calcite stalactites to bottom flange of PB1 – PB7 indicating extensive water ingress through deck structure.

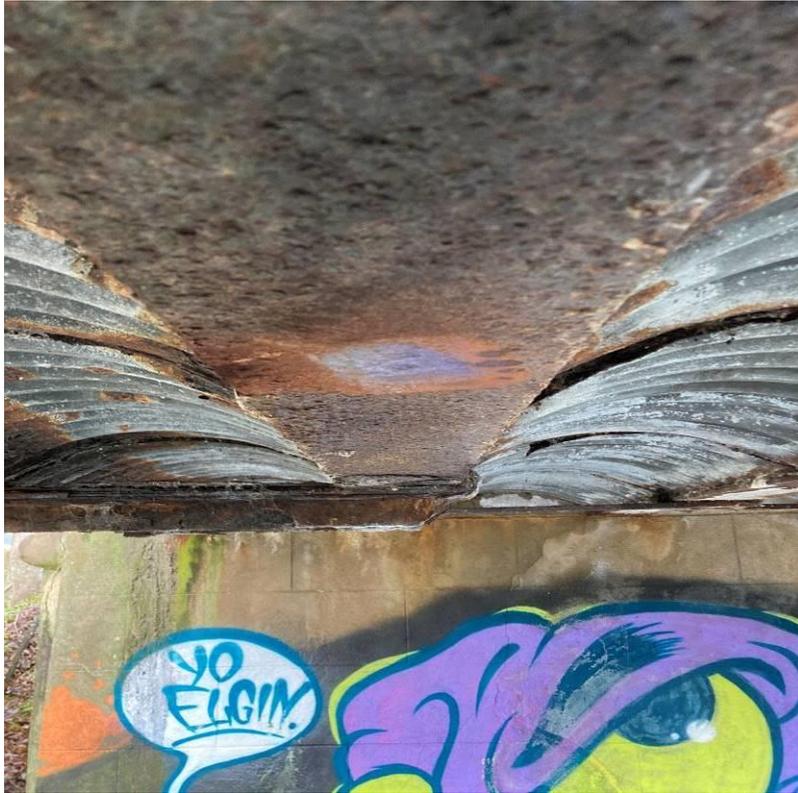
Photograph 9: Typical defect to internal beams - moderate surface rust and pitting to soffit of bottom flange (PB6, Span 1 shown).

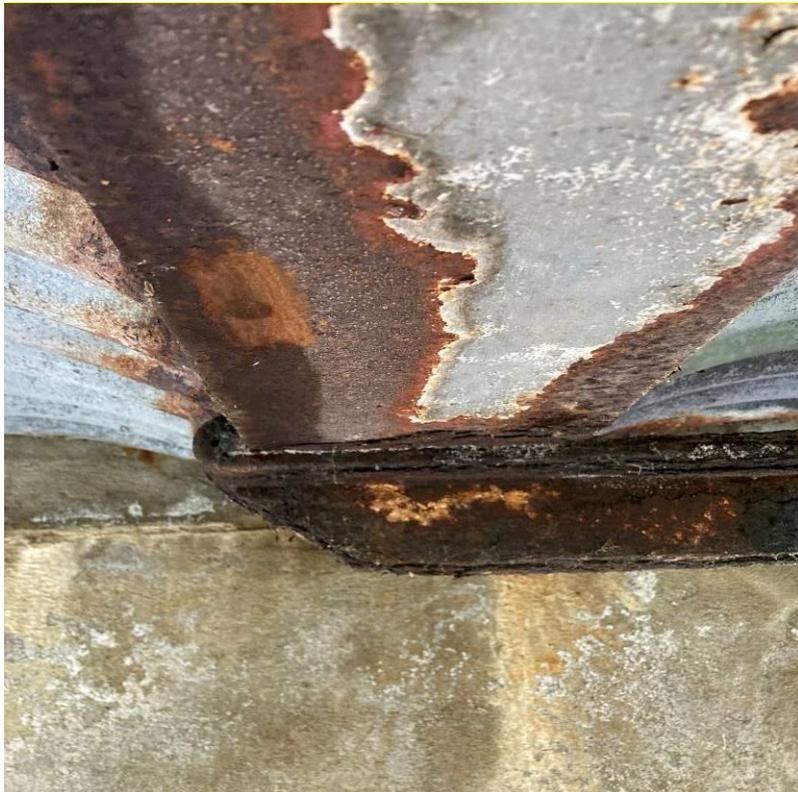
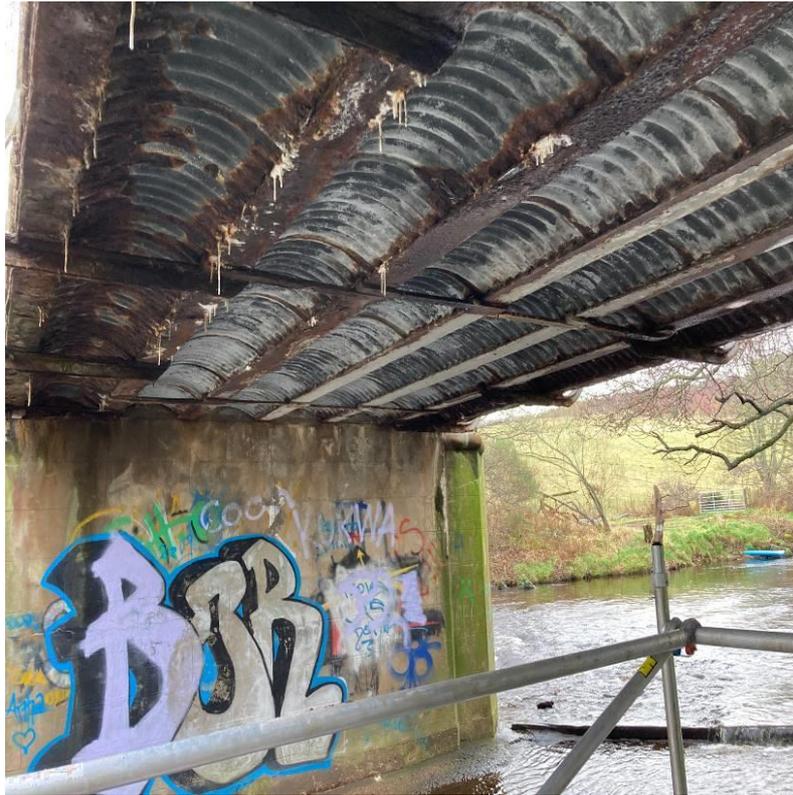
- There is general moderate surface rust and pitting to soffit of bottom flange of internal beams (Photograph 9).
- The flaking paint to soffit of bottom flange of PB4 – PB6 in Span 1. Is indicative of condition where paint coating was only partially intact throughout all three spans. No paint coating was generally visible to PB1 and PB7 as rust layering and delamination was too extensive (Photograph 10 & 11).

Photograph 10: Flaking paint to soffit of bottom flange of PB4-PB6 in Span 1. Indicative of condition where paint coating was partially intact throughout all three spans.

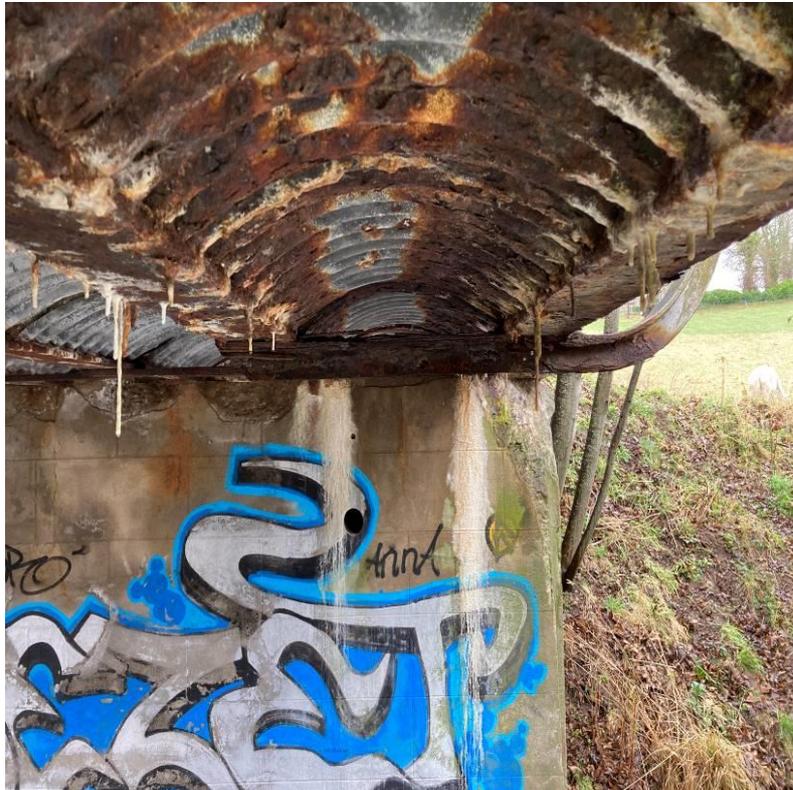
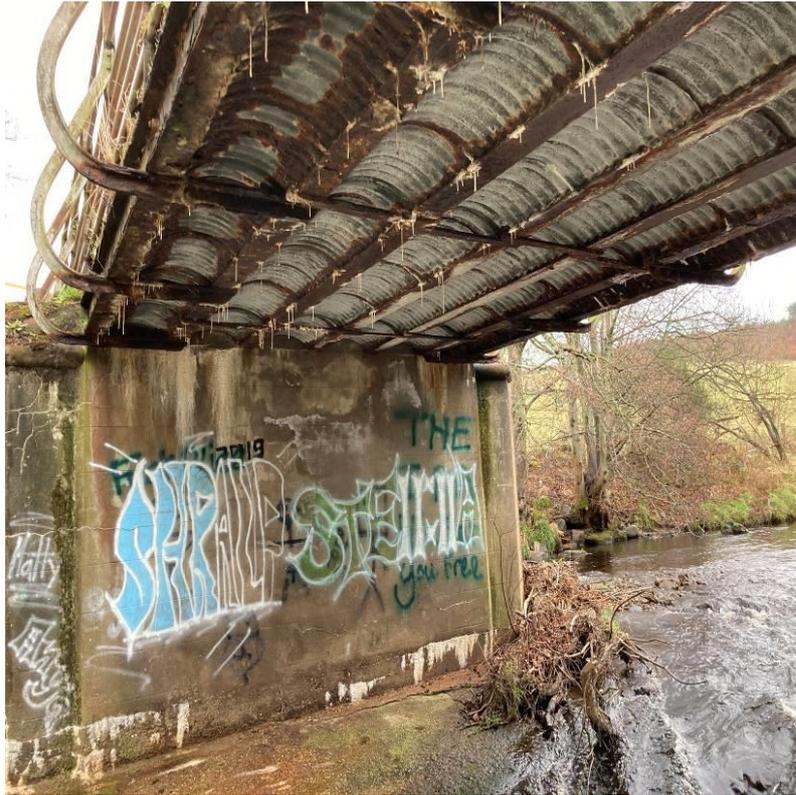
- There is surface rust, delamination and corrosion to the corrugated steel shuttering to the soffit of the structure. This is widespread through the structure but predominantly found between PB1 – PB2 and PB6 – PB7 within each span (Photograph 12 & 13).
- Typical localised surface rust is present at the junction between the corrugated steel shuttering and primary steel beam bottom flange. This rust is also prevalent throughout the entire structure (Photograph 7 & 14).
- Localised failure of corrugated steel shuttering was observed at junction with PB3 within Span 1 (Photograph 15 & 16).
- The mass concrete to the jack arched slab is honeycombed with visible areas of rounded river gravel aggregate indicating the poor quality of the original concrete. (Photograph 17).

Photograph 12: Surface rust, delamination and corrosion to the corrugated steel shuttering forming the soffit of the structure. Predominant in arches between PB1 - PB2 and PB6 - PB7.

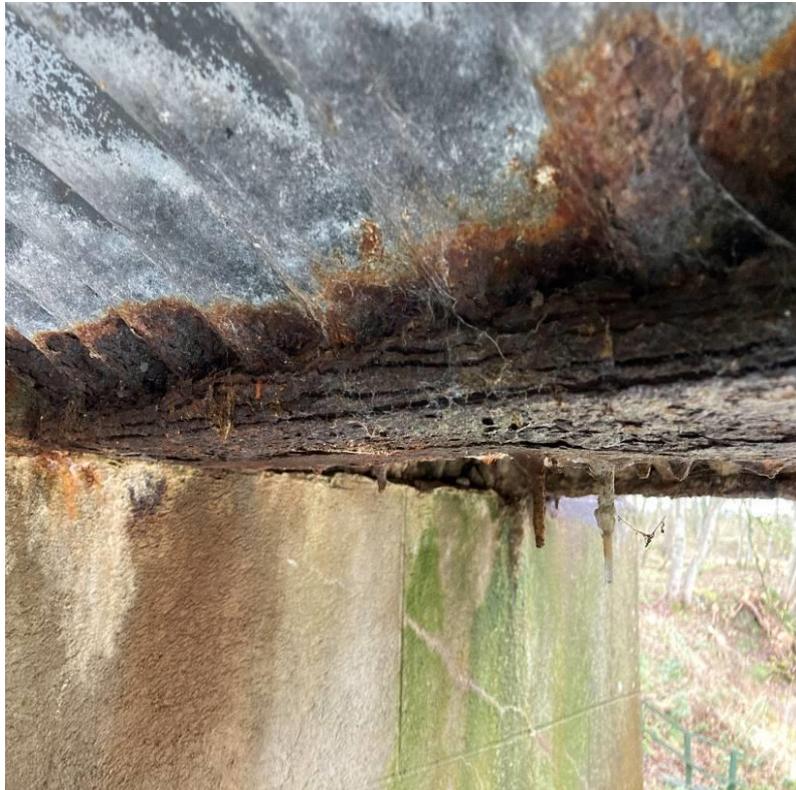
Photograph 14: Typical localised surface rust at junction between corrugated steel shuttering and steel beam bottom flange.

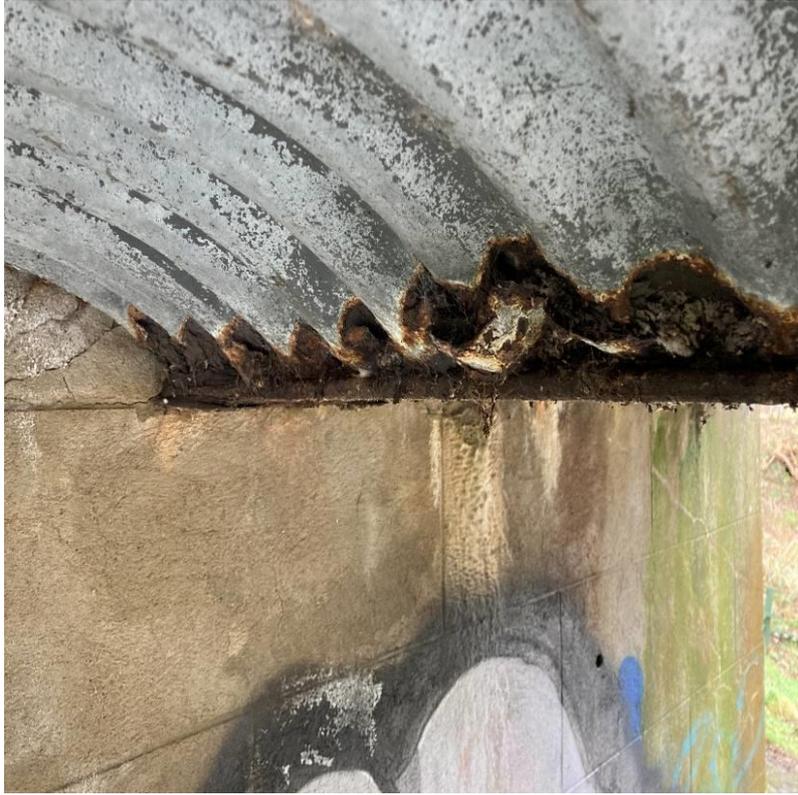
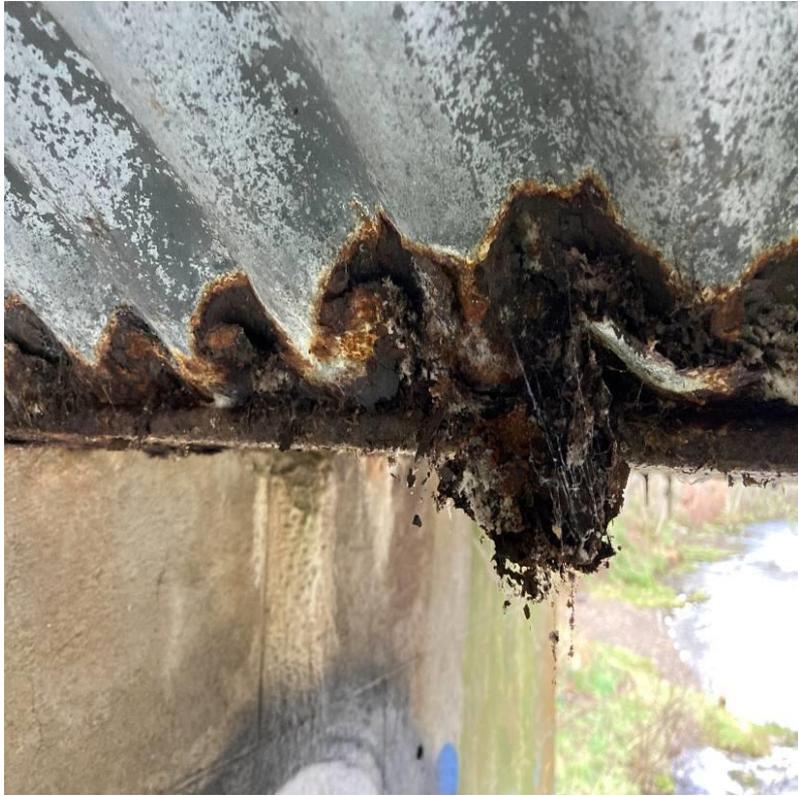
Photograph 15: Localised failure of corrugated steel shuttering at junction with PB3 within Span 1.

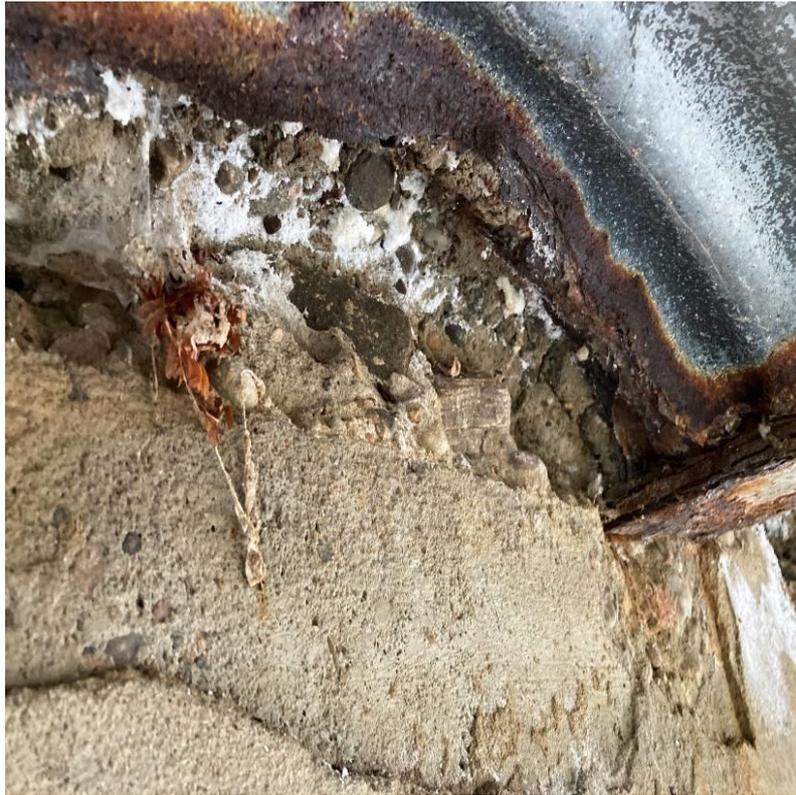
Photograph 17: Mass concrete jack arched slab visible with rounding river gravel aggregate indicating a low grade concrete mix.

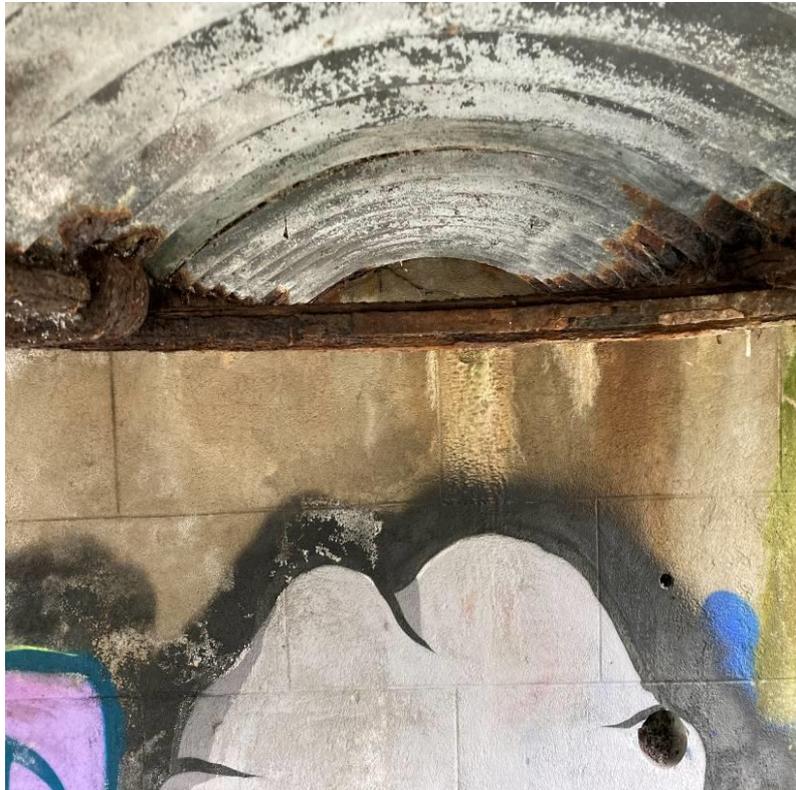
- There is typical layered surface rust and delamination to all transverse ties. Areas with extensive corrosion were measured to be approximately 30mm deep with true section depth taken as 10mm within less corroded areas (Photograph 18).

Photograph 18: Typical layered surface rust and delamination to all transverse ties.

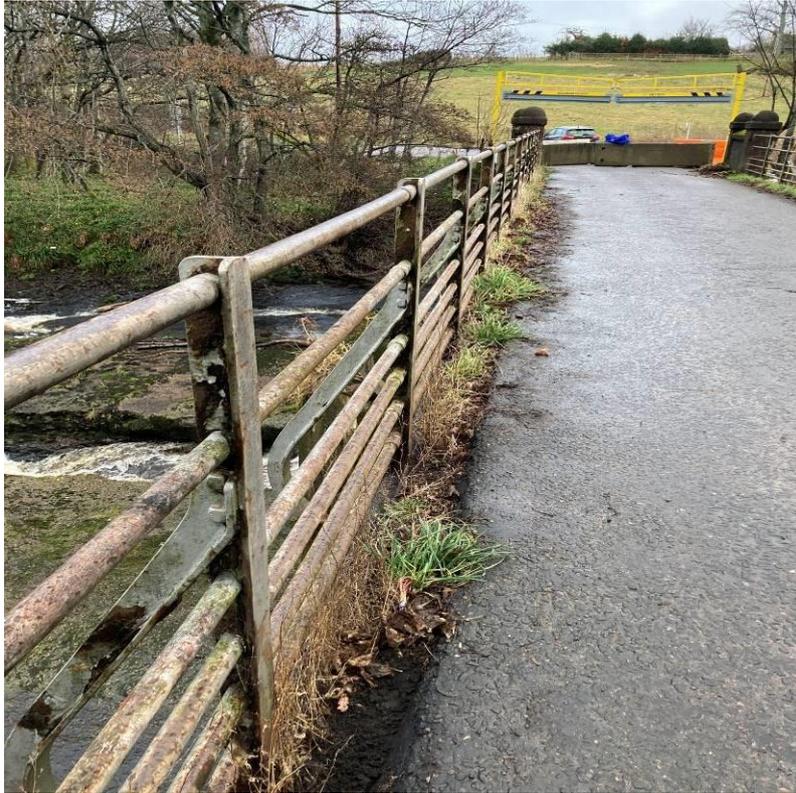
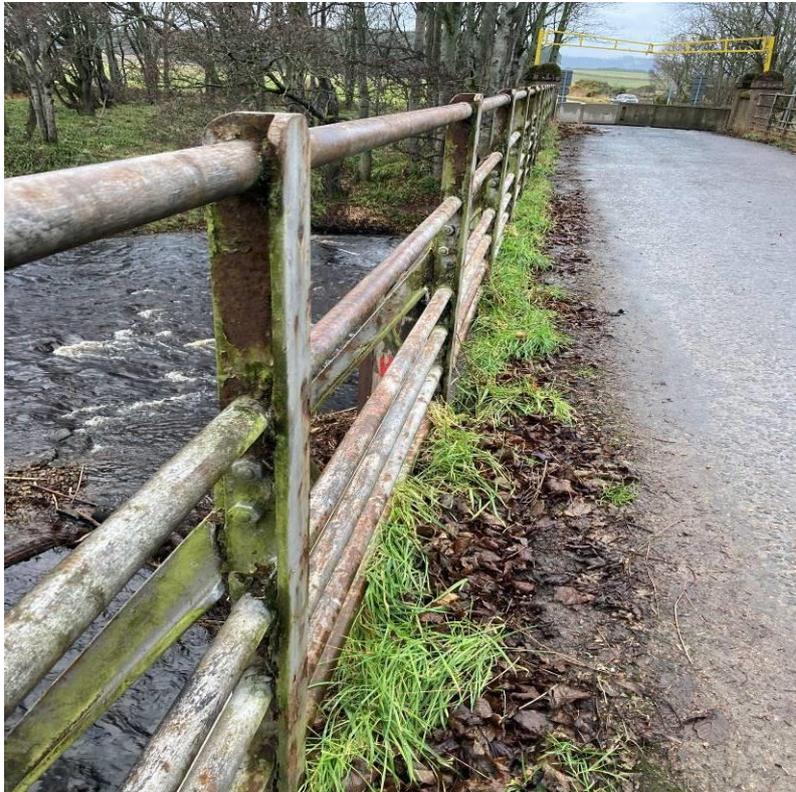
- Typical weathering with surface rust and failure of coating system to parapet rails and upstands has been noted (Photograph 19 & 20).
- Typical cracks are propagating from the junction between the steel parapet rails and the mass concrete approach wing walls (Photograph 21).
- There is widespread hairline cracking to approach wing walls (Photograph 22 & 23).

Photograph 19: Typical weathering, surface rust and failure of coating system to parapet rails and upstands.

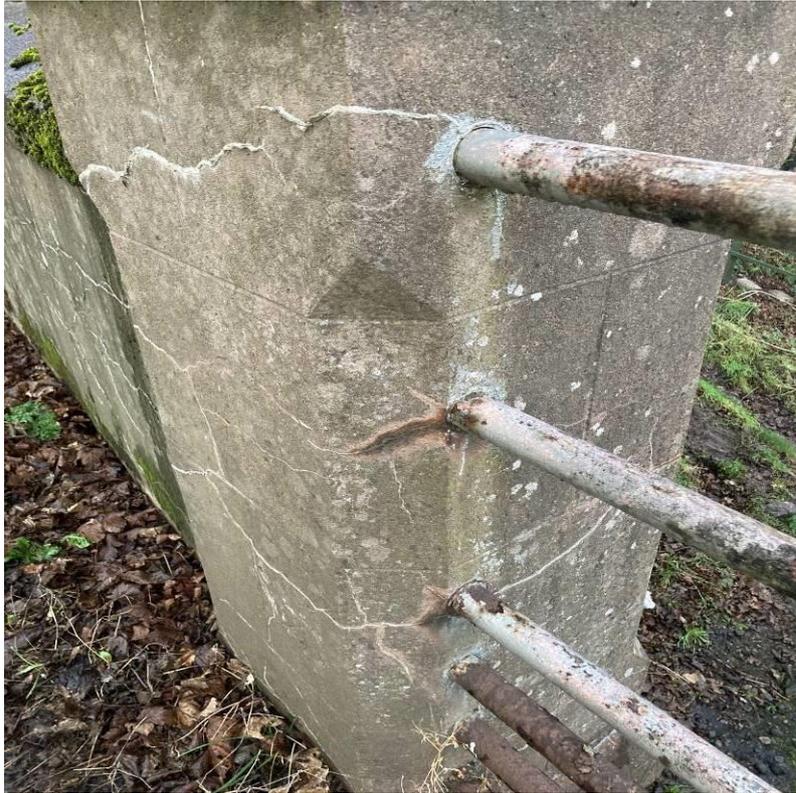
Photograph 21: Typical cracks propagating from the junction between the steel parapet rails and mass concrete approach wing walls.

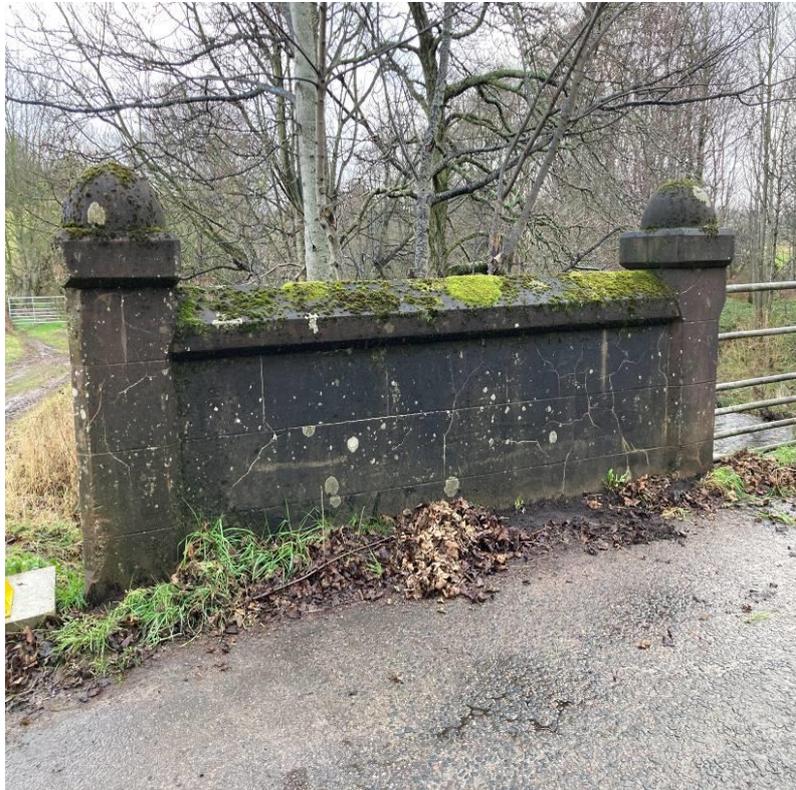
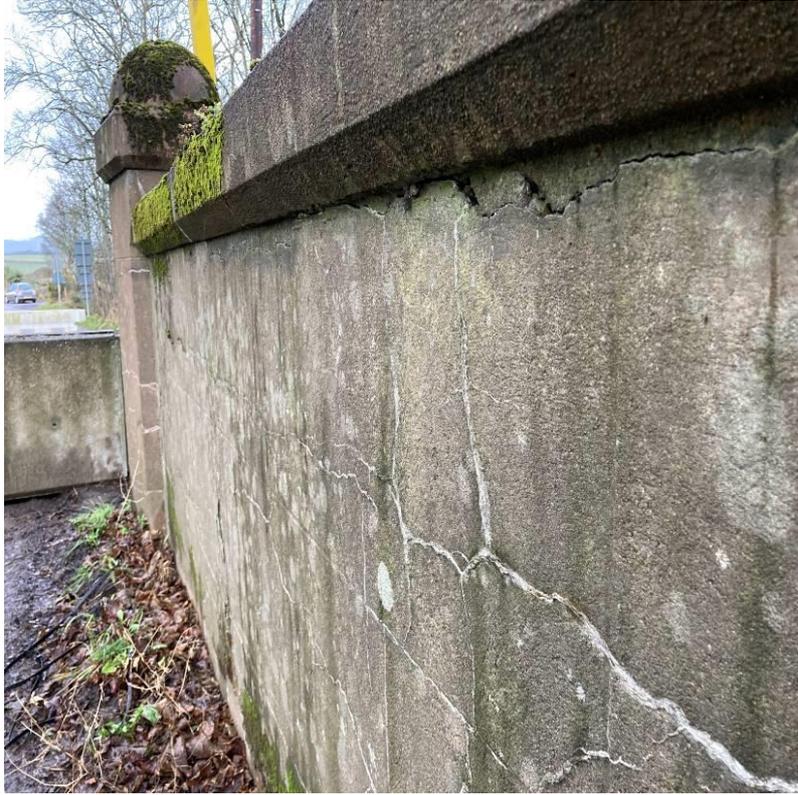
Photograph 22: Typical widespread hairline cracking to approach wing walls.

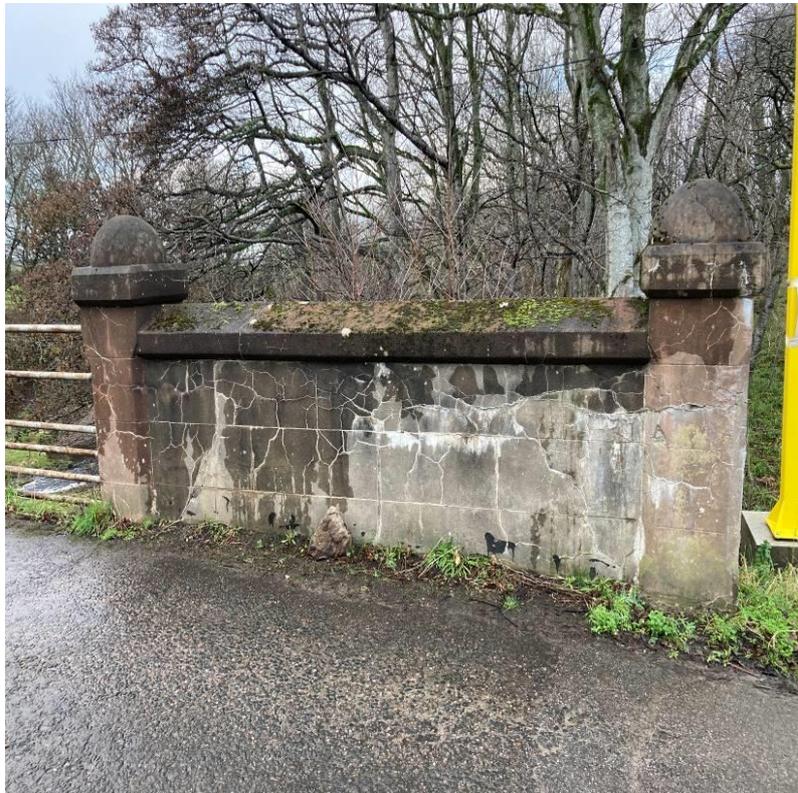
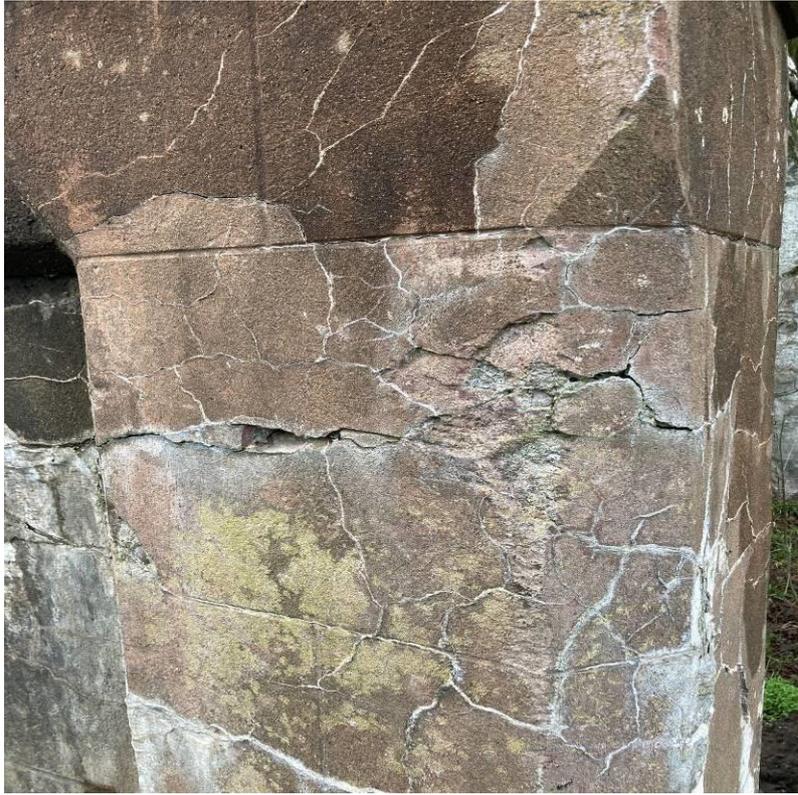
- There is evidence of vehicle collision to north-east approach wing wall with spalled concrete and widespread cracking to wall and cope (Photograph 24 & 25).
- A band of vegetation growth was observed within the drainage channel to the carriageway edge (Photograph 26 & 27).
- Typical drainage outlets are situated to north and south of bridge at mid-point of each span. One of the drainage outlets was cleared for the photograph but the remaining outlets were generally blocked by silt and vegetation throughout structure (Photograph 28).
- There is widespread corrosion, delamination and layered rust build-up to lower section of parapet brace member. A paint coating is visible to the upper section but appears to stop and is not visible to lower section (Photograph 29, 30 & 31).
- Vegetation is present due to nesting birds resting on parapet brace to east and west of Span 2 (Photograph 32).

Photograph 24: Evidence of vehicle collision to north-east approach wing wall with spalled concrete and widespread cracking to wall and cope.

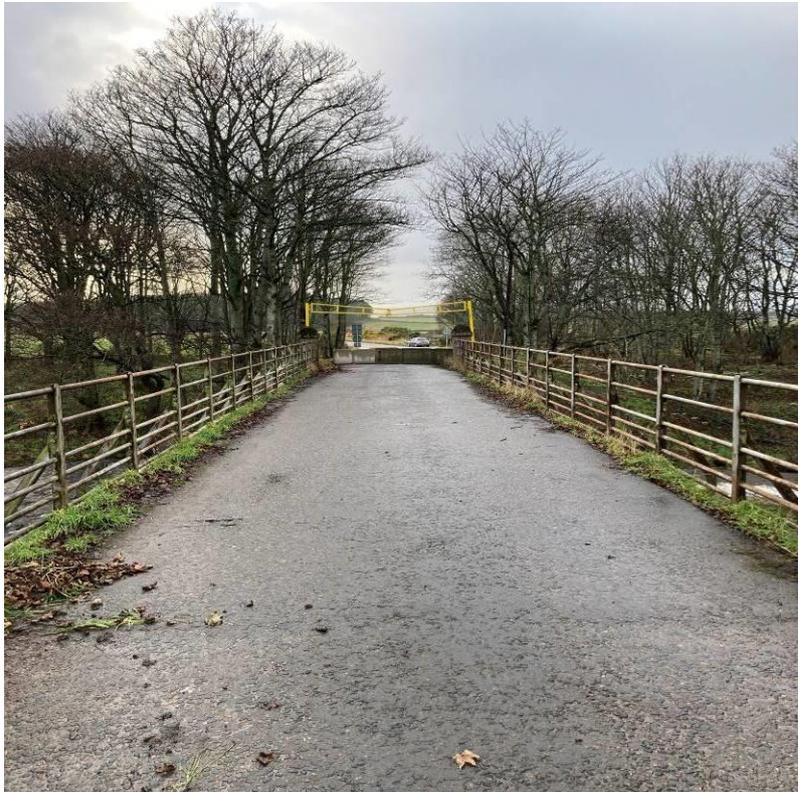
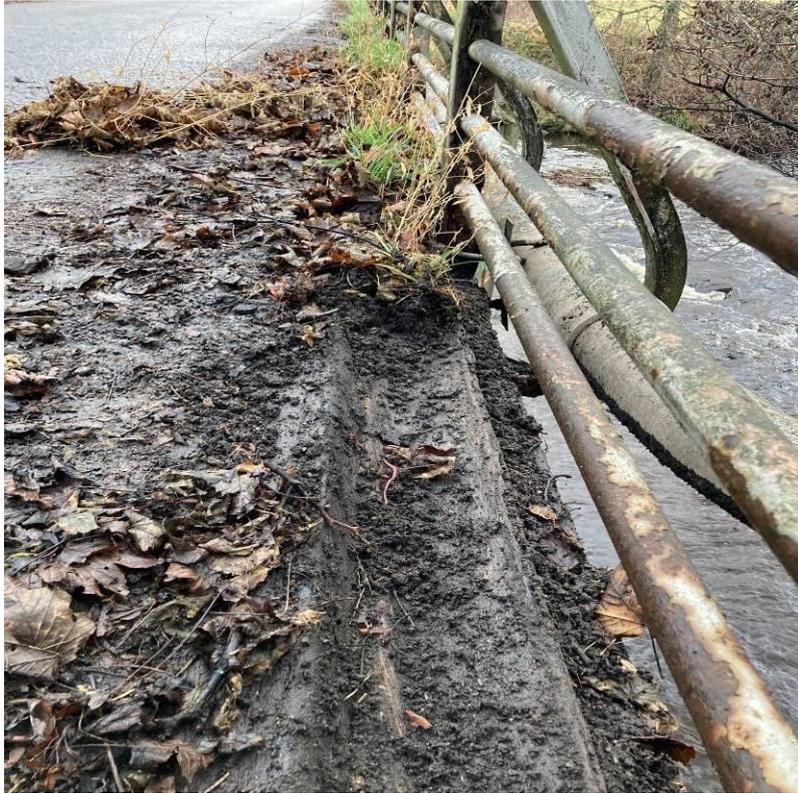
Photograph 26: Typical band of vegetation growth within drainage channel to carriageway edge.

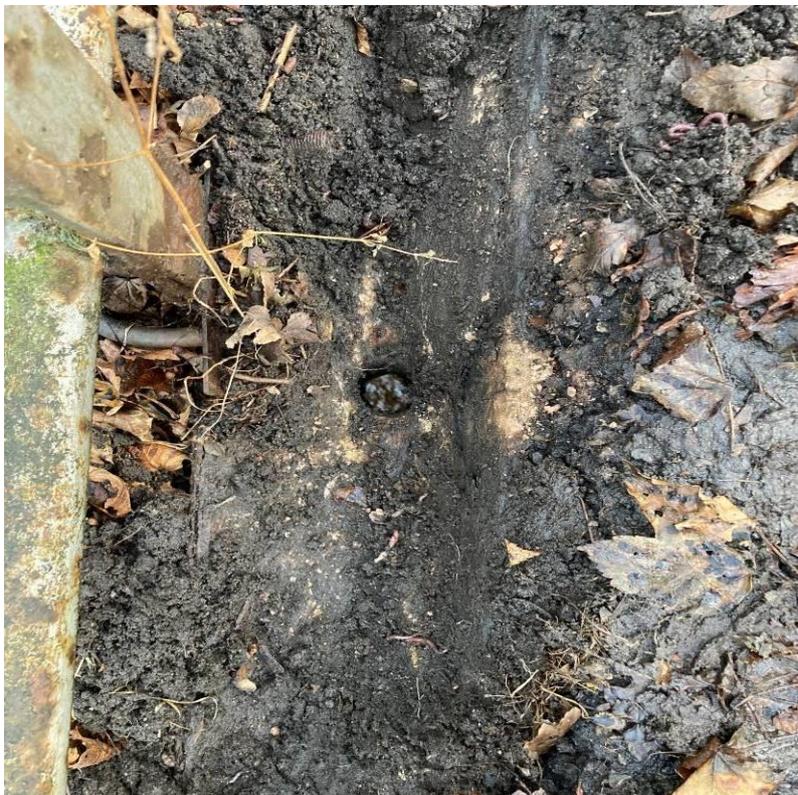
Photograph 28: Typical drainage outlet situated to north and south of bridge at mid-point of each span. Typically blocked by silt and vegetation.

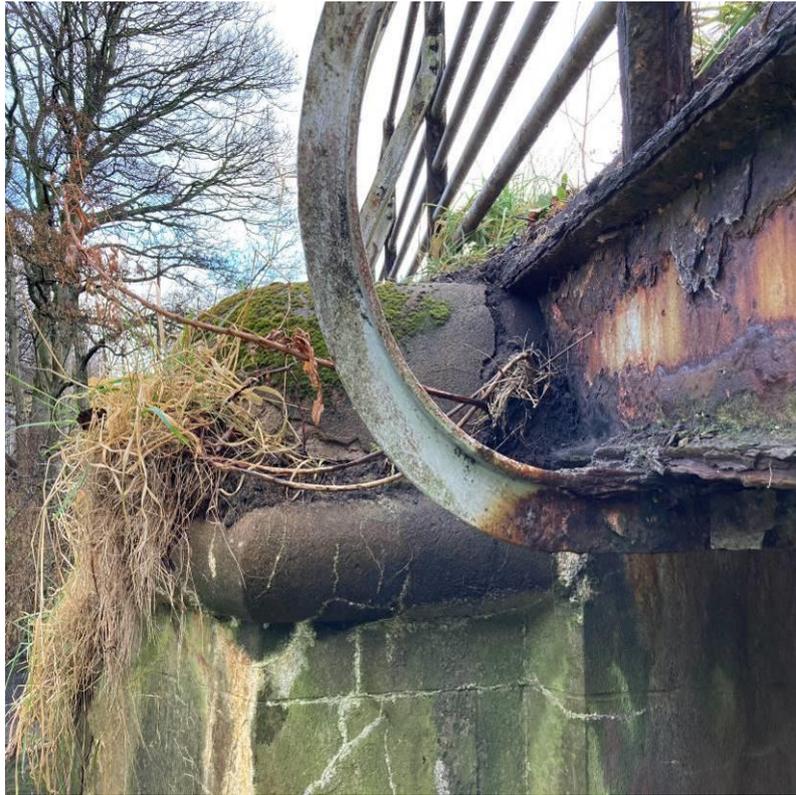
Photograph 29: Widespread corrosion, delamination and layered rust build-up to lower section of parapet brace member. Paint coating visible to upper section stops and is not visible to lower section.

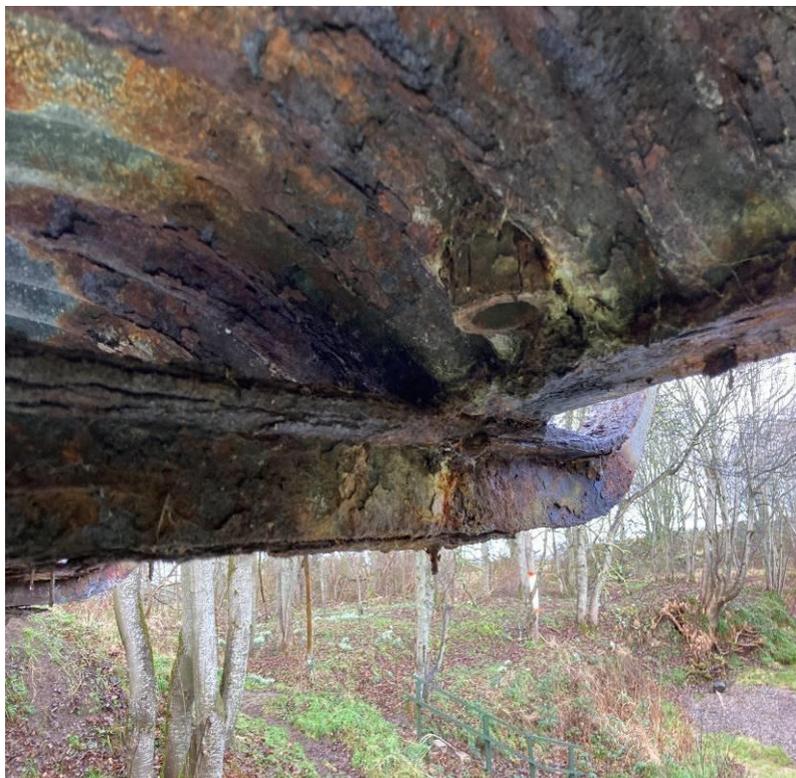
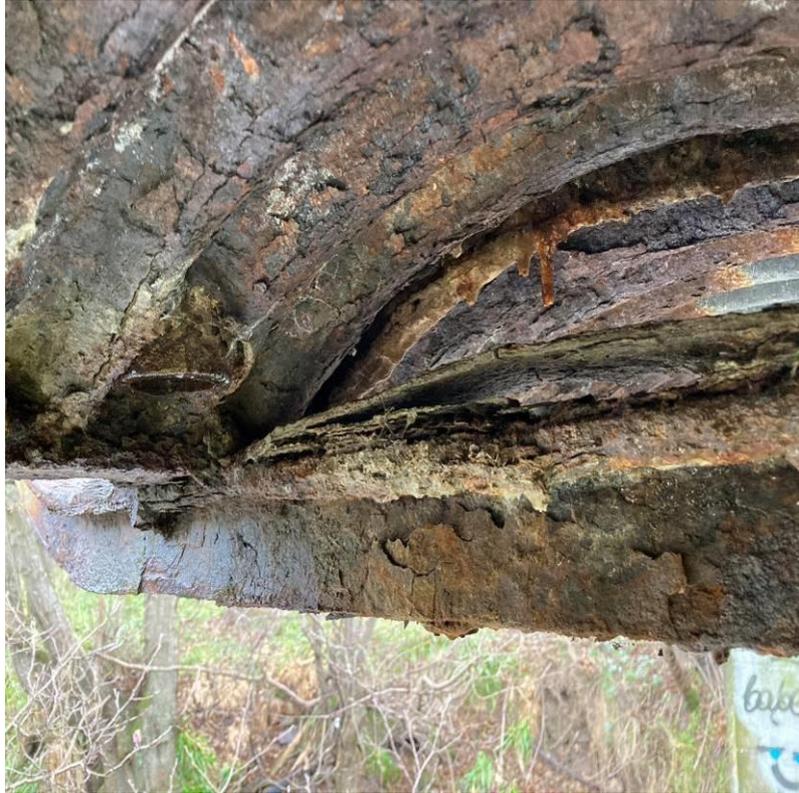
Photograph 30: Widespread corrosion, delamination and layered rust build-up to lower section of parapet brace member.

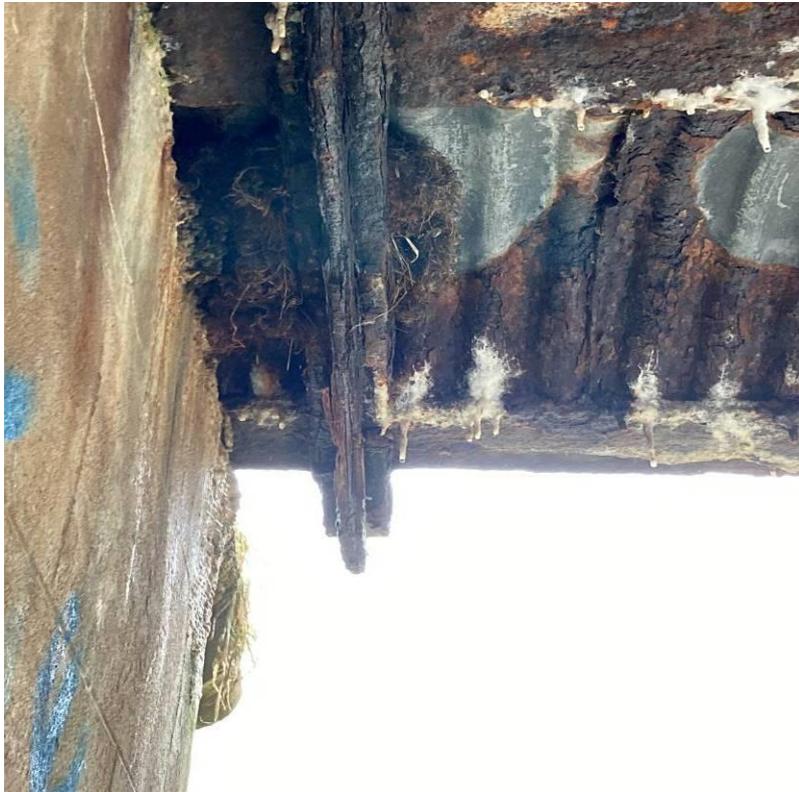
Photograph 32: Vegetation due to nesting birds resting on parapet brace to east and west of Span 2.

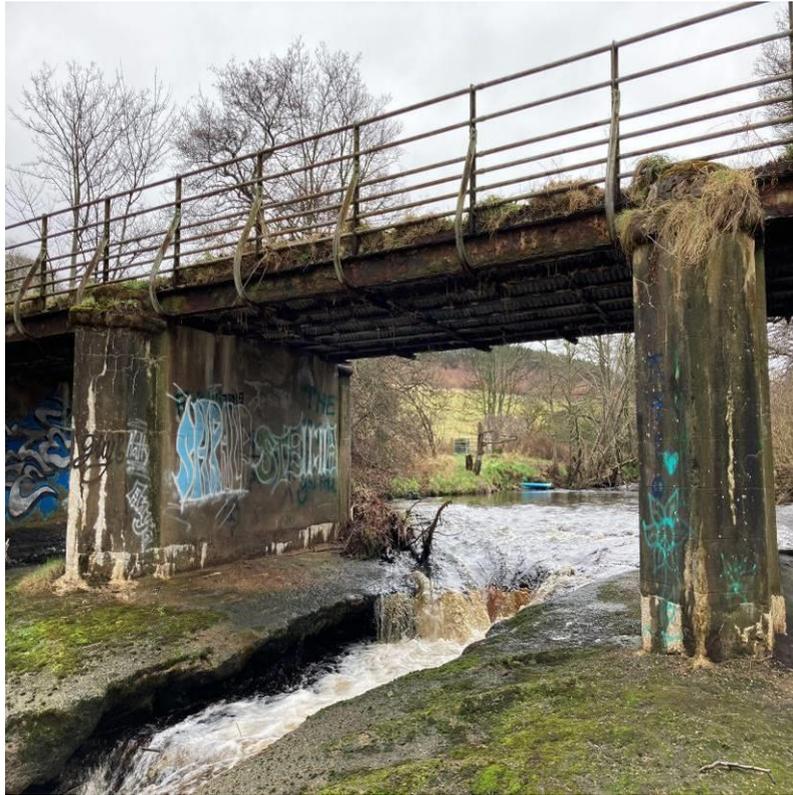
Photograph 33: Visible cut in concrete invert below Span 2 with fast flowing water. Extent of scour below invert unclear. Accumulation of vegetation to upstream cutwater of Pier 2.
