Inspection and Assessment Report

Cloddach Bridge, Elgin

March 2022

CLIENT: The Moray Council
REPORT TITLE: Inspection for Assessment Report
PROJECT REFERENCE: 140163F – Cloddach Bridge, Elgin

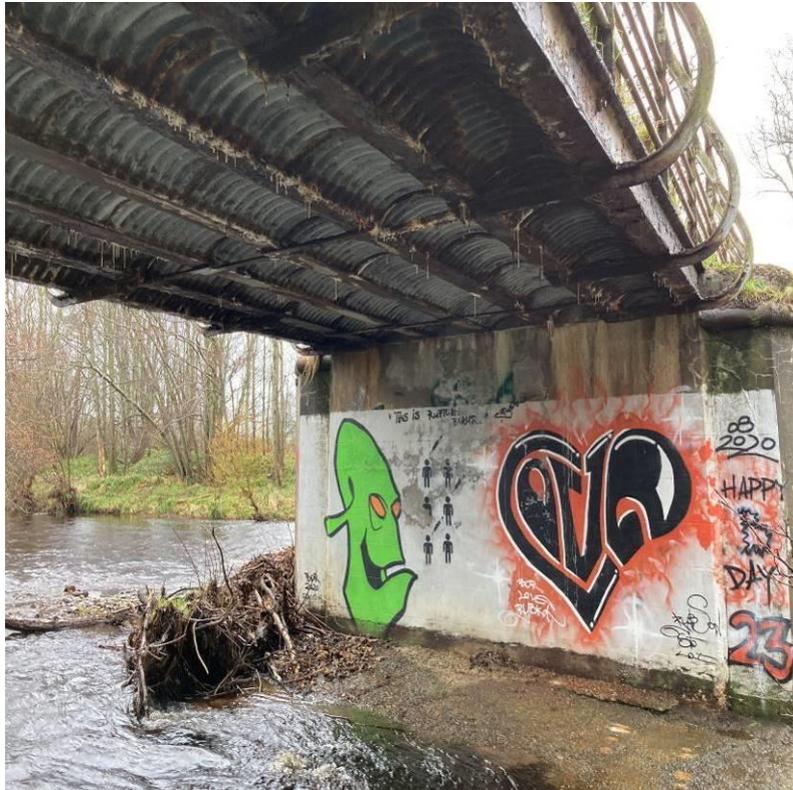
Photograph 34: Accumulation of vegetation to upstream cutwater of Pier 2.

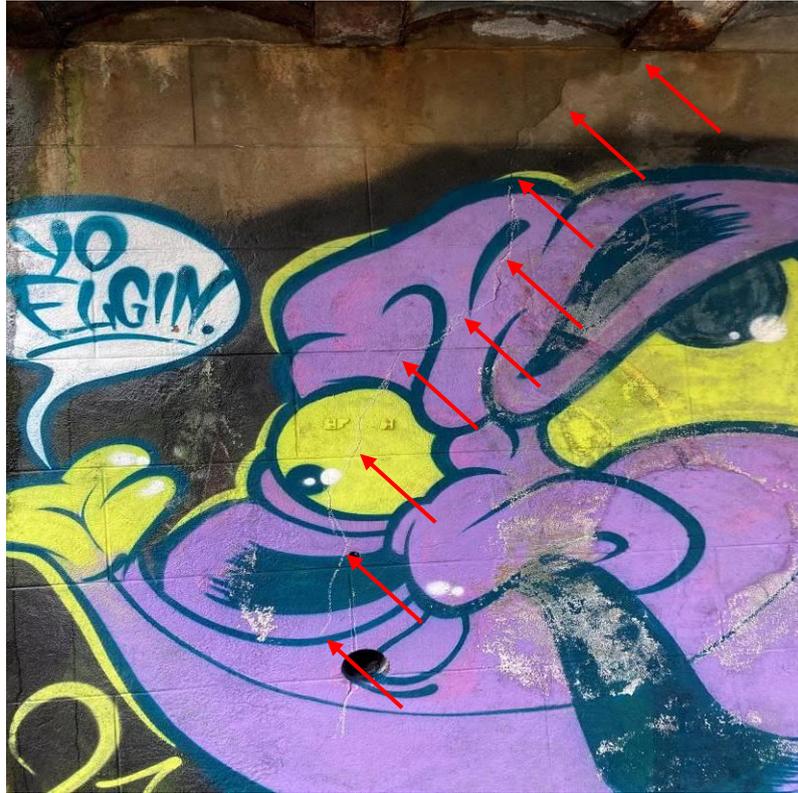
- Graffiti is present along the entire face of both west and east abutments.
- A vertical crack emanating from the support position of PB5 to approximately 950mm above invert level to west abutment. The crack width was measured to be approximately 1mm (Photograph 35).

- A historic crack monitor was identified across vertical crack which is in a state of disrepair. There is no evidence of when crack monitor was installed (Photograph 35).

Photograph 35: Vertical crack emanating from the support position of PB5 to approximately 950mm above invert level to west abutment. Crack width measured to be approximately 1mm. Historic crack monitor in state of disrepair.

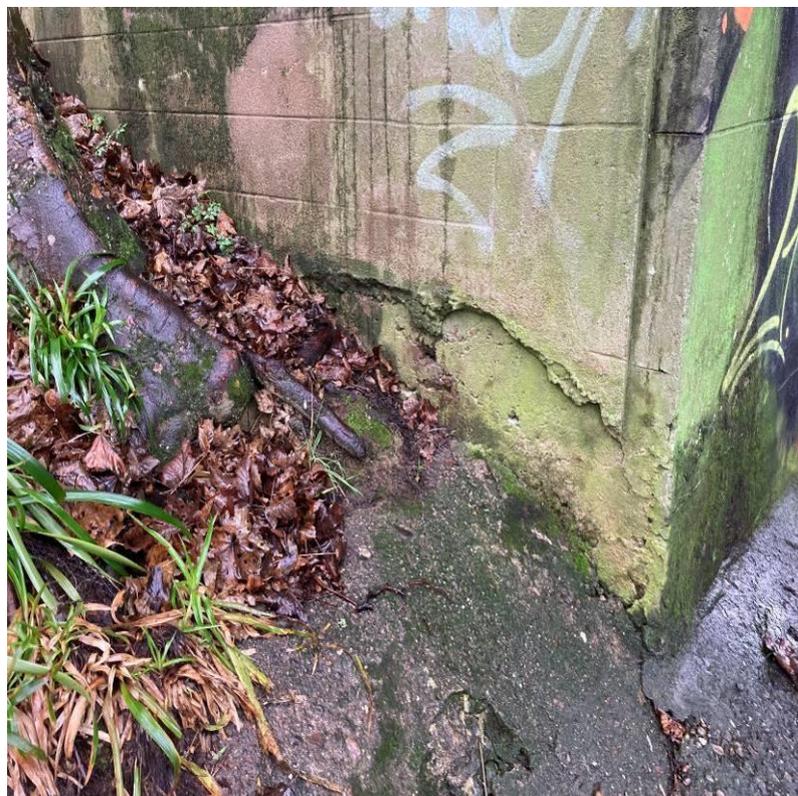
Photograph 36: Typical scour to render at base of west abutment.

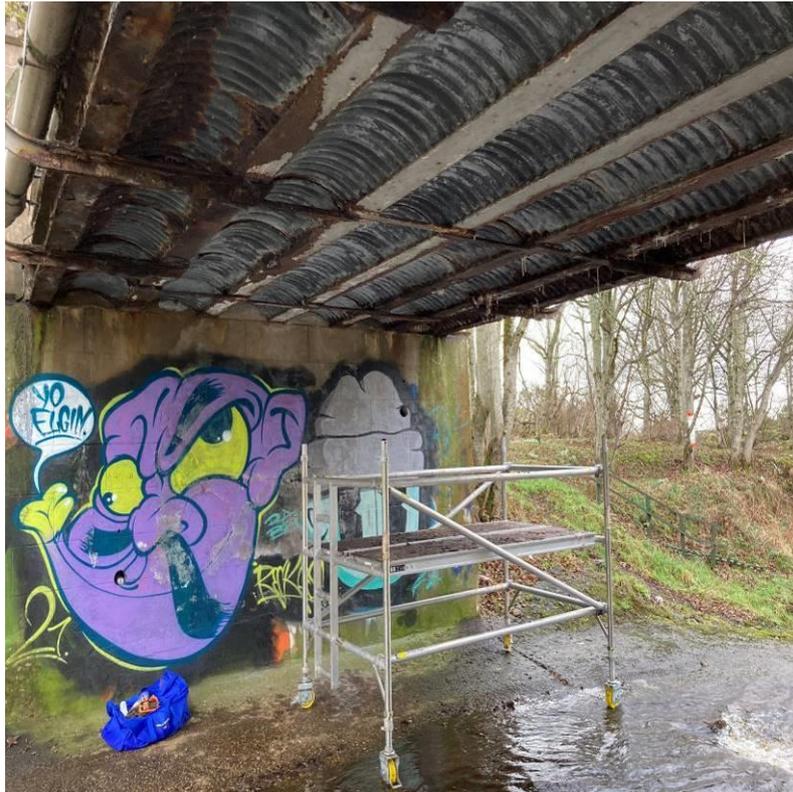
- Two 100mm diameter cores were identified to face of west abutment extending approximately 700mm back into structure (Photograph 37).
- There is significant calcite and algae staining to the face of east abutment below the support positions of steel beams (Photograph 38 & 39).

Photograph 37: Damp and algae staining to face of west abutment below support position of PB1 and PB7. Two 100mm diameter cores noted to face of abutment extending 700mm back into structure.

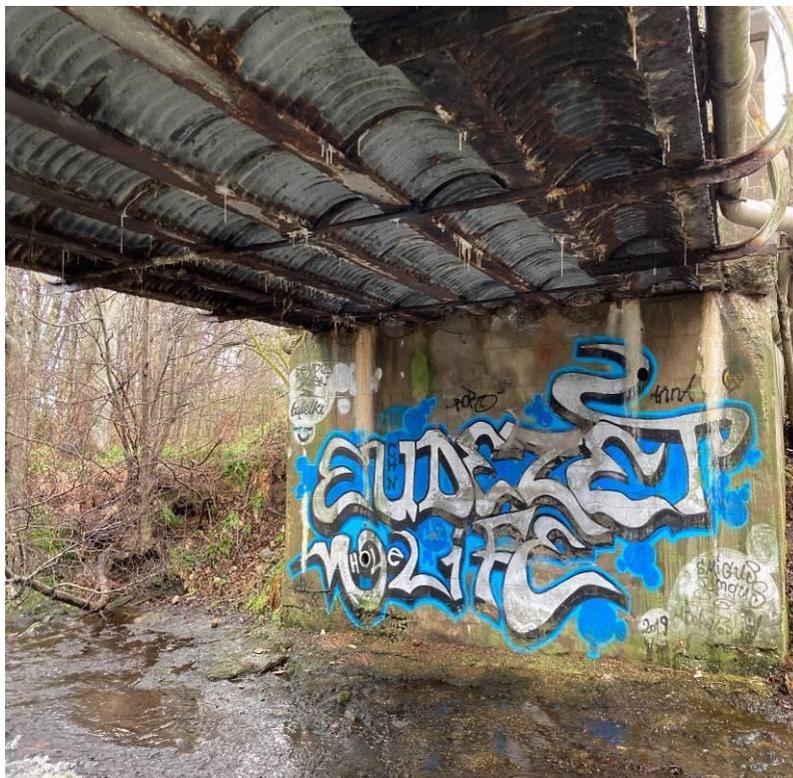
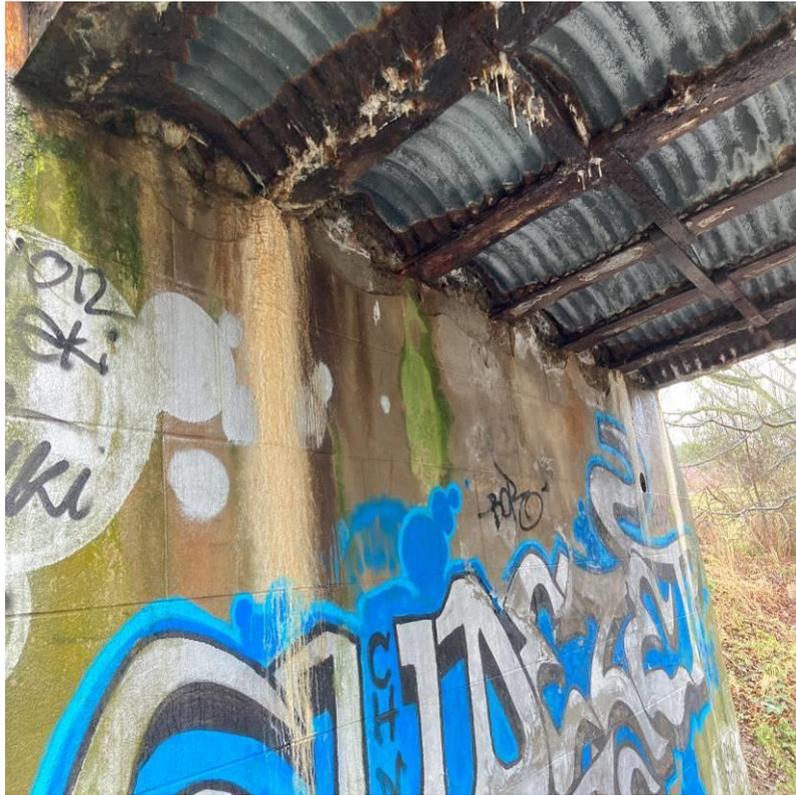
Photograph 38: Significant calcite and algae staining to face of east abutment below support positions of steel beams.

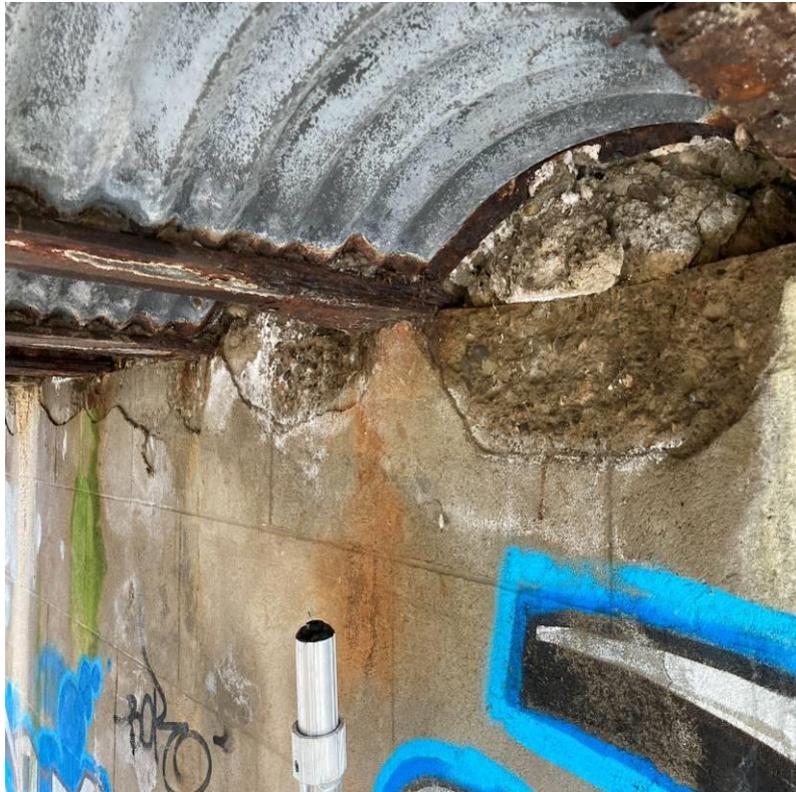
- Significant concrete spalling is present along top of east abutment between beams in each bay. The aggregate is exposed and loose when disturbed (Photograph 40).
- There is a significant concrete spalled area to south-east corner of east abutment leaving approach wing wall above partially unsupported (Photograph 41 & 42).
- There is scour to render at base of east abutment with exposed aggregate (Photograph 43).
- Typical mature vegetation growth is present to the east and west abutment (Photograph 44 & 45).

Photograph 40: Significant concrete spalling along top of east abutment between beams in each bay. Aggregate exposed and loose when disturbed.

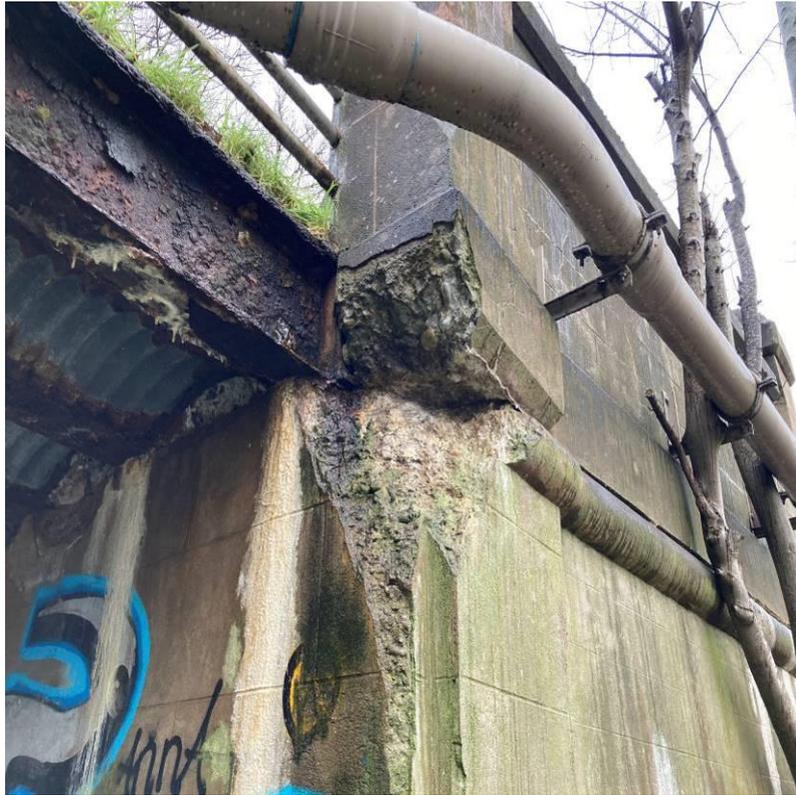
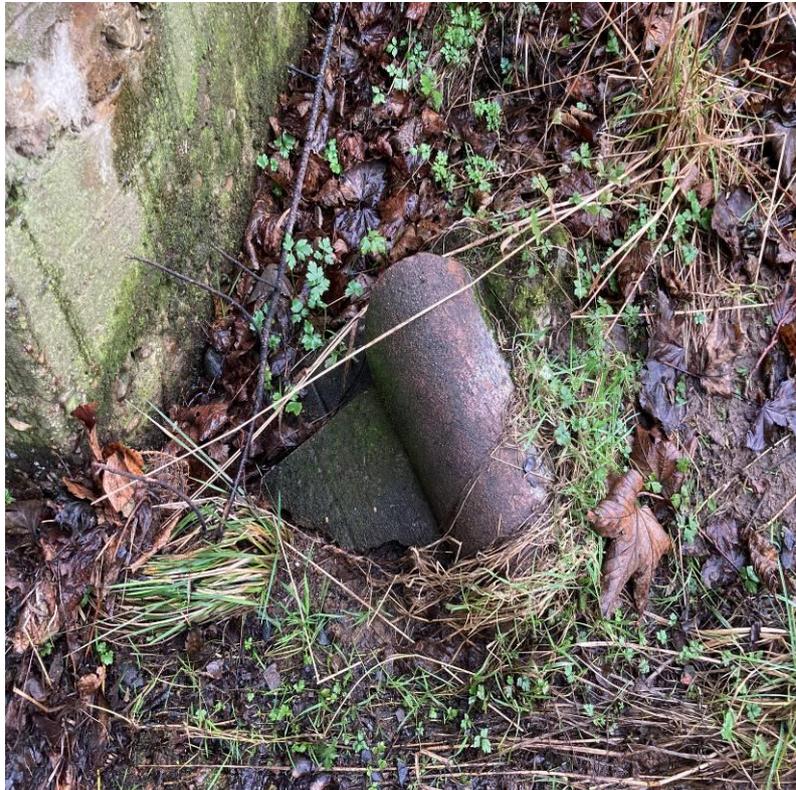
Photograph 41: Significant concrete spalling to south-east corner of east abutment leaving approach wing wall partially unsupported.

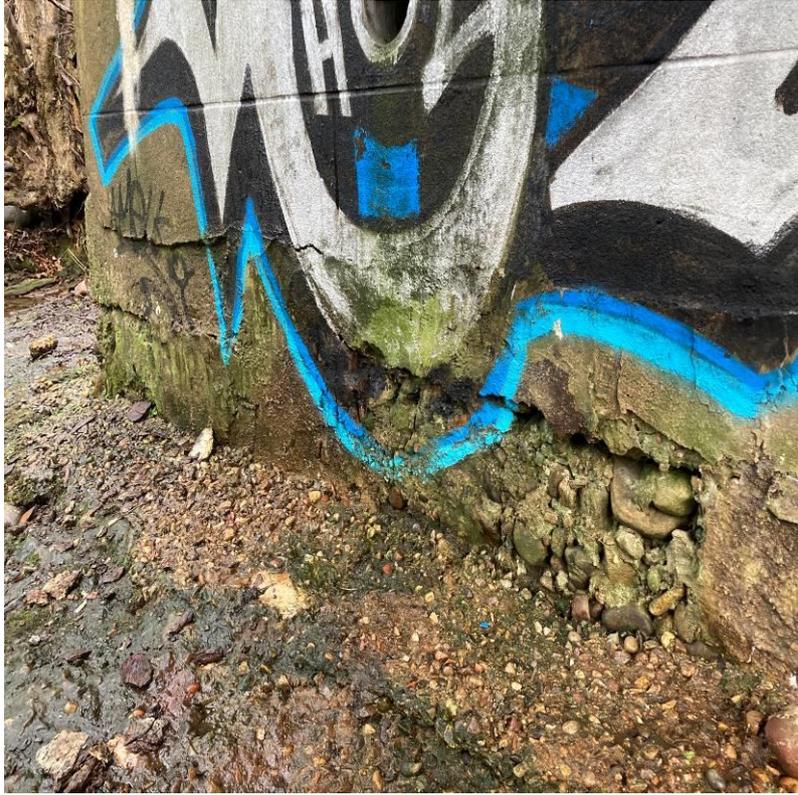
Photograph 43: Typical scour to base at base of east abutment with exposed aggregate.

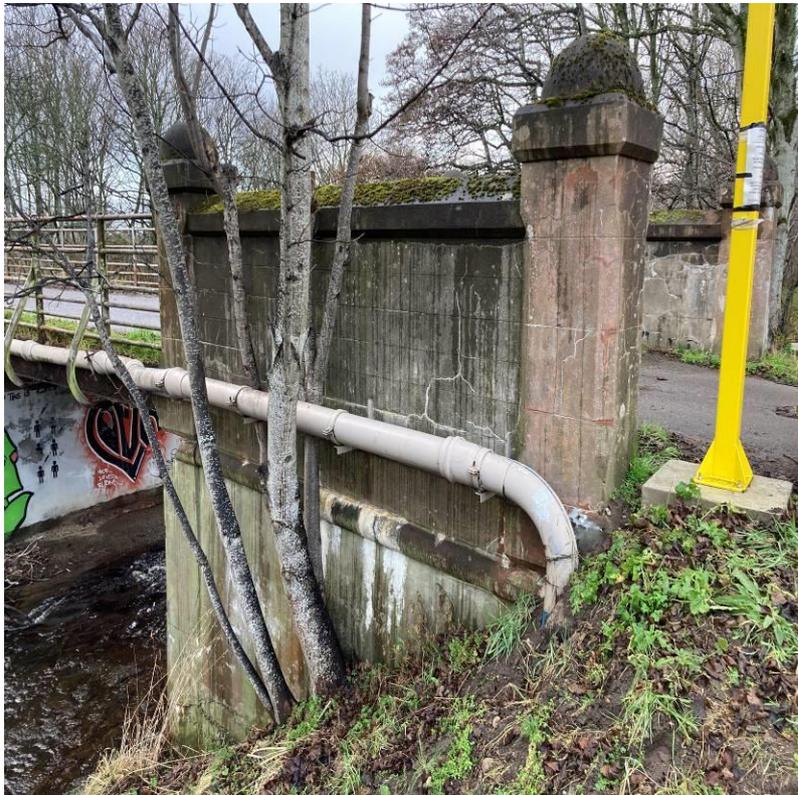
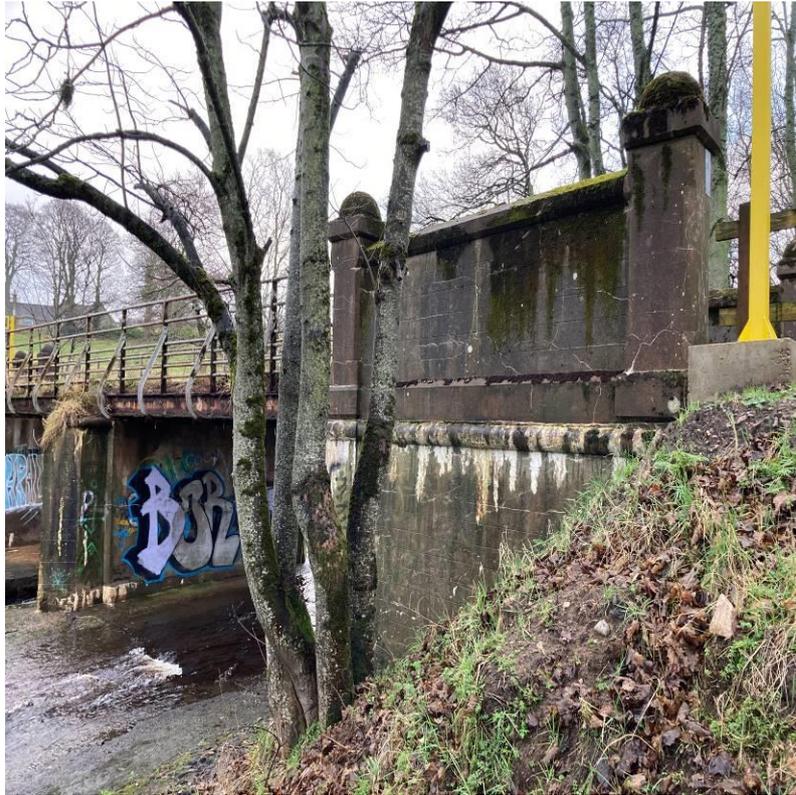
Photograph 44: Typical mature vegetation growth to east and west abutment.

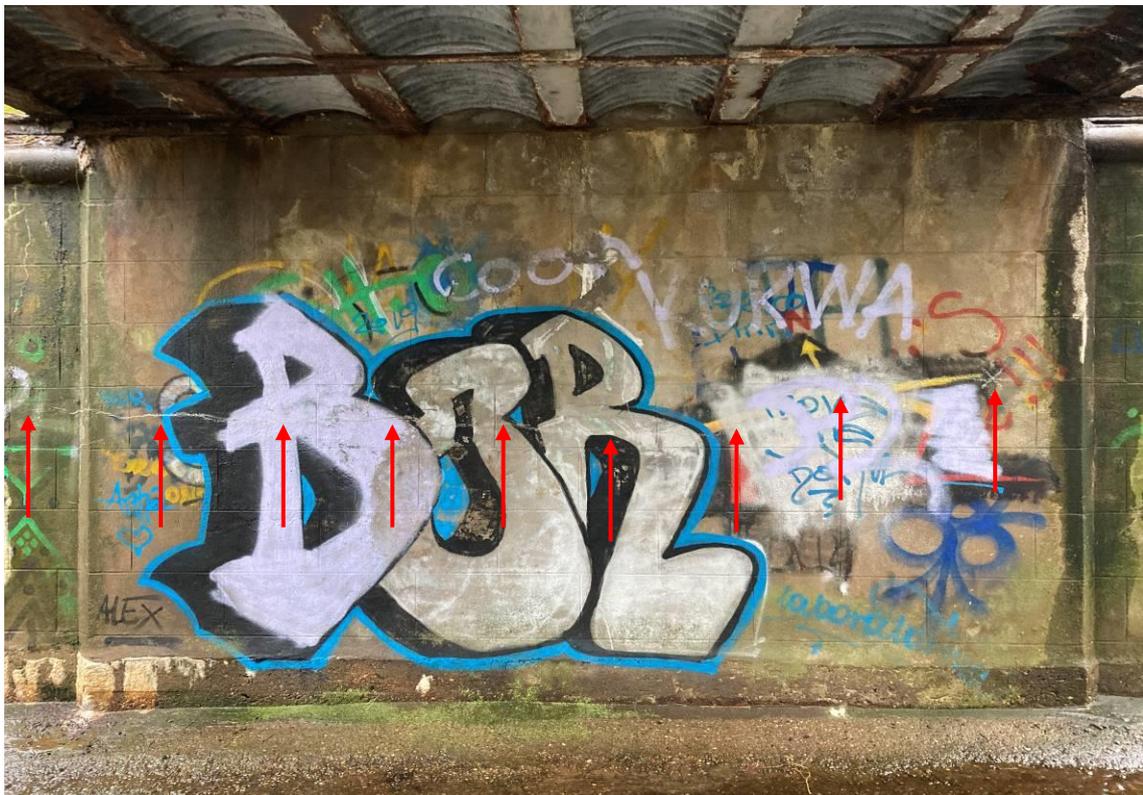
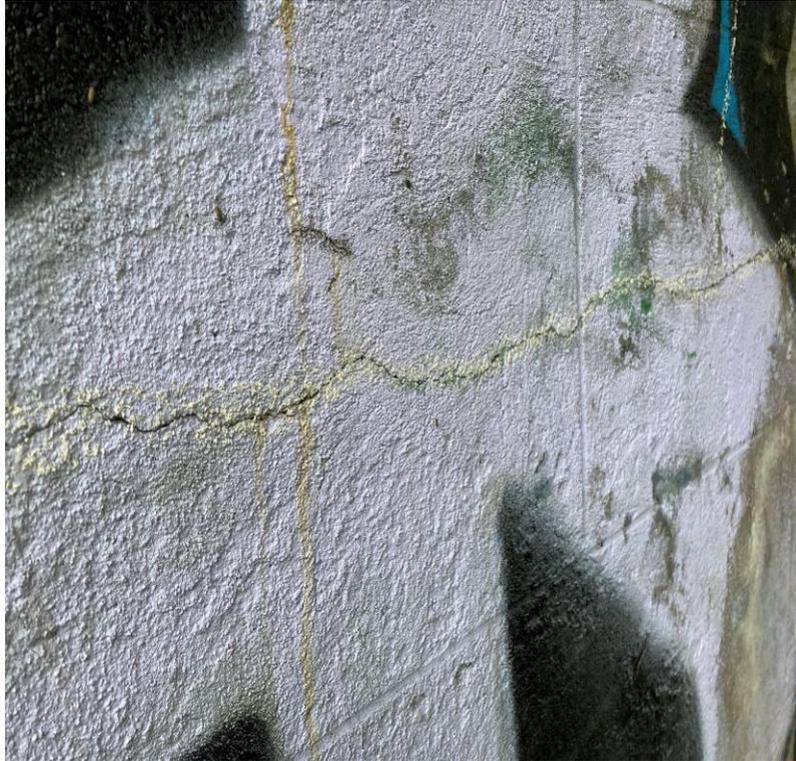
Photograph 46: Horizontal crack propagating full width of western face of Pier 1. Height of crack varies between 1.3m and 1.6m above invert level. Width of crack varies along length but is less than 1mm at all times.

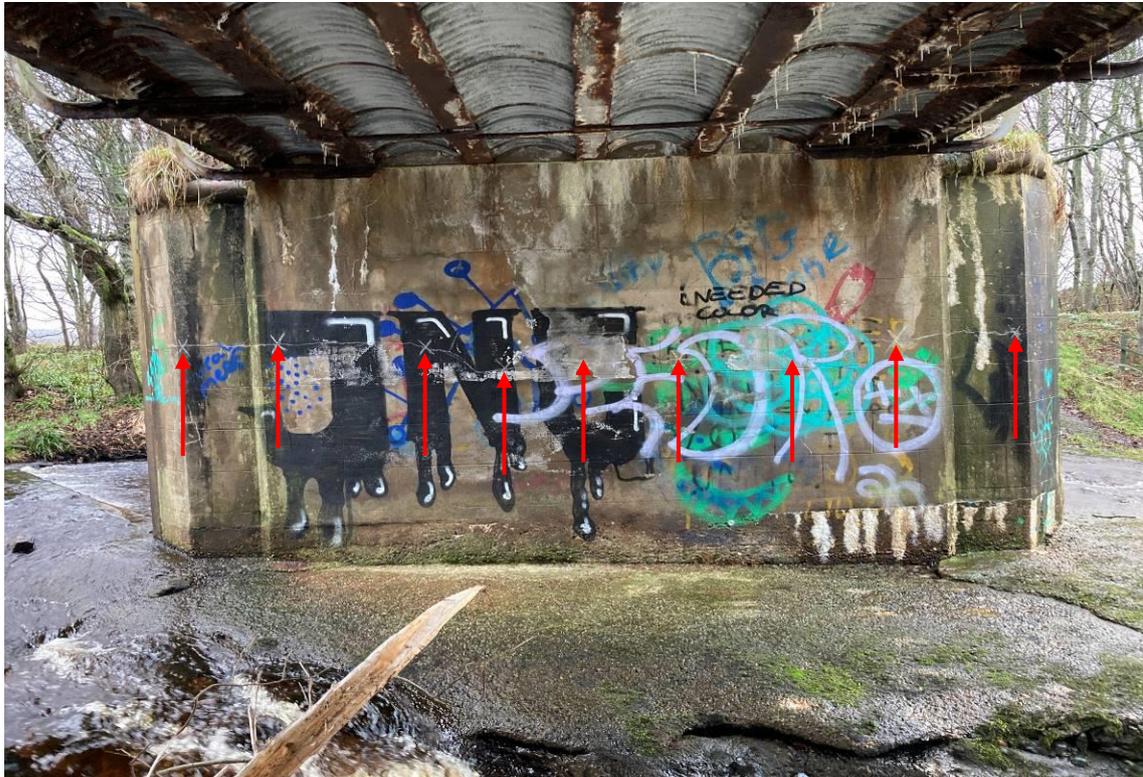
Photograph 48: Horizontal crack propagating full width of eastern face of Pier 1. Height of crack varies between 1.3m and 1.6m above invert level. Width of crack varies along length but is less than 1mm at all times. Typical calcite staining to face of Pier 1 and Pier 2.

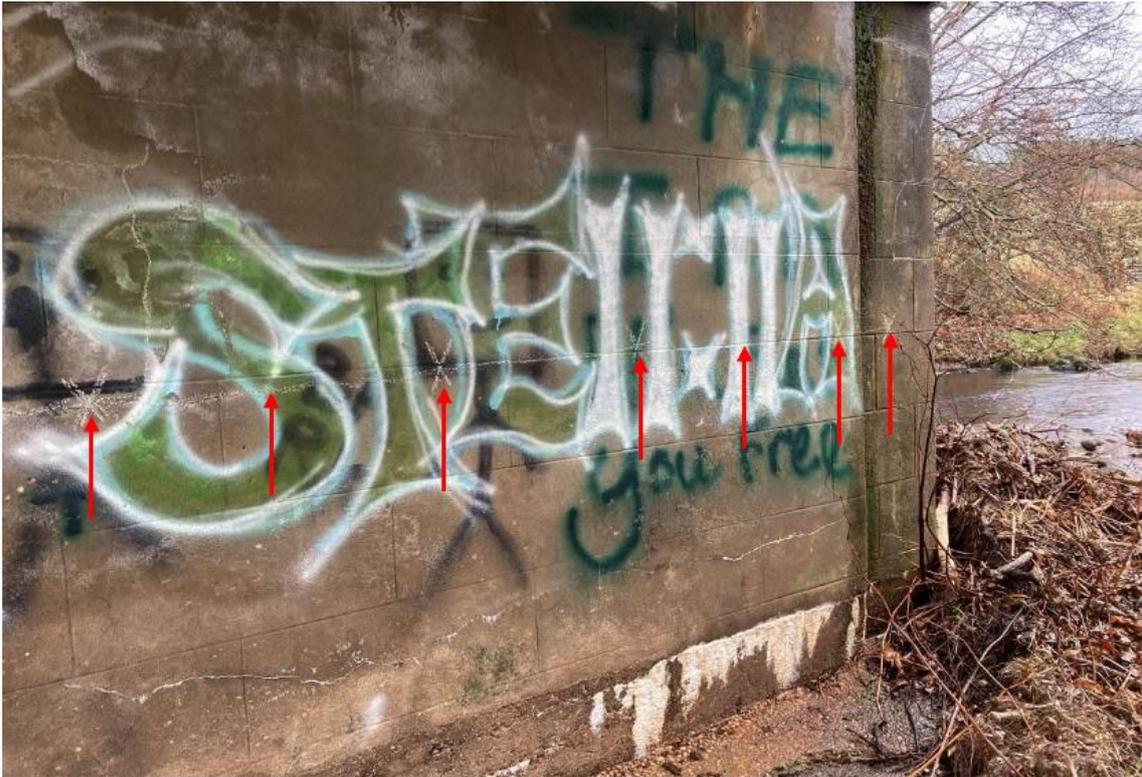
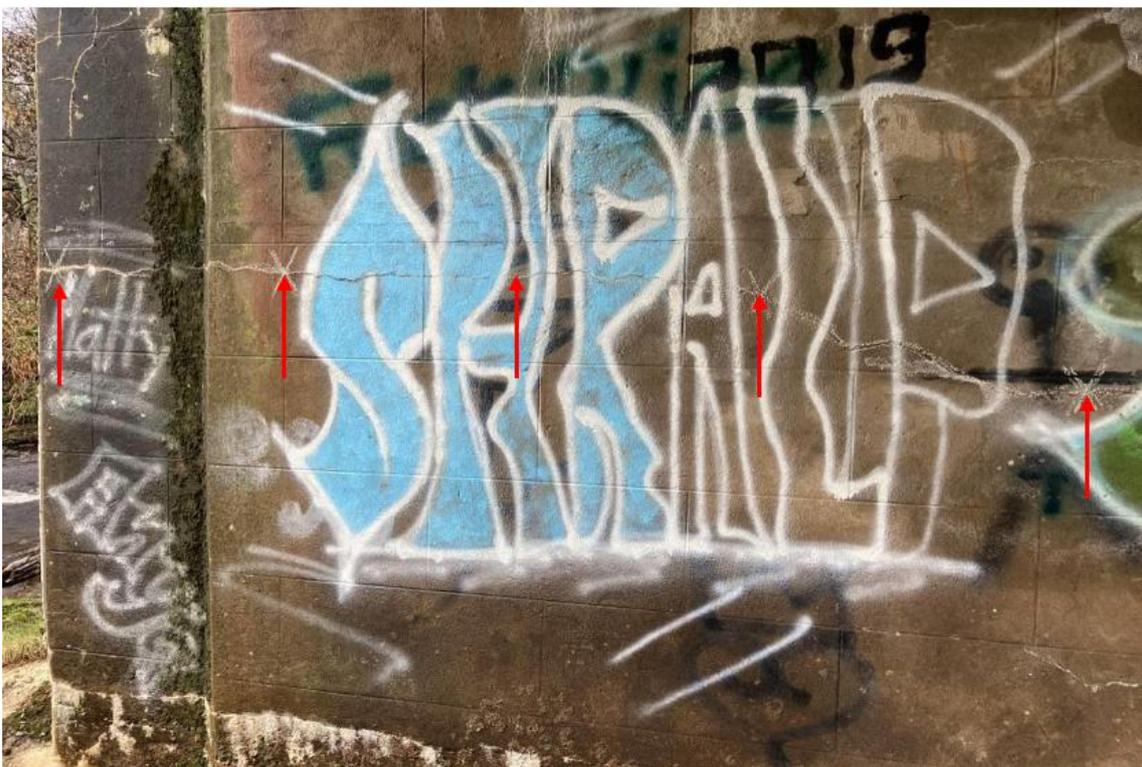
Photograph 49: Horizontal crack propagating full width of western face of Pier 2. Height of crack varies between 1.3m and 1.6m above invert level. Width of crack varies along length but is less than 1mm at all times.

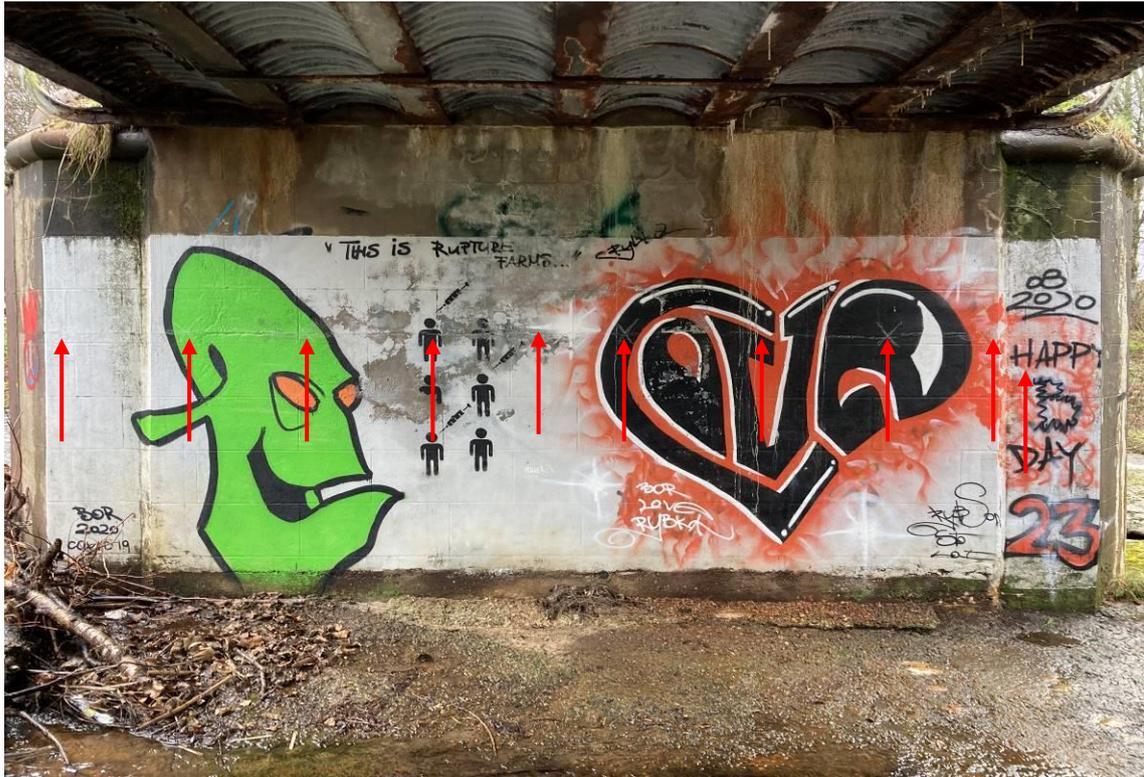
Photograph 51: Horizontal crack propagating full width of eastern face of Pier 2. Height of crack varies between 1.3m and 1.6m above invert level. Width of crack varies along length but is less than 1mm at all times. Typical calcite staining to face of Pier 1 and Pier 2.

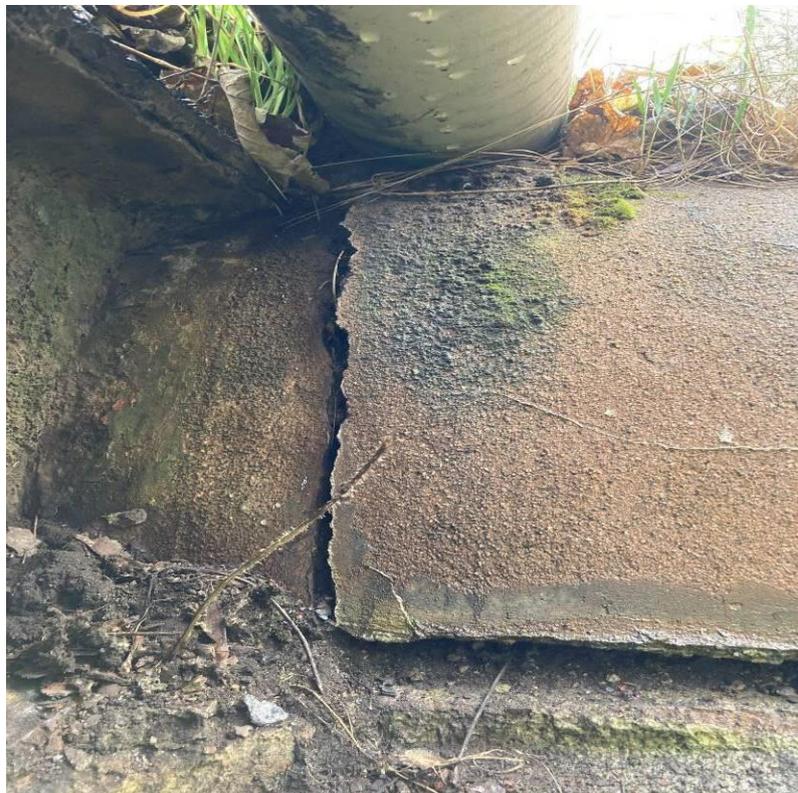
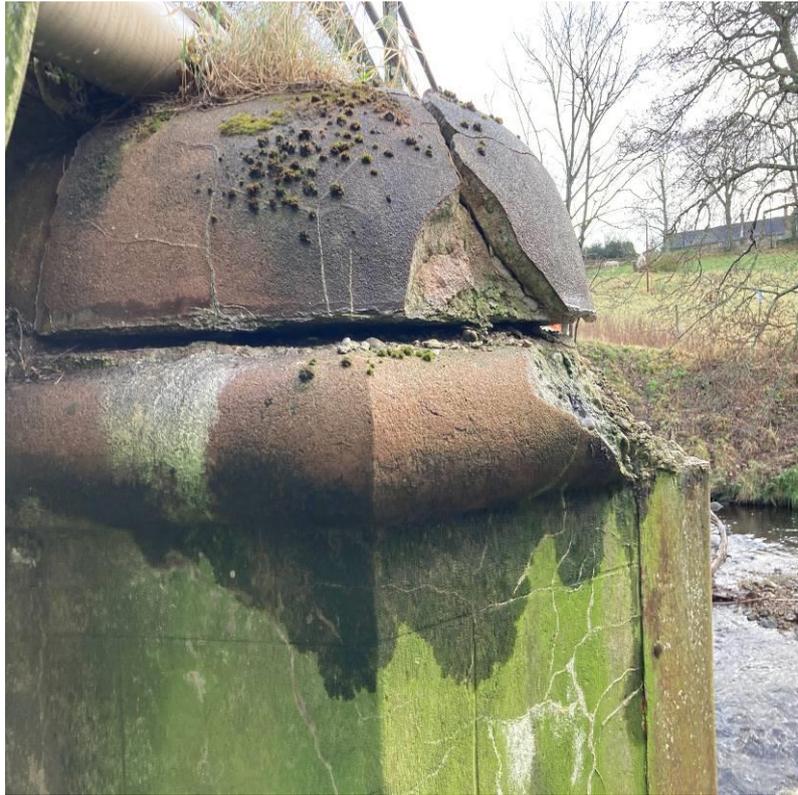
- Graffiti is present to both faces of each intermediate pier.
- There is a horizontal crack propagating full width of both the western and eastern face of Pier 1. The height of the crack varies between 1.3m and 1.6m above invert level. The width of the crack varies along length but is less than 1mm at all times (Photograph 46, 47 & 48).
- A horizontal crack propagates the full width of both western and eastern face of Pier 2. The height of crack varies between 1.3m and 1.6m above invert level. The width of crack varies along the length but is less than 1mm at all times (Photograph 49, 50 & 51).
- Typical calcite staining is present to faces of both Pier 1 and 2 below support positions of steel beams (Photograph 48 & 51).
- Typical concrete spalling and cracking with vegetation growth is present to the decorative cutwater capping (Photograph 52 & 53).

Photograph 52: Typical concrete breakout and cracking with vegetation growth to decorative cutwater capping.

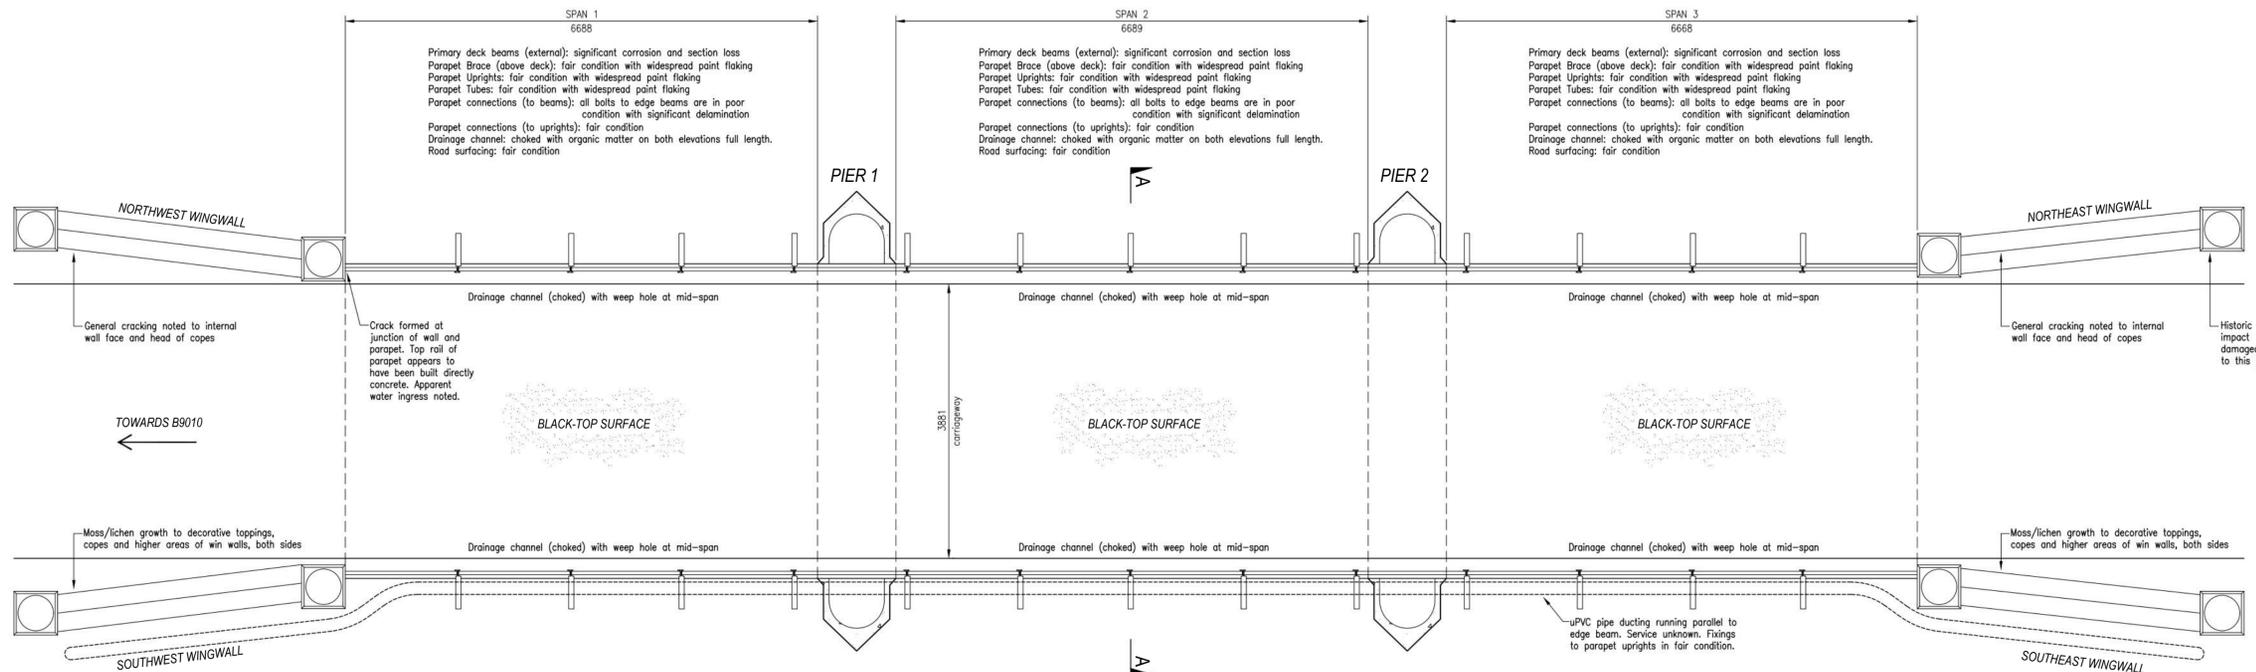
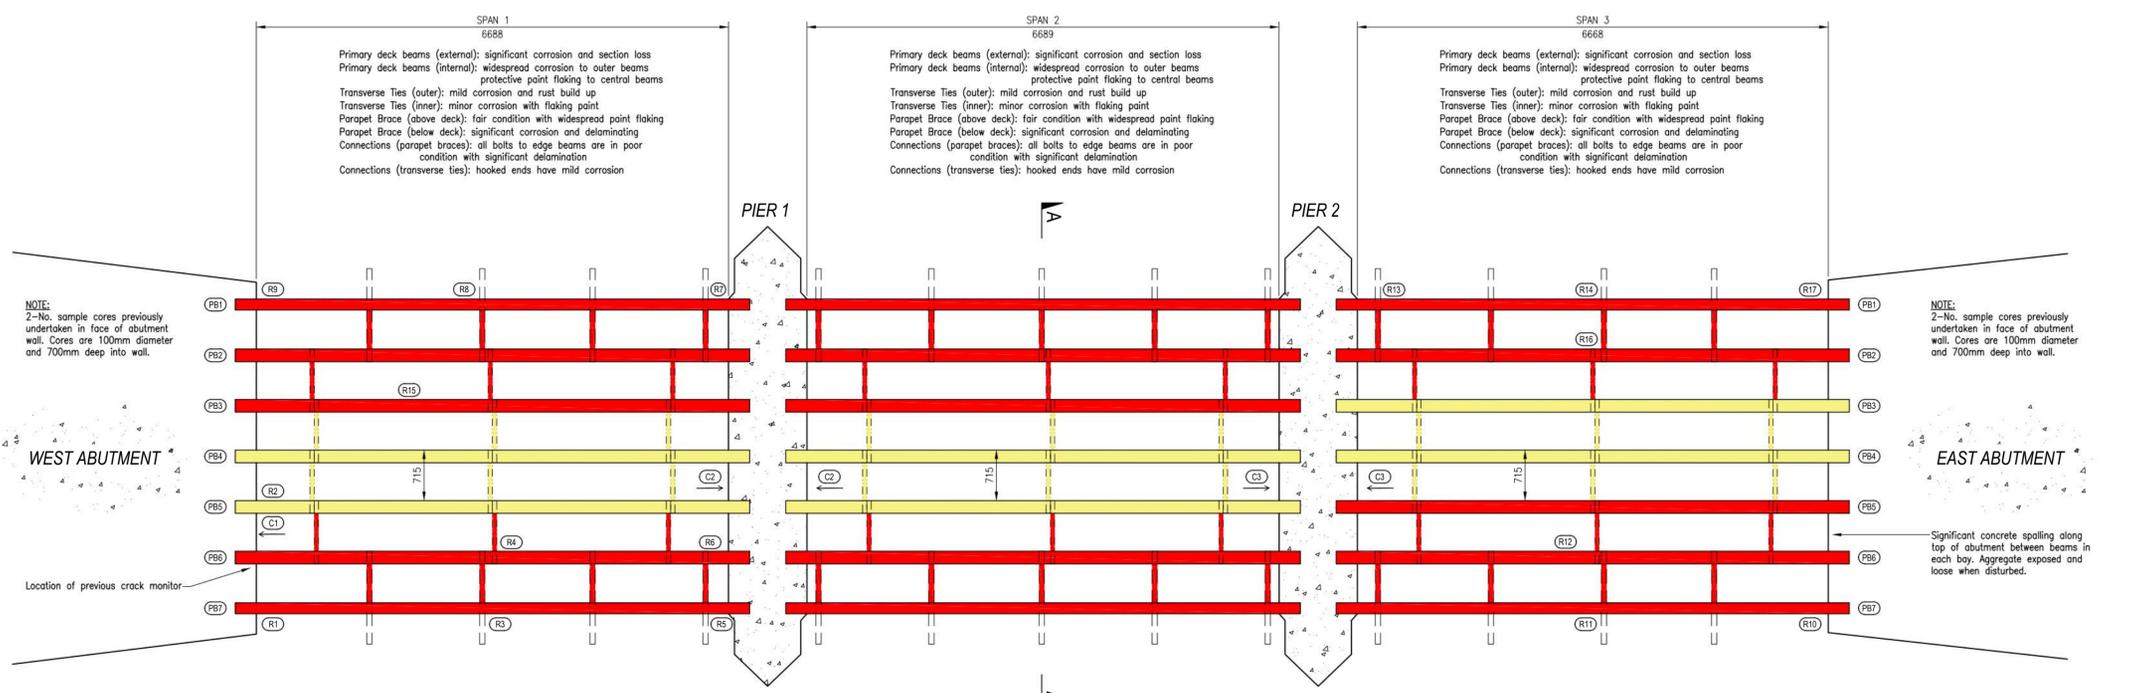
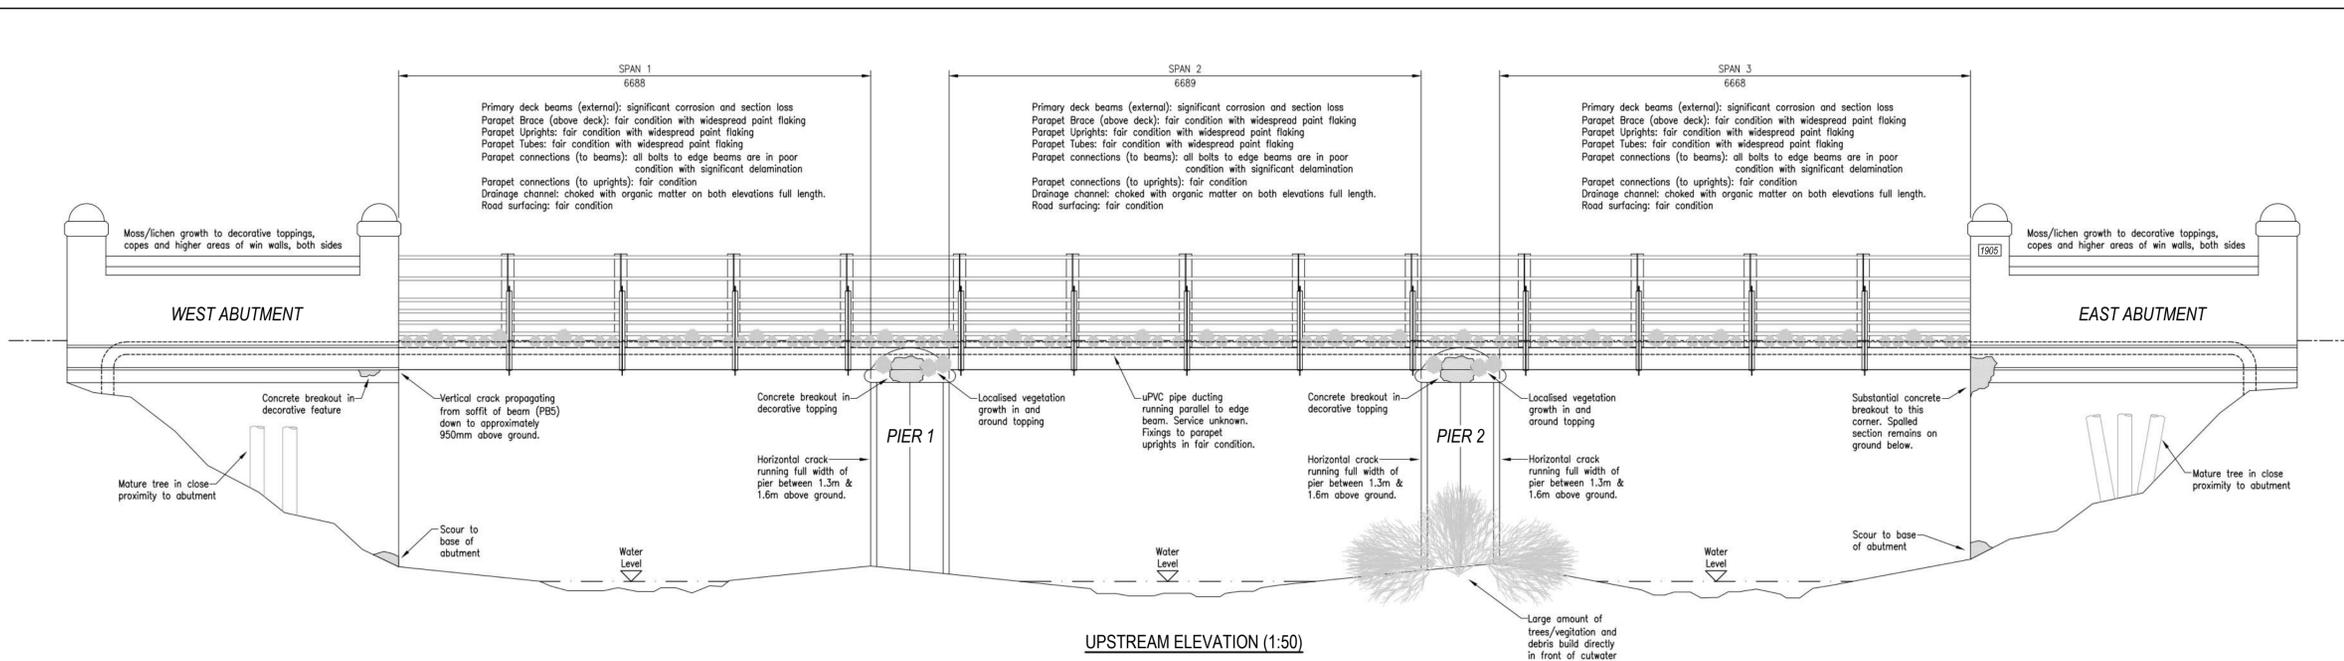
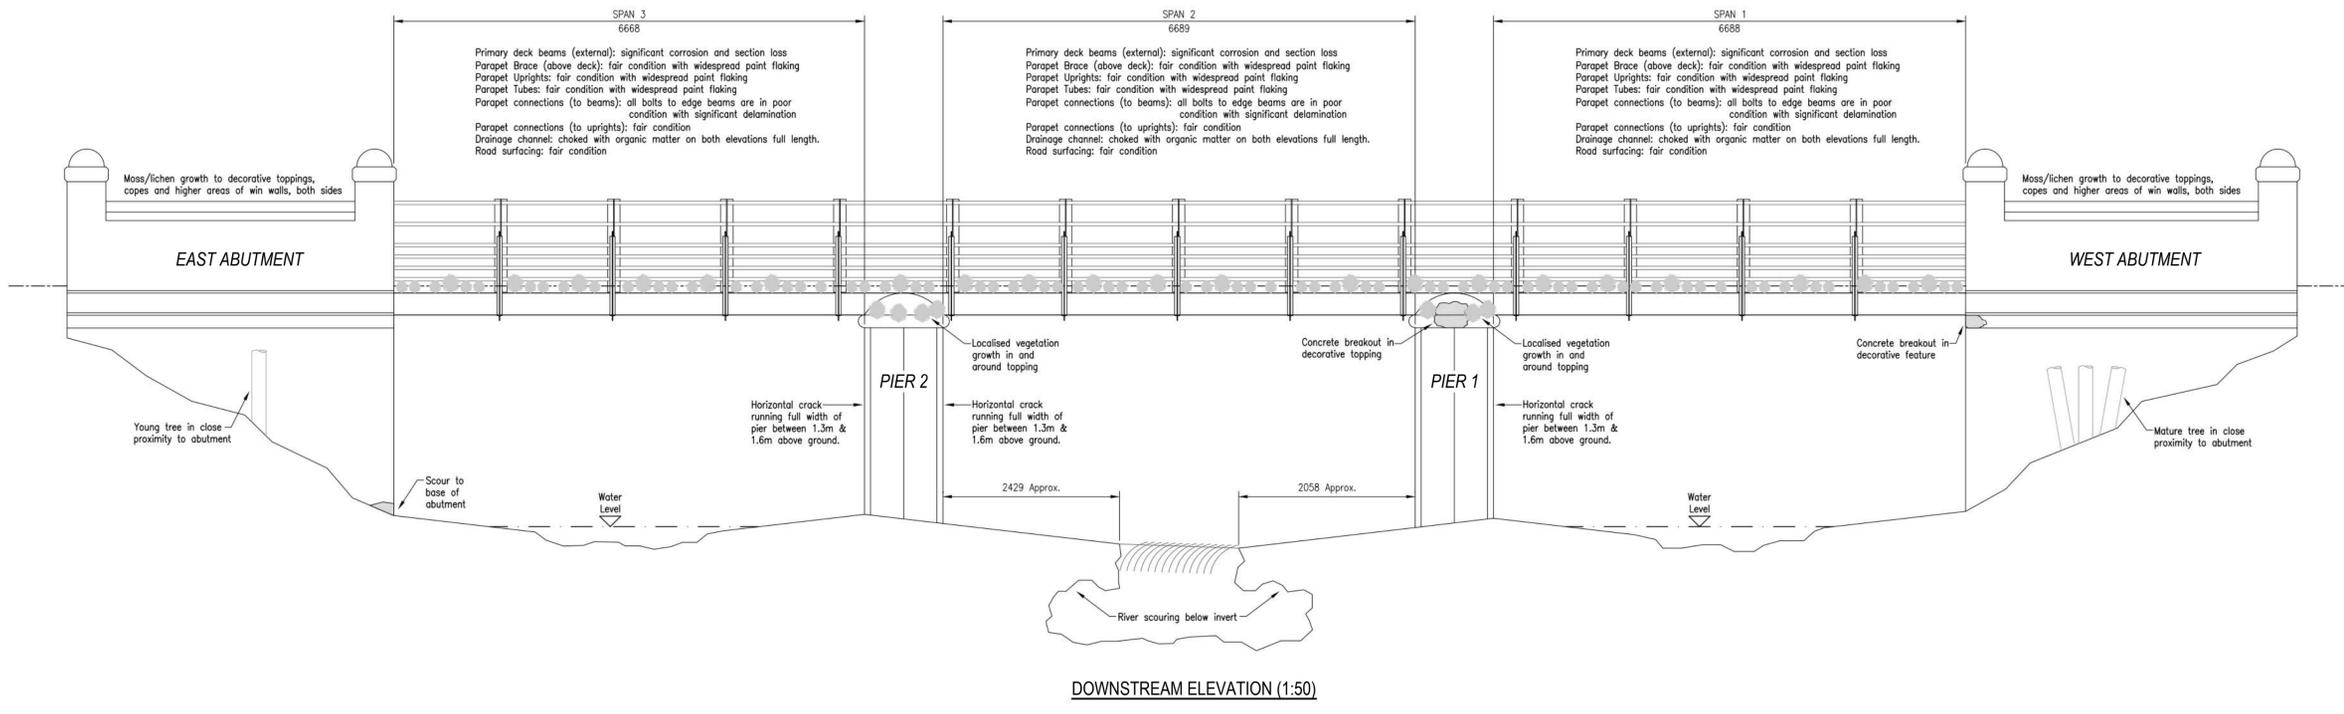
DRAWING NUMBER : 140163F/01 REVISION : -

Location	Reading from bottom flange (mm) taken at quarter points (u.n.o)	Reading from web (mm)
R1	12.7	9.9
R2	11.4	Not Accessible
R3	11.5	11.5
R4	11.1	Not Accessible
R5	18.1 (mid)	5.8
R6	15.4 - 16.5 (mid)	Not Accessible
R7	12.7	13.0
R8	9.9	12.5
R9	10.6	8.9
R10	12.4	8.8 - 10.1
R11	13.0	10.9
R12	12.9	Not Accessible
R13	11.5	13.5
R14	12.0	11.4
R15	16.6	Not Accessible
R16	18.5 (mid)	Not Accessible
R17	12.1	7.1
