STRUCTURAL INSPECTION,
HOPEMAN SURGERY,
15 HARBOUR STREET,
HOPEMAN,
MORAY, IV30 5SJ.

FEBRUARY 2022

MORAY COAST MEDICAL PRACTICE
MUIRTON ROAD
LOSSIEMOUTH
IV31 6TU

CAMERON + ROSS
CONSULTING ENGINEERS
15 VICTORIA STREET
ABERDEEN
AB10 1XB

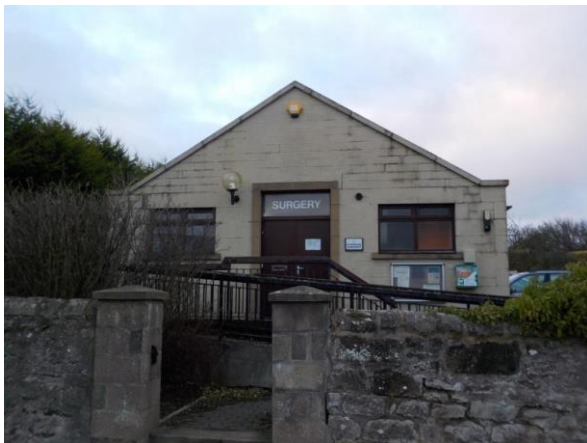
East entrance gable.

4.3 The slope of the ground floors and the cracking pattern of the East entrance gable would suggest that the side elevations are dropping relative to the central portion of the building.

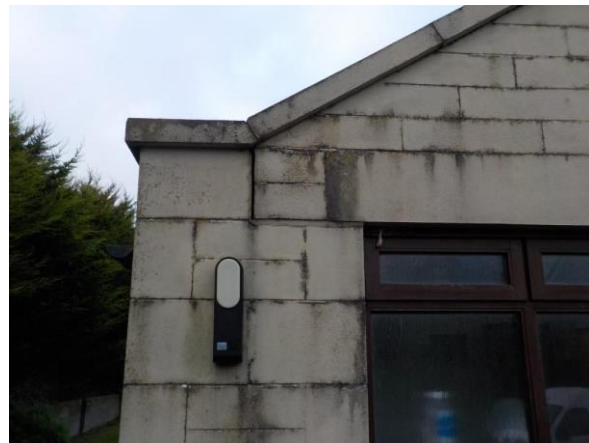
Open joints southeast side.

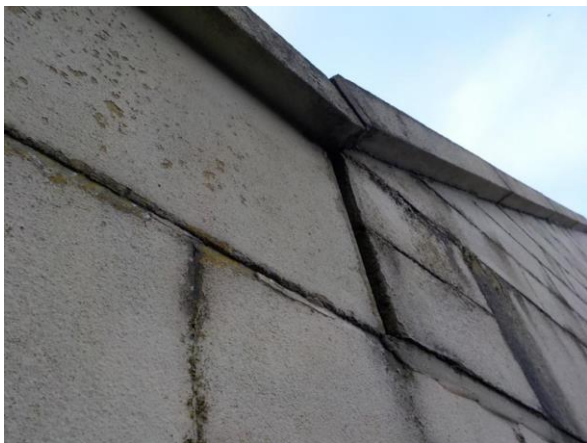
Lateral movement southeast side.

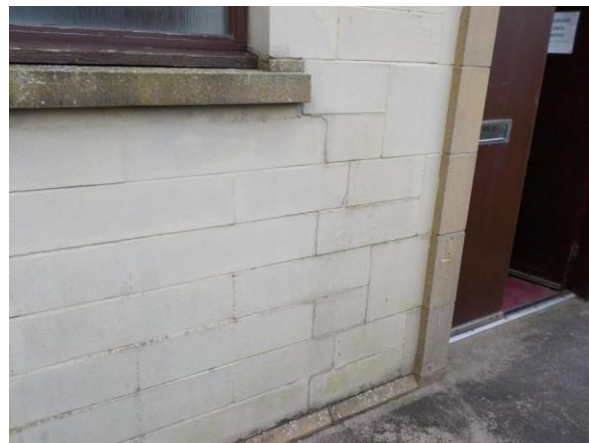
Joint cracking east gable.

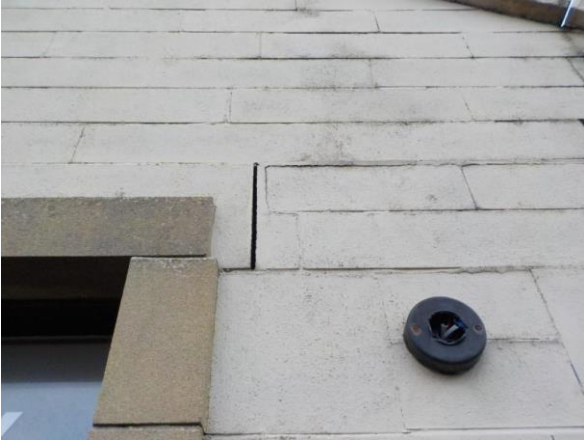
Open joints northeast side.

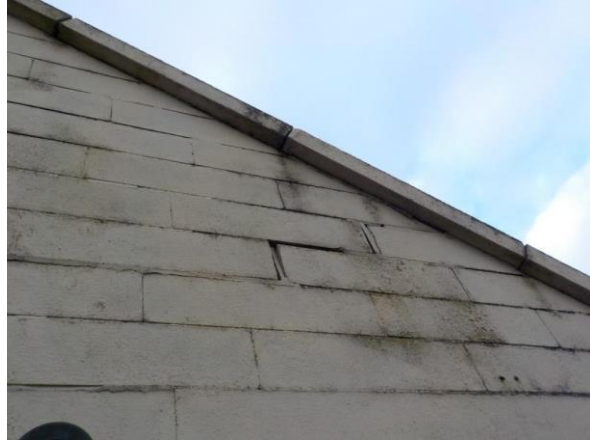
Open joints northeast side.

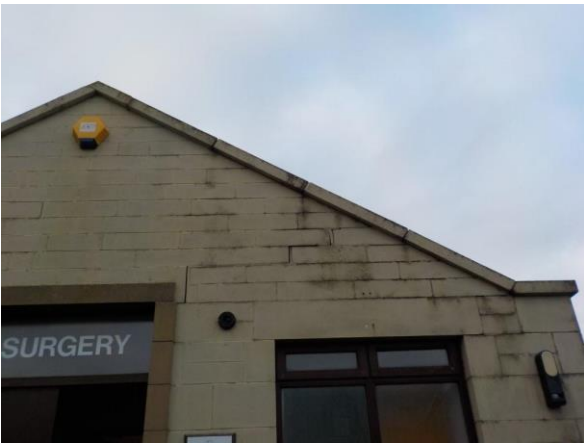
Open joints northeast side.

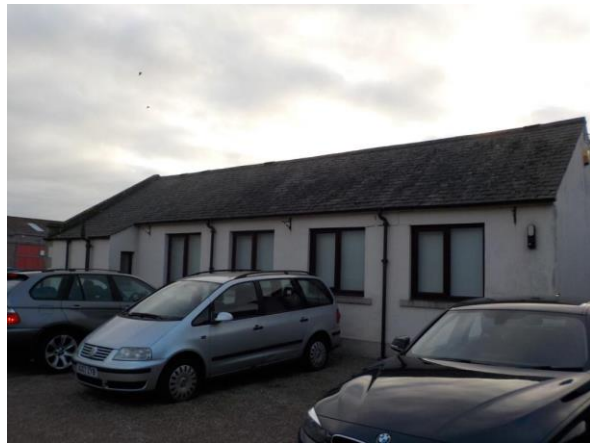
North elevation.

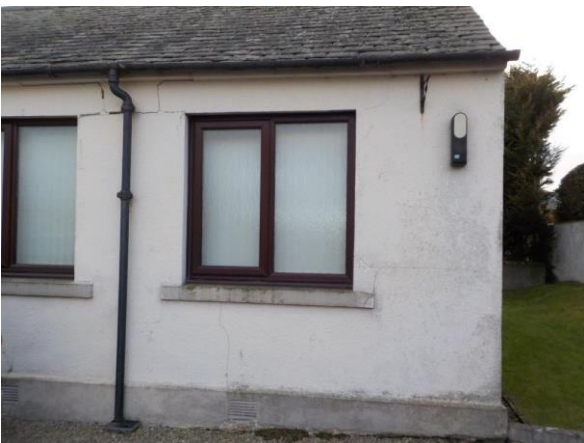
Cracking to west end.

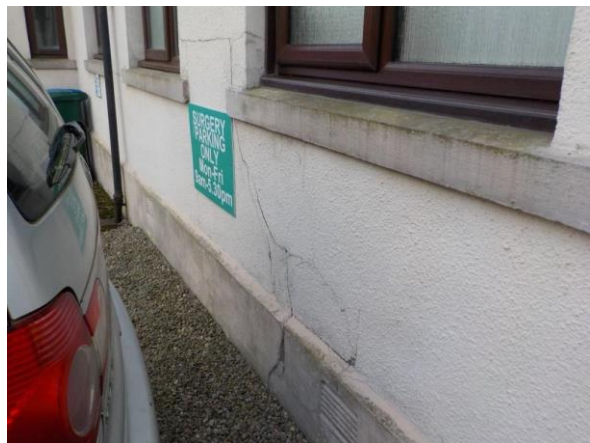
Cracking to west end.

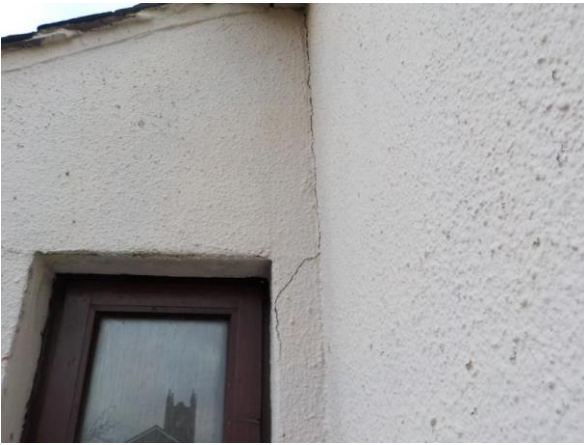
Cracking of side extension east end.

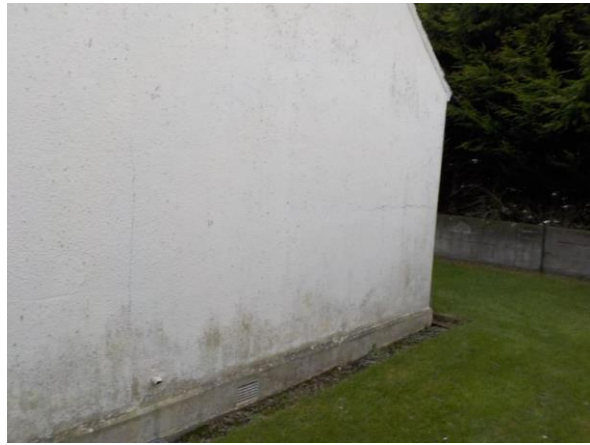
West gable elevation.

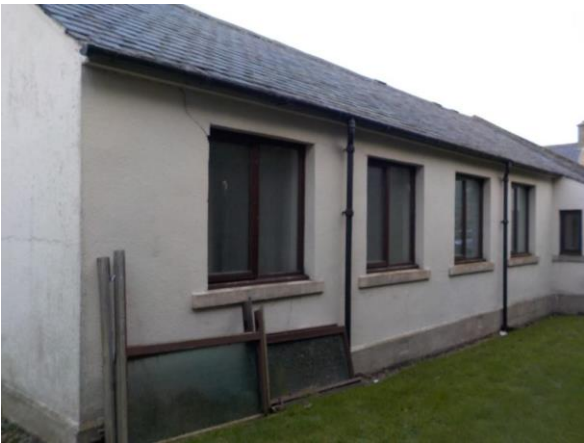
South elevation.

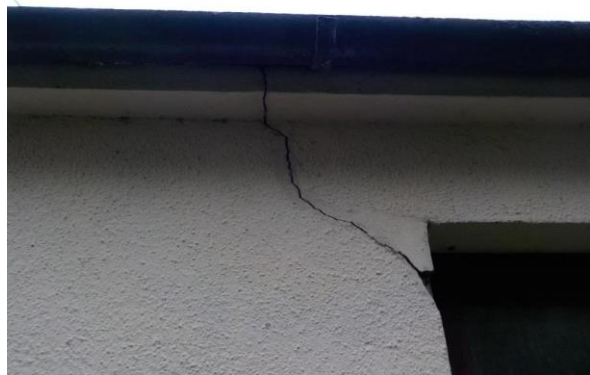
Cracking to west end.

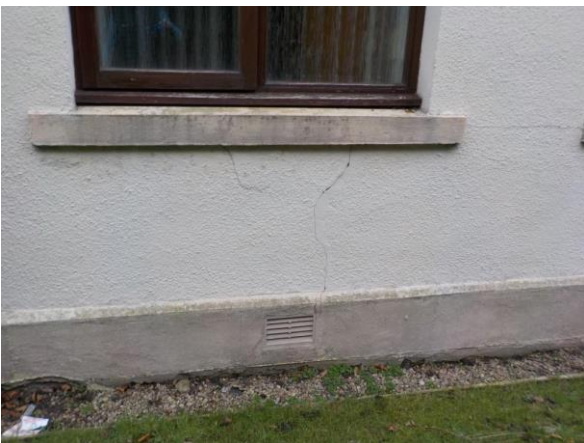
Cracking to south elevation.

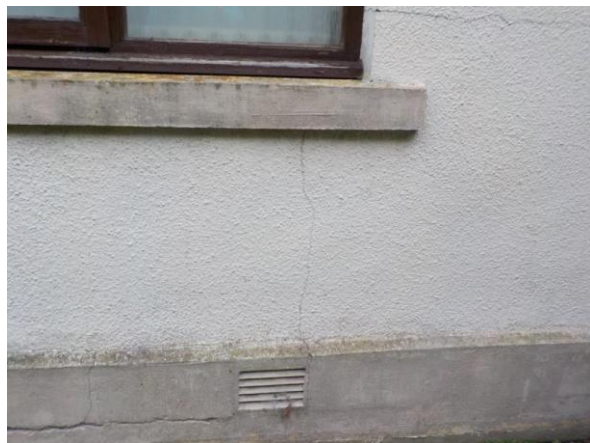
Cracking to south elevation.

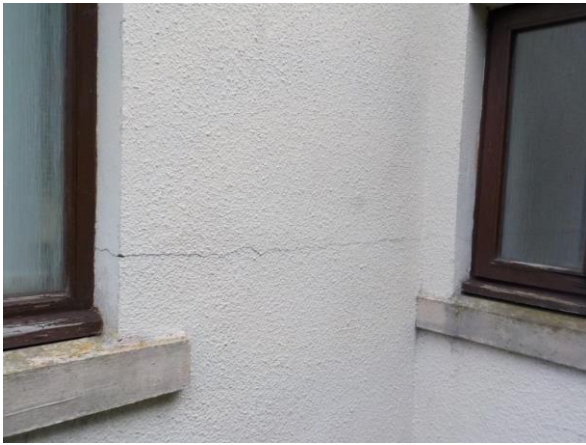
Cracking to east end.

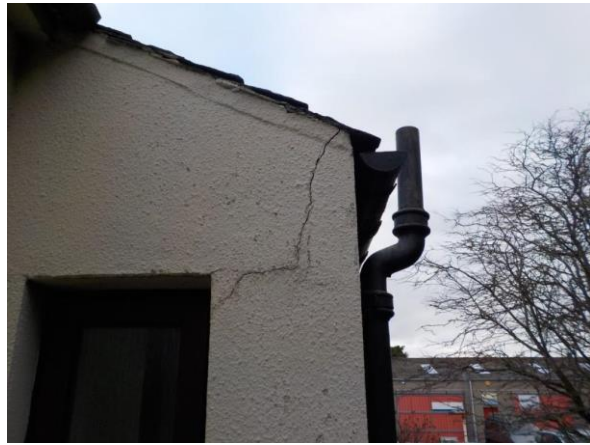
Cracking of side extension east end.

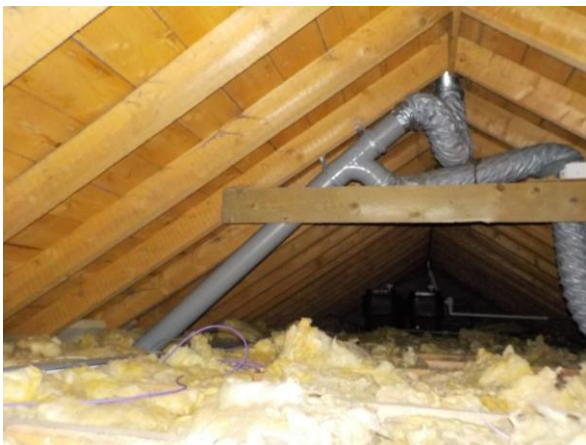
3.6 Access was not taken to the roof space, but the roof structure was observed from an access hatch near the main entrance. The roof structure is of simple construction, consisting only of a raised ceiling tie spanning between rafters. There are no internal timbers to the roof structure. The rafters have the appearance of sagging between the ridge and ceiling tie points.

Internal view of roof structure.

4.2 The roof timbers although not checked by calculation appear to be overstressed and are deflecting as a result. This is potentially placing some outward thrust on the wallheads.

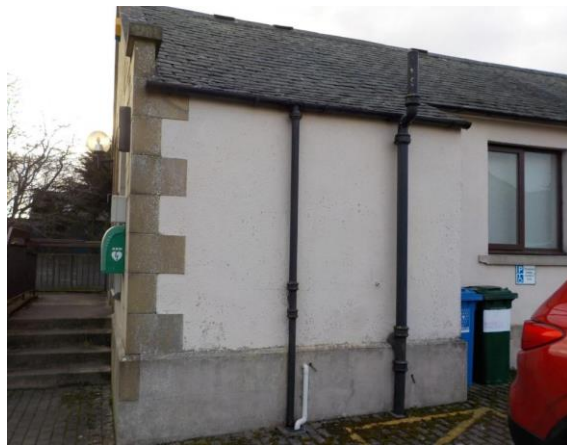
3.2 The roof appears to sag over the small extensions to each side towards the building frontage.

External view of sagging roof.
