Inspection and Assessment Report

Cloddach Bridge, Elgin

March 2022

REPORT TITLE: Inspection for Assessment Report

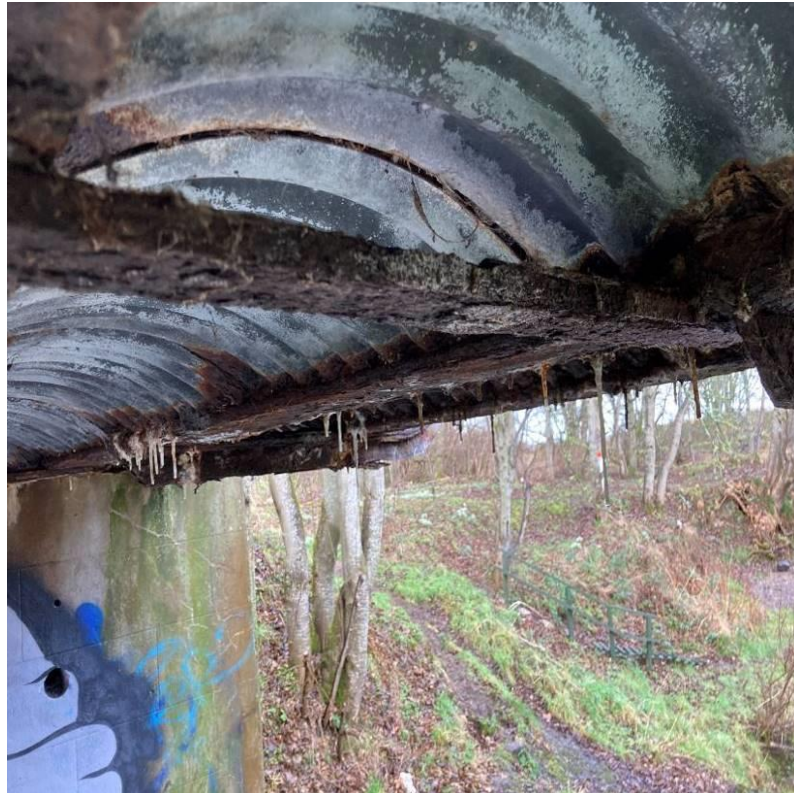
- There is widespread corrosion delamination and layered rust build-up to entire length of visible bottom flange of PB2 and PB6 over all three spans (Photograph 4).

Photograph 4: Widespread corrosion, delamination and layered rust build up to entire length of visible bottom flange of PB2 & PB6 over all three spans.

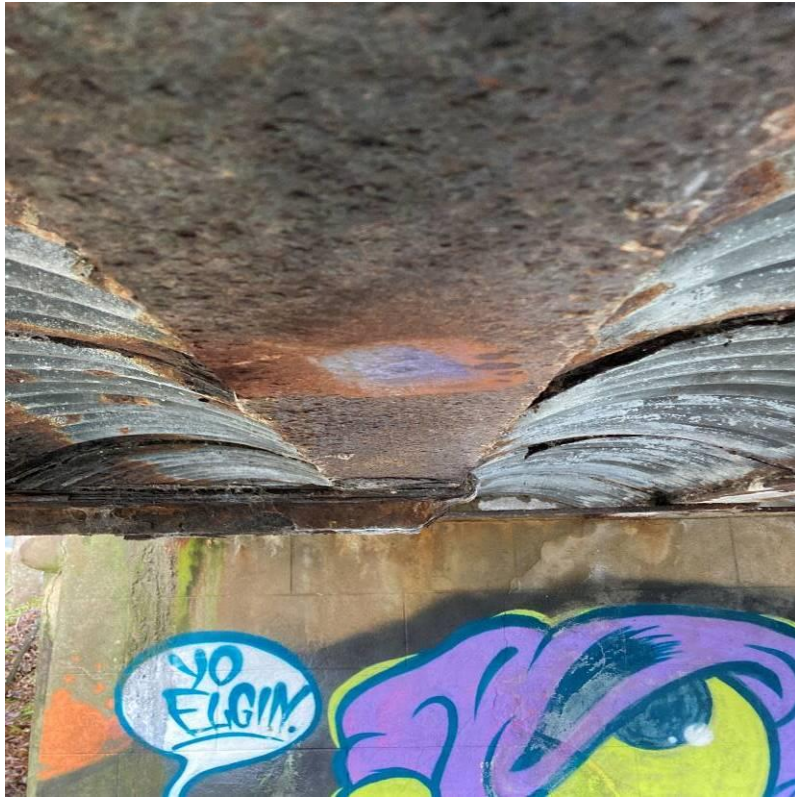
- There is general moderate surface rust and pitting to soffit of bottom flange of internal beams (Photograph 9).
- The flaking paint to soffit of bottom flange of PB4 – PB6 in Span 1. Is indicative of condition where paint coating was only partially intact throughout all three spans. No paint coating was generally visible to PB1 and PB7 as rust layering and delamination was too extensive (Photograph 10 & 11).

Photograph 9: Typical defect to internal beams - moderate surface rust and pitting to soffit of bottom flange (PB6, Span 1 shown).

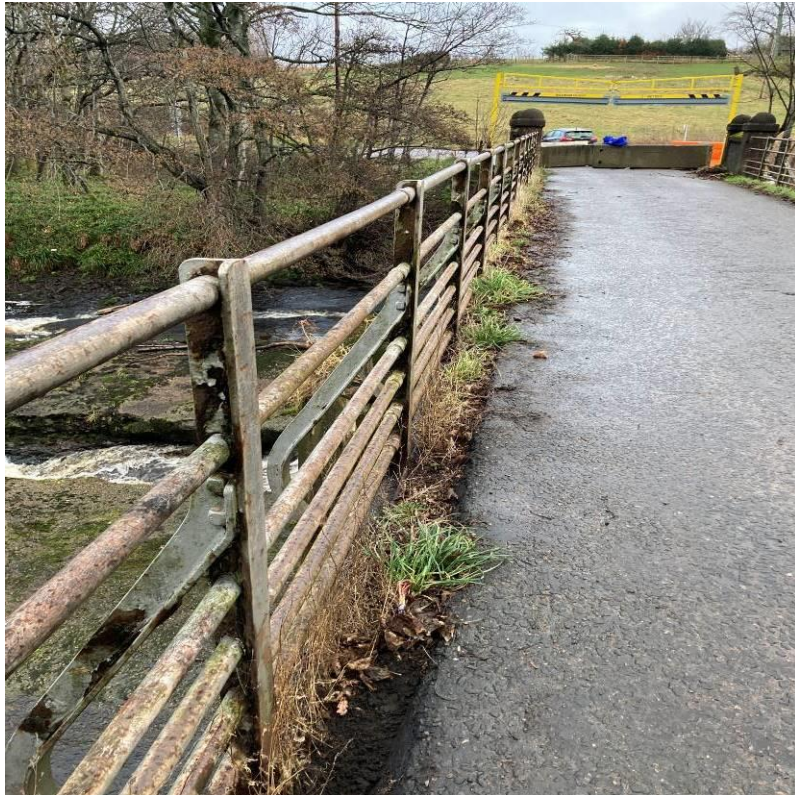
Photograph 19: Typical weathering, surface rust and failure of coating system to parapet rails and upstands.

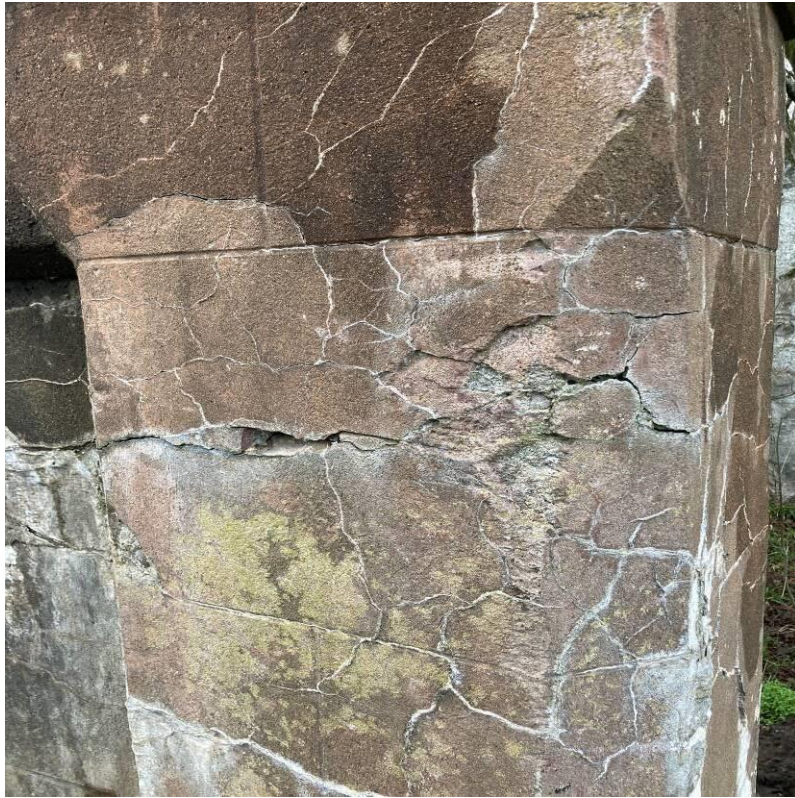
Photograph 25: Evidence of vehicle collision to north-east approach wing wall with spalled concrete and widespread cracking to wall and cope.

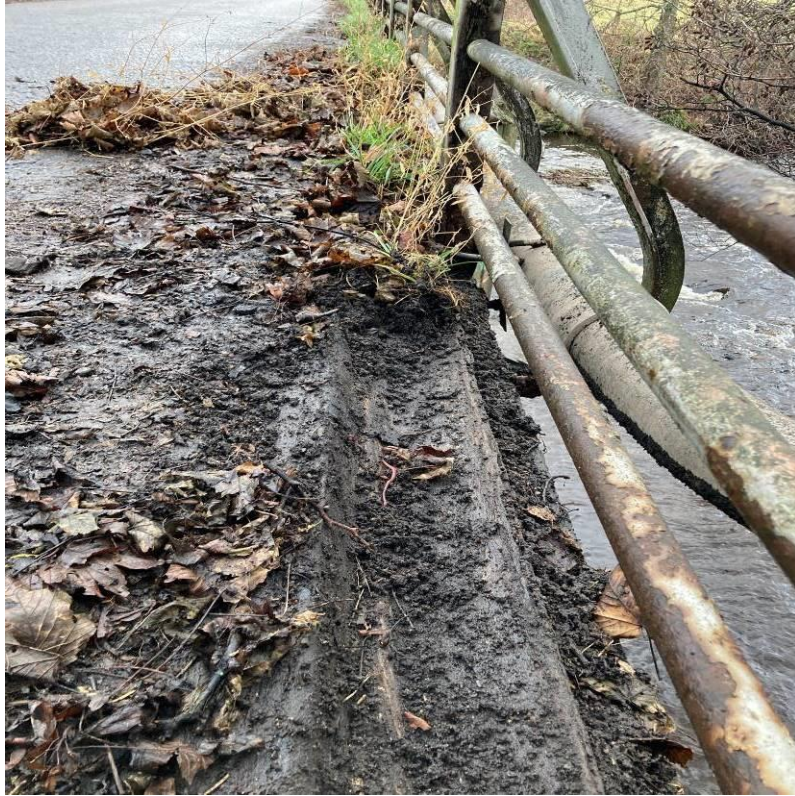
Photograph 27: Typical band of vegetation growth within drainage channel to carriageway edge.

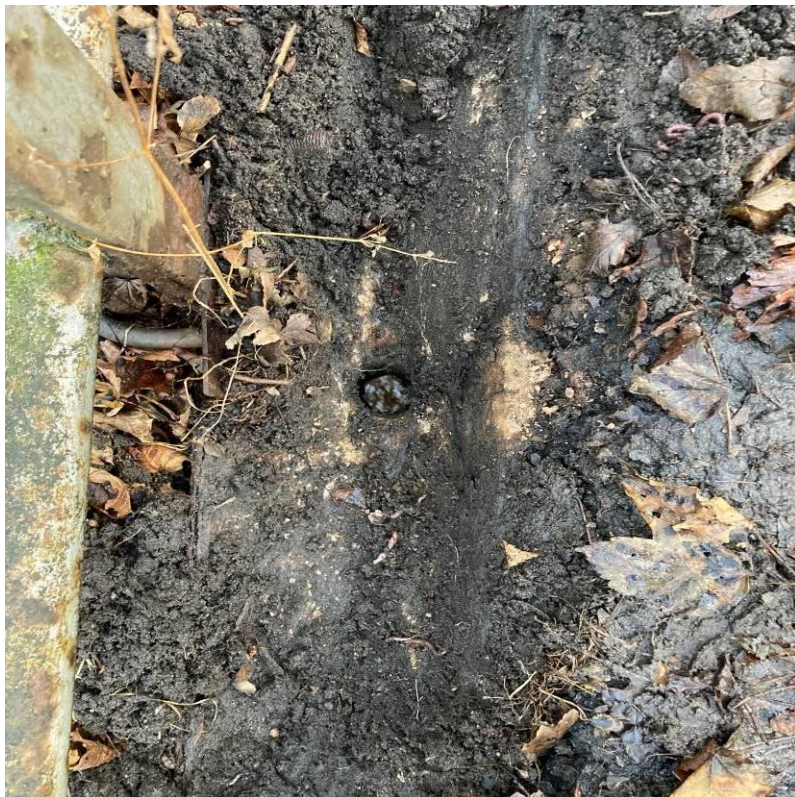
Photograph 28: Typical drainage outlet situated to north and south of bridge at mid-point of each span. Typically blocked by silt and vegetation.

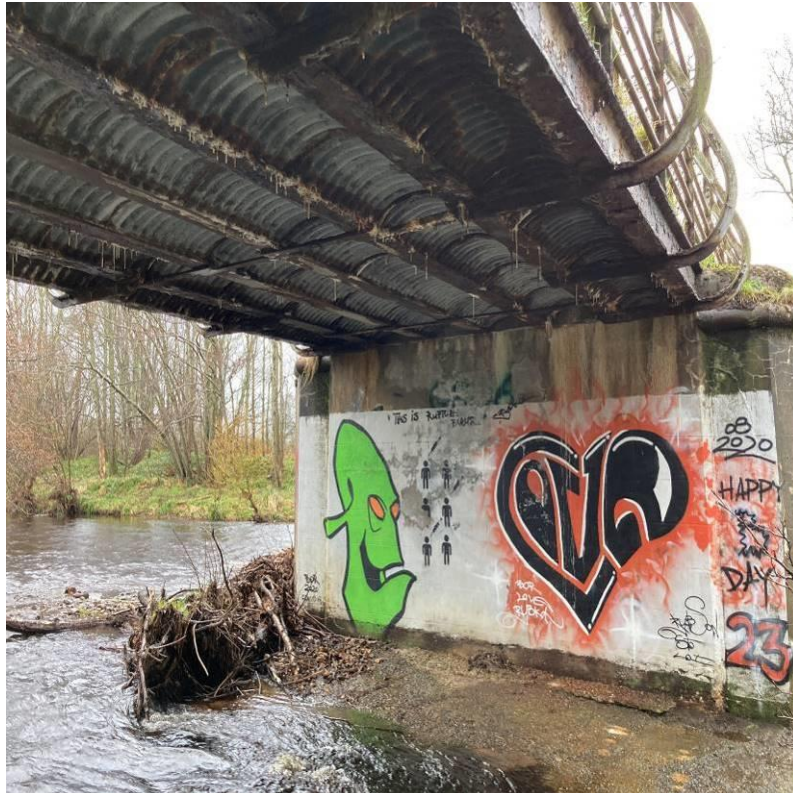
Photograph 34: Accumulation of vegetation to upstream cutwater of Pier 2.

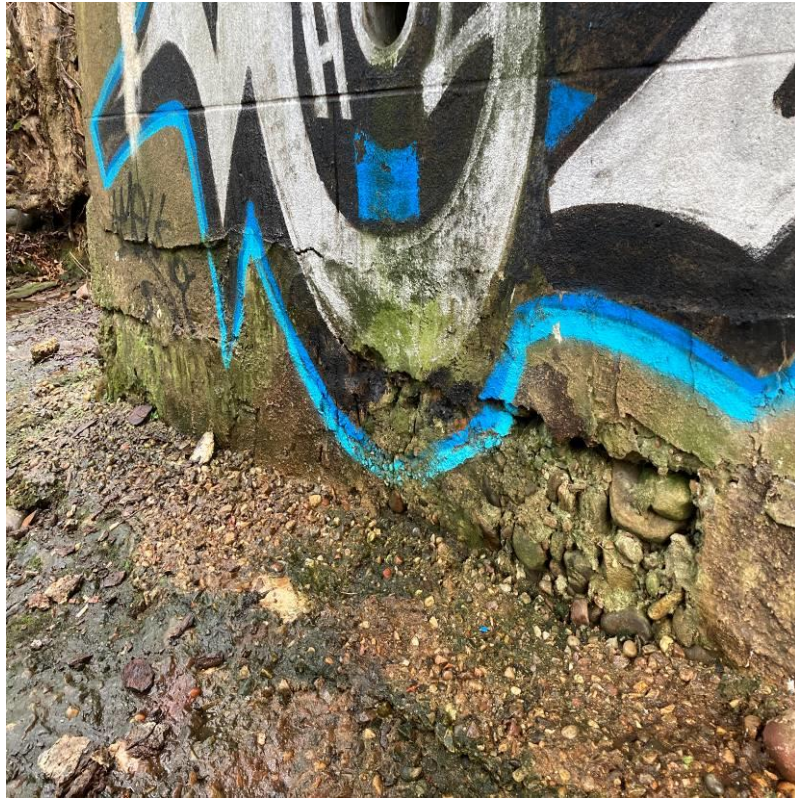
Photograph 43: Typical scour to base at base of east abutment with exposed aggregate.

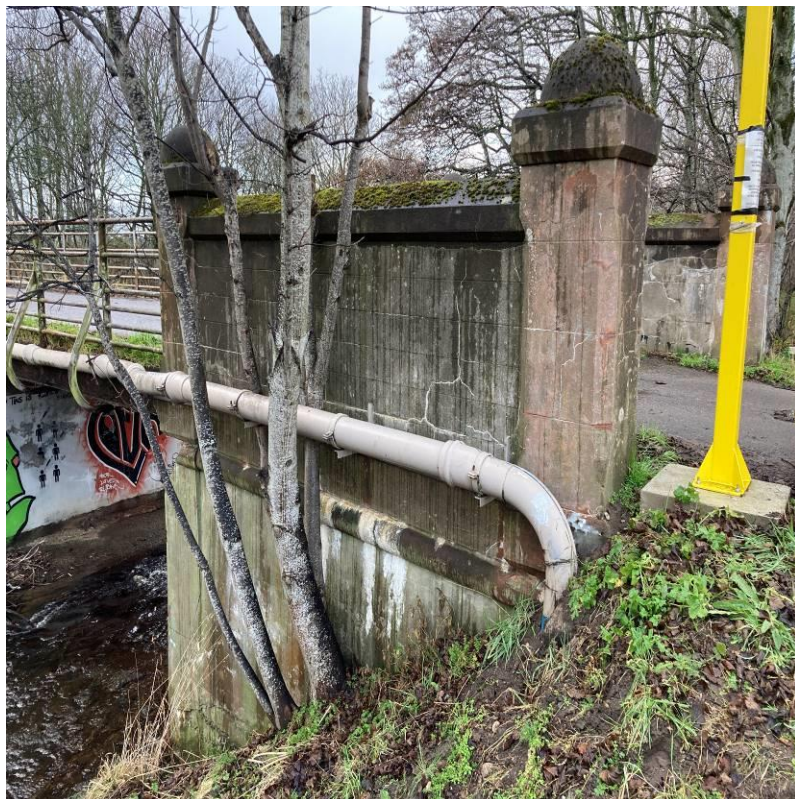
Photograph 44: Typical mature vegetation growth to east and west abutment.

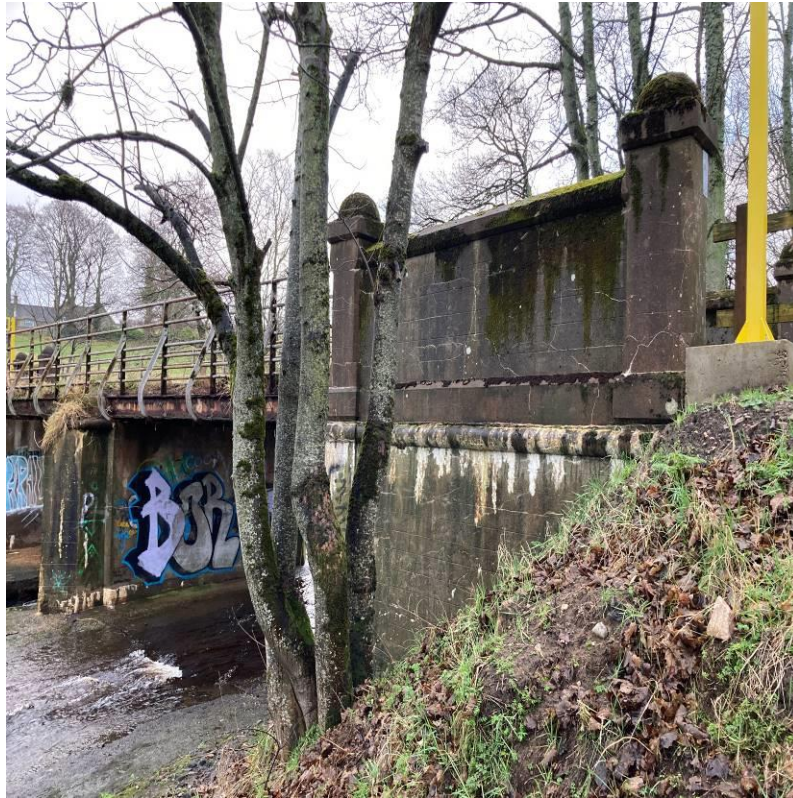
Photograph 45: Typical mature vegetation growth to east and west abutment.

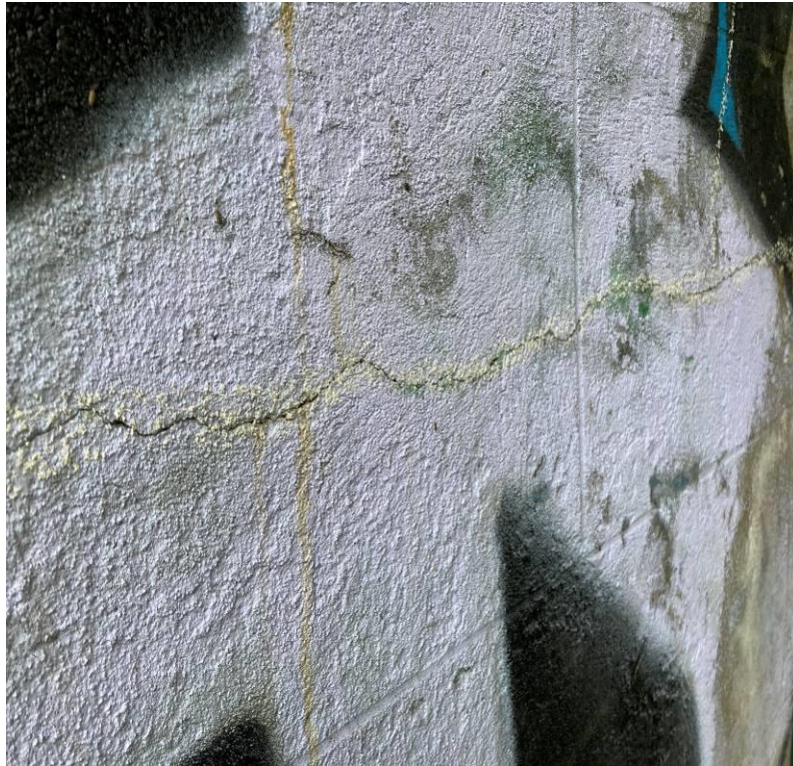
Photograph 47: Horizontal crack propagating full width of western face of Pier 1. Height of crack varies between 1.3m and 1.6m above invert level. Width of crack varies along length but is less than 1mm at all times.
