**Notice of Motion
Moray Council
15th September 2021**

River Spey Flooding

River Spey, Garmouth Report, August, 2021

Date:	11 th August 2021	Version:	FINAL
To:	Innes Community Council		
From:	Hamish Moir, cbec eco-engineering UK Ltd		
Project:	Lower Spey Sustainable Channel Management		
Subject:	Proposed options and outline designs for channel management at Ross House

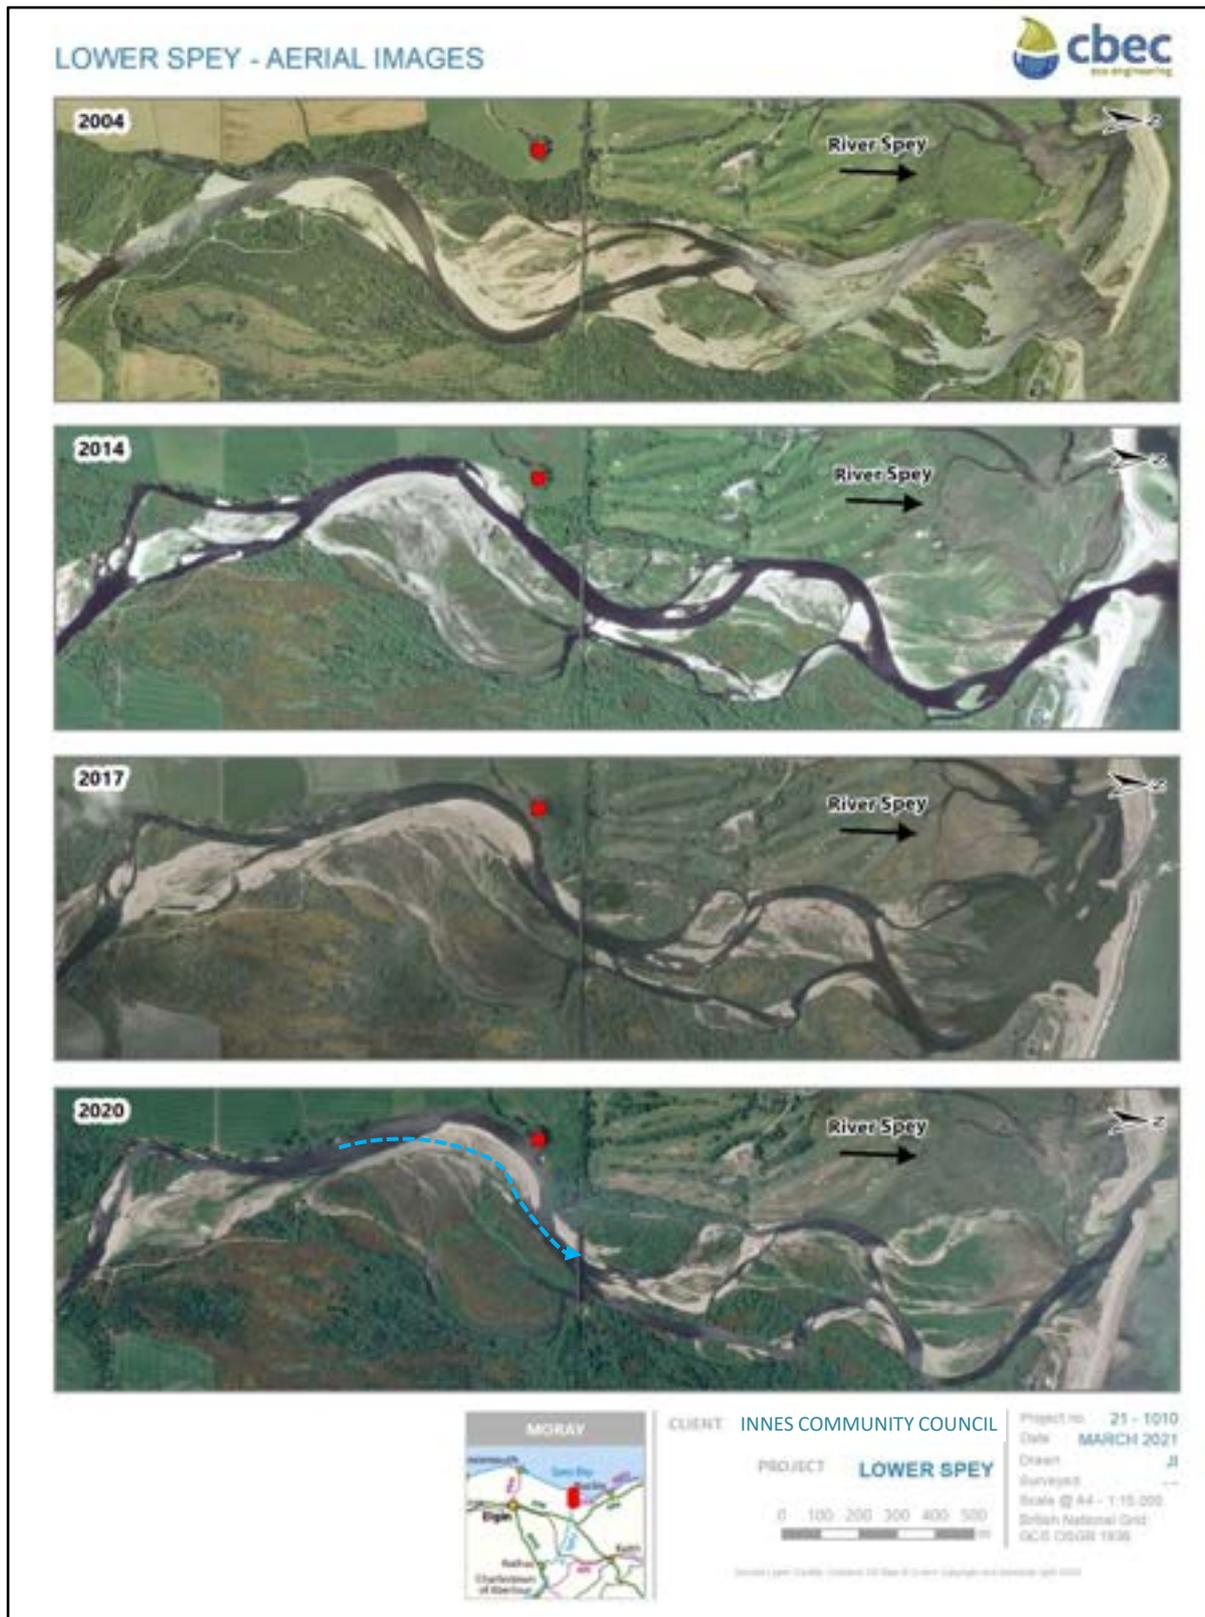
Figure 2.2. Aerial imagery of the lower River Spey at Garmouth and Spey Bay showing significant changes in the location and morphology of the channel between 2004 and 2020. For instructional purposes, the dashed light blue line in the 2020 frame represents the preferred alignment of the main flow of the river that the proposed works intend to deliver.

Aerial Imagery (Figure 2.2) and historical maps (Figure 3.1) illustrate the highly dynamic behaviour of the lower River Spey in the Garmouth area which has implications for the study section at Ross House.

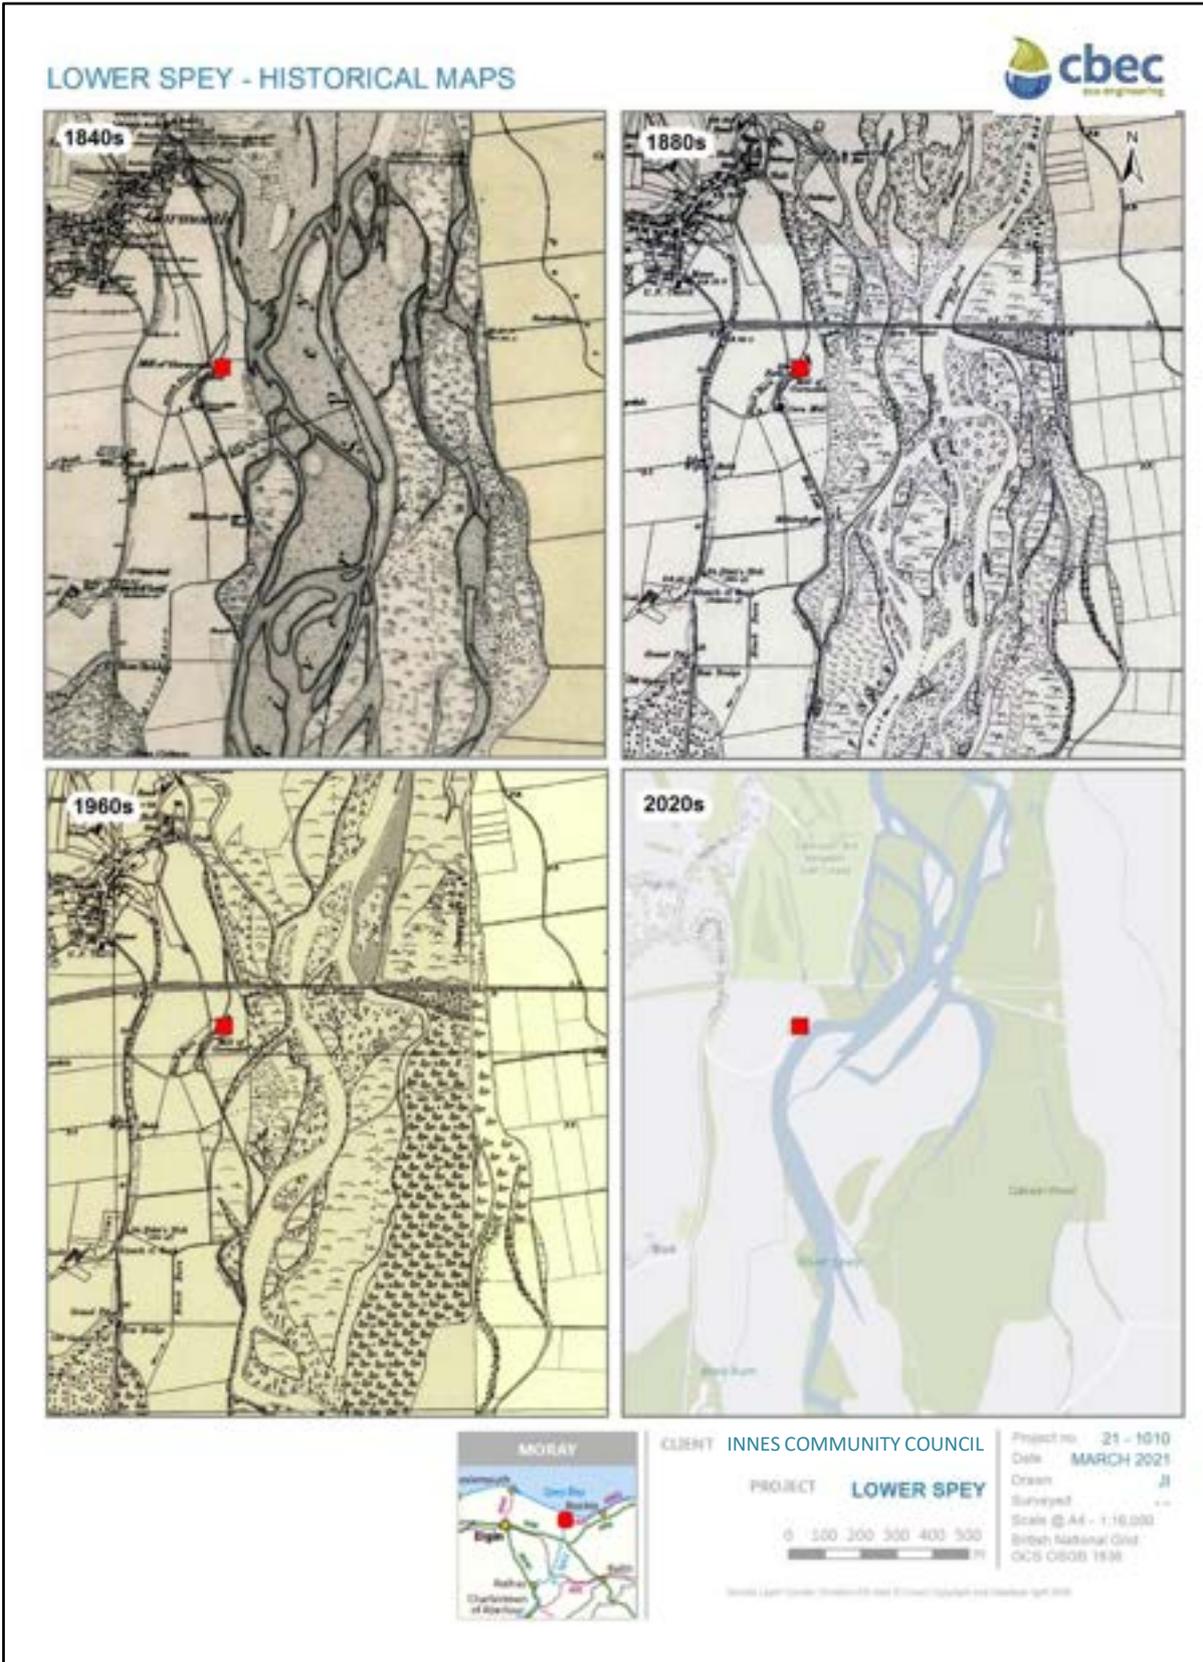
Figure 3.1. Historical channel changes of the lower River Spey near Garmouth from published maps over the last ~160 years. The location of Ross House is indicated by the red square.

In particular, the historical maps¹ note that:

- Ross House is located at the former Mill of Garmouth. Maps produced after 1905 show that the mill lade, Millcroft and Corn Mill to the south of the Mill of Garmouth between Newton and Essil are no longer marked and may have been lost as the Spey has migrated west.

- The Black Burn originates to the south of Newton and flows north through Garmouth to Spey Bay. Between 2004 and 2012 the Black Burn watercourse at this location was also captured by westward migration of the River Spey.

- The Black Burn originally flowed to the west of Ross House and formed part of an artificial drainage network linked with the mill lade system. The former course can be seen on modern aerial imagery as a topographic low/wetter ground.

- Maps published in the 1960s show that there is evidence of a new topographic low to the east of Ross House which has been connected to the Black Burn and the mill lade at the former Millcroft location. It is not clear if this connection was artificially dredged as a navigation/access channel but remains apparent on recent OS maps and aerial imagery.

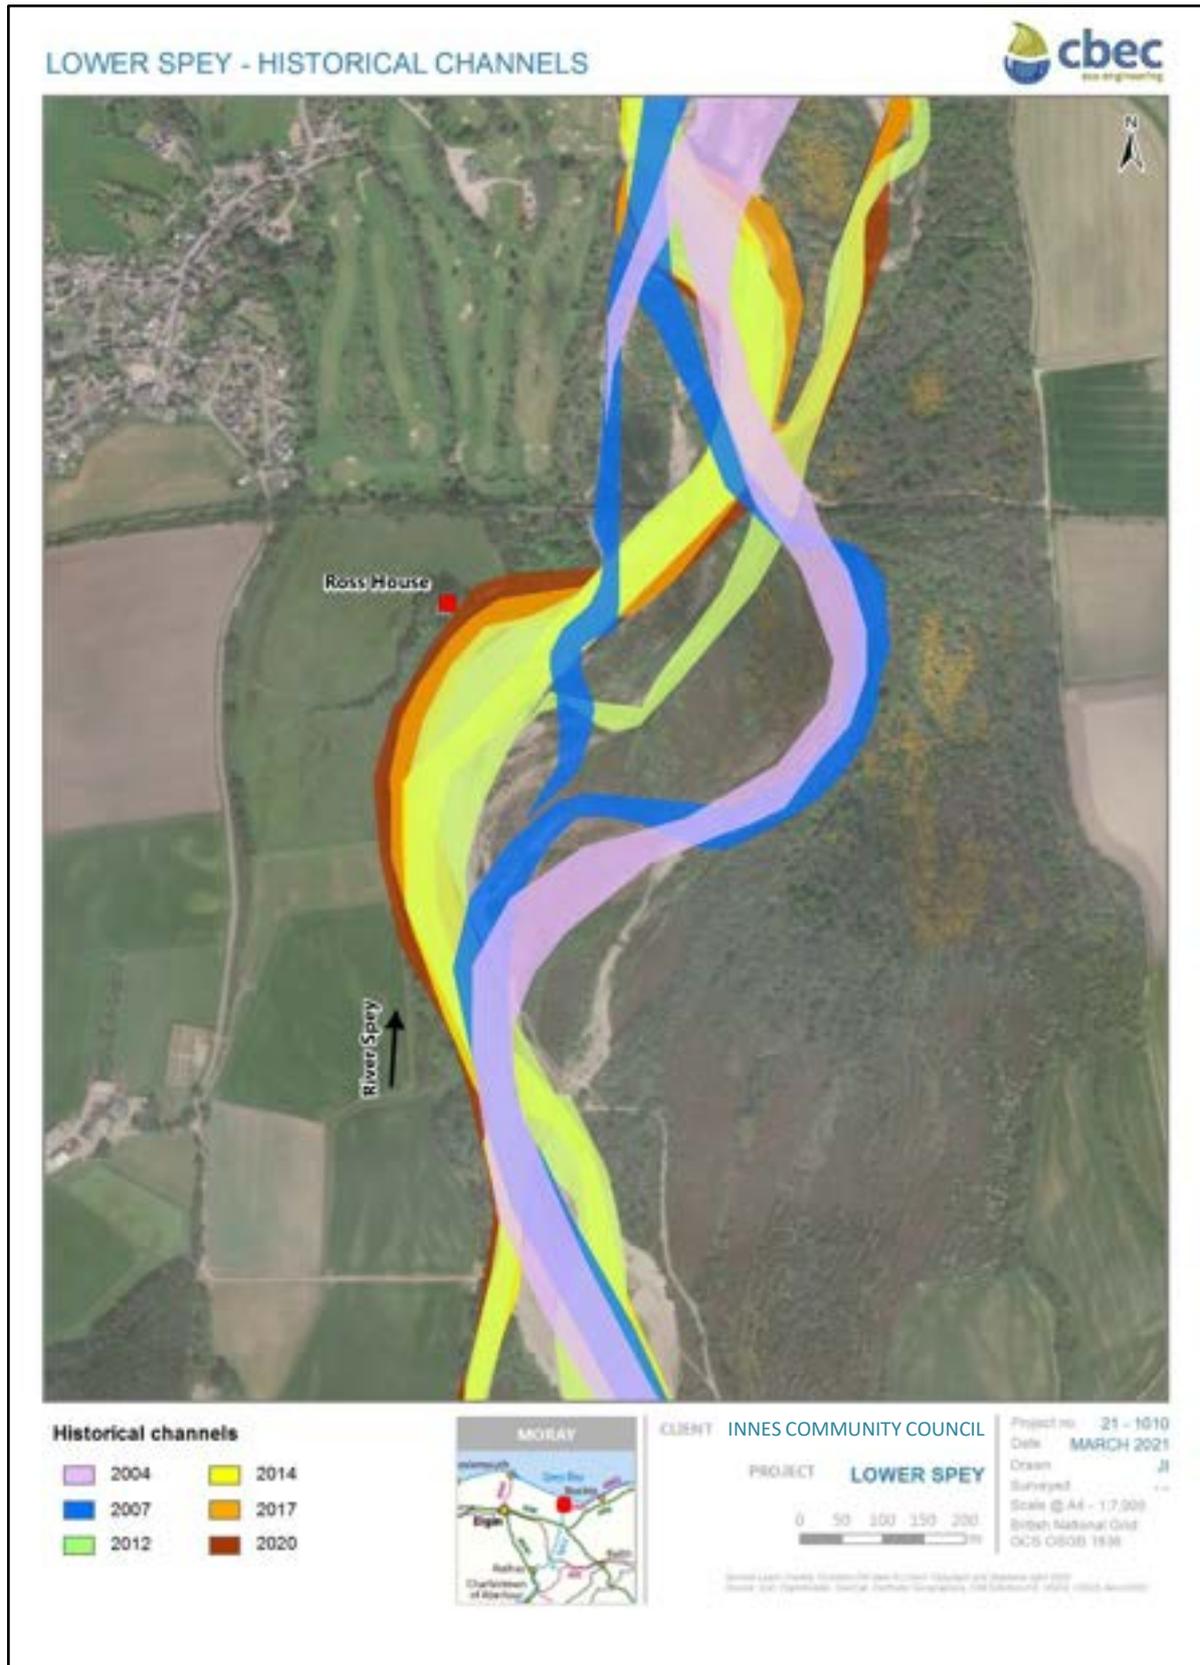
Figure 3.2. Summary of recent historical channel changes of the lower River Spey near Garmouth from aerial imagery since 2004. The location of Ross House is indicated by the red square.

The proposed management options at the locations shown in Figure 5.1 are intended to provide sustainable medium- to long-term solution for the risk posed to the Ross House founded on a process-based approach which work in tandem with interim bank stabilisation measures at the property. It is also anticipated that the management options proposed in this report will tie into long-term plans proposed for this reach of the River Spey which may include restoring the main flow path to the 2004 alignment (Figure 3.2).

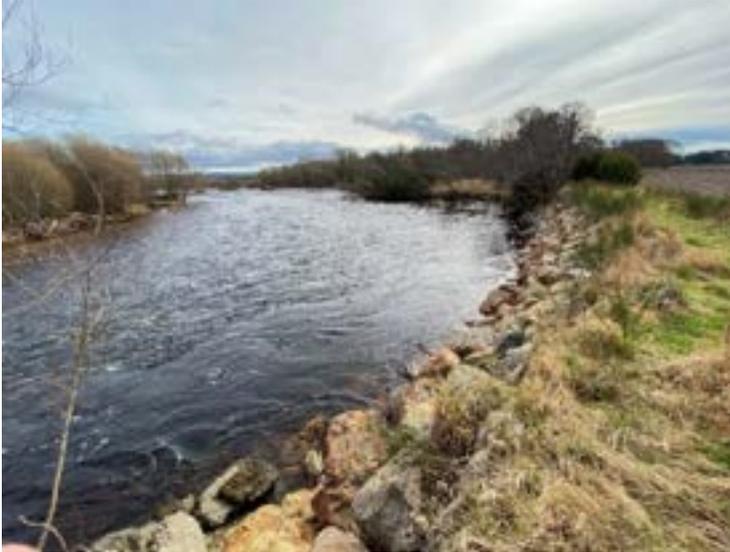
<p>Artificial embankment extending ~200 m downstream from the end of the rock bank protection in the photo above. This feature inhibits high flows naturally connecting with the river left/ west floodplain, focussing overbank flow into the reach downstream (i.e., in the vicinity of Ross House).</p>

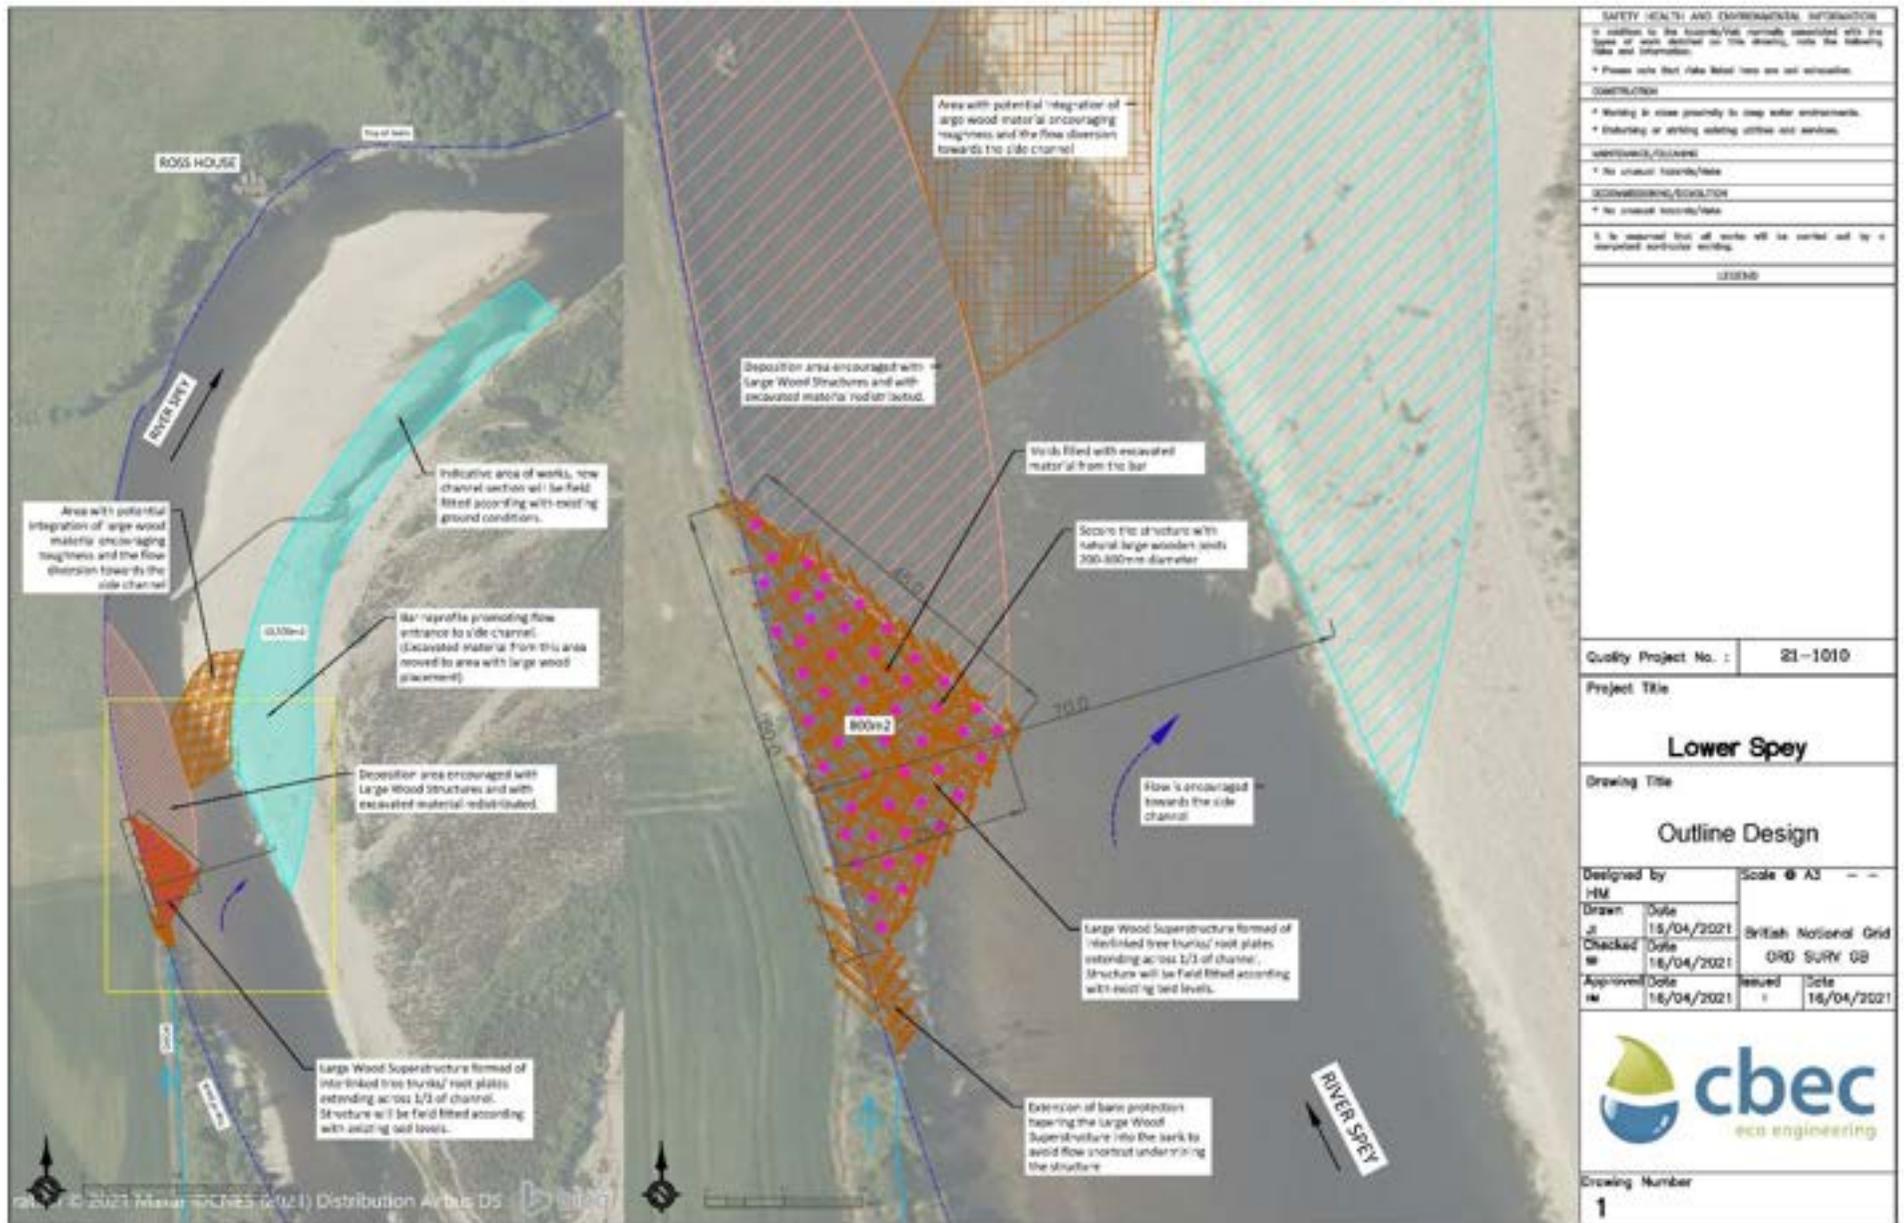
Figure 5.1: Location and general design specifications of proposed channel management works to encourage flow diversion into the former 2014 channel.

Upstream from the riffle, an exposed embryonic lateral bar was evident on the aerial image in Figure 5.1 during low flow conditions. Recent site observations suggest that this lateral bar feature is no longer as apparent although the associated transverse bar/riffle crest have remained largely in situ indicating a zone of net sediment storage. This natural sediment accumulation along the left bank can be accentuated through the addition of a substantial LWS, a feature that will increase roughness and reduce the competency of the flow in the vicinity of the structure, encouraging a zone of enhanced/preferential sediment deposition. The gradual increase in elevation and volume of this left bank bar associated with the enhanced sediment transport processes will direct flows away from the left bank and towards the existing point bar back channel to the right/ east.

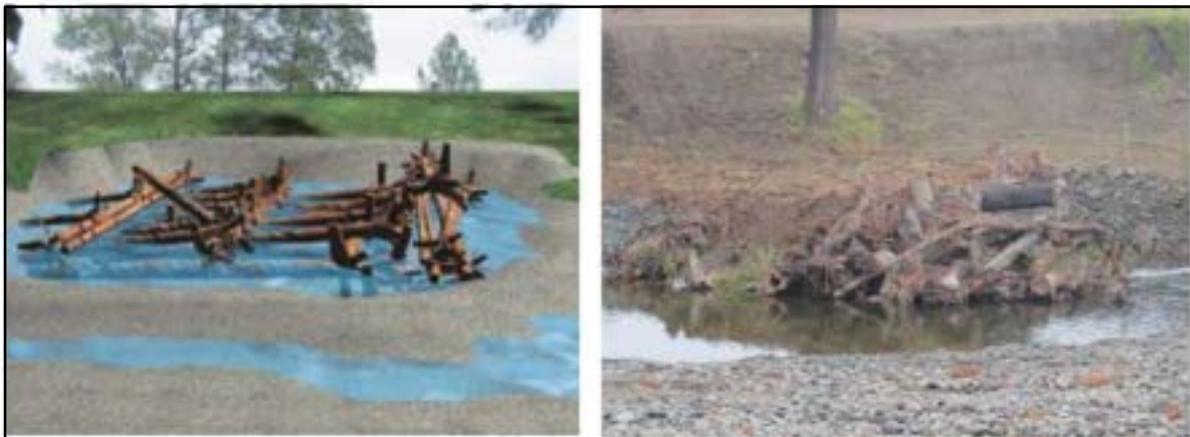
Figure 6.1: Examples of engineered log jam flow deflectors (from Brooks, A. P. 2006)

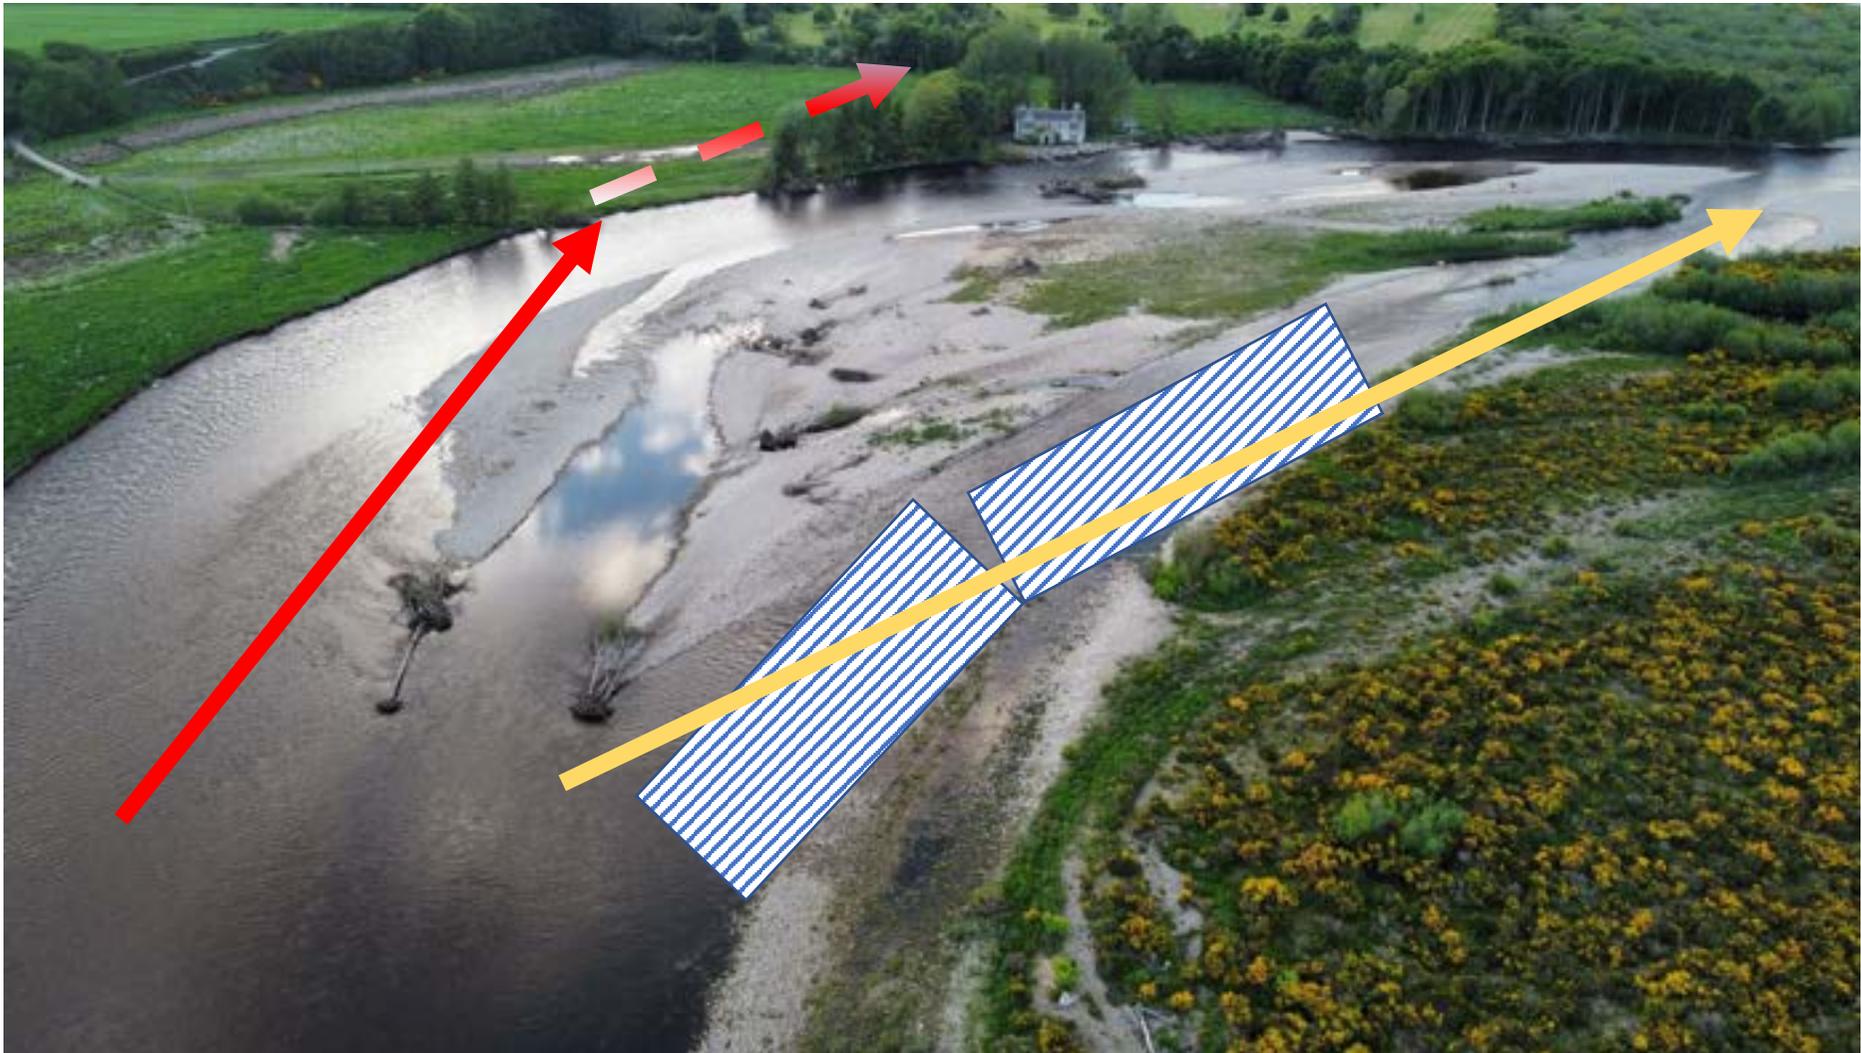
Proposed engineering works for River Spey at Queenshaugh, August, 2021

Red line current main flow of river directly into lands of Queenshaugh. Broken line direction river heading
Red box represents proposed tree construction to guide river eastwards. Yellow line direction that river will be guided.
Blue hash box. Channel to be deepened and widened to encourage river eastwards away from Queenshaugh land.

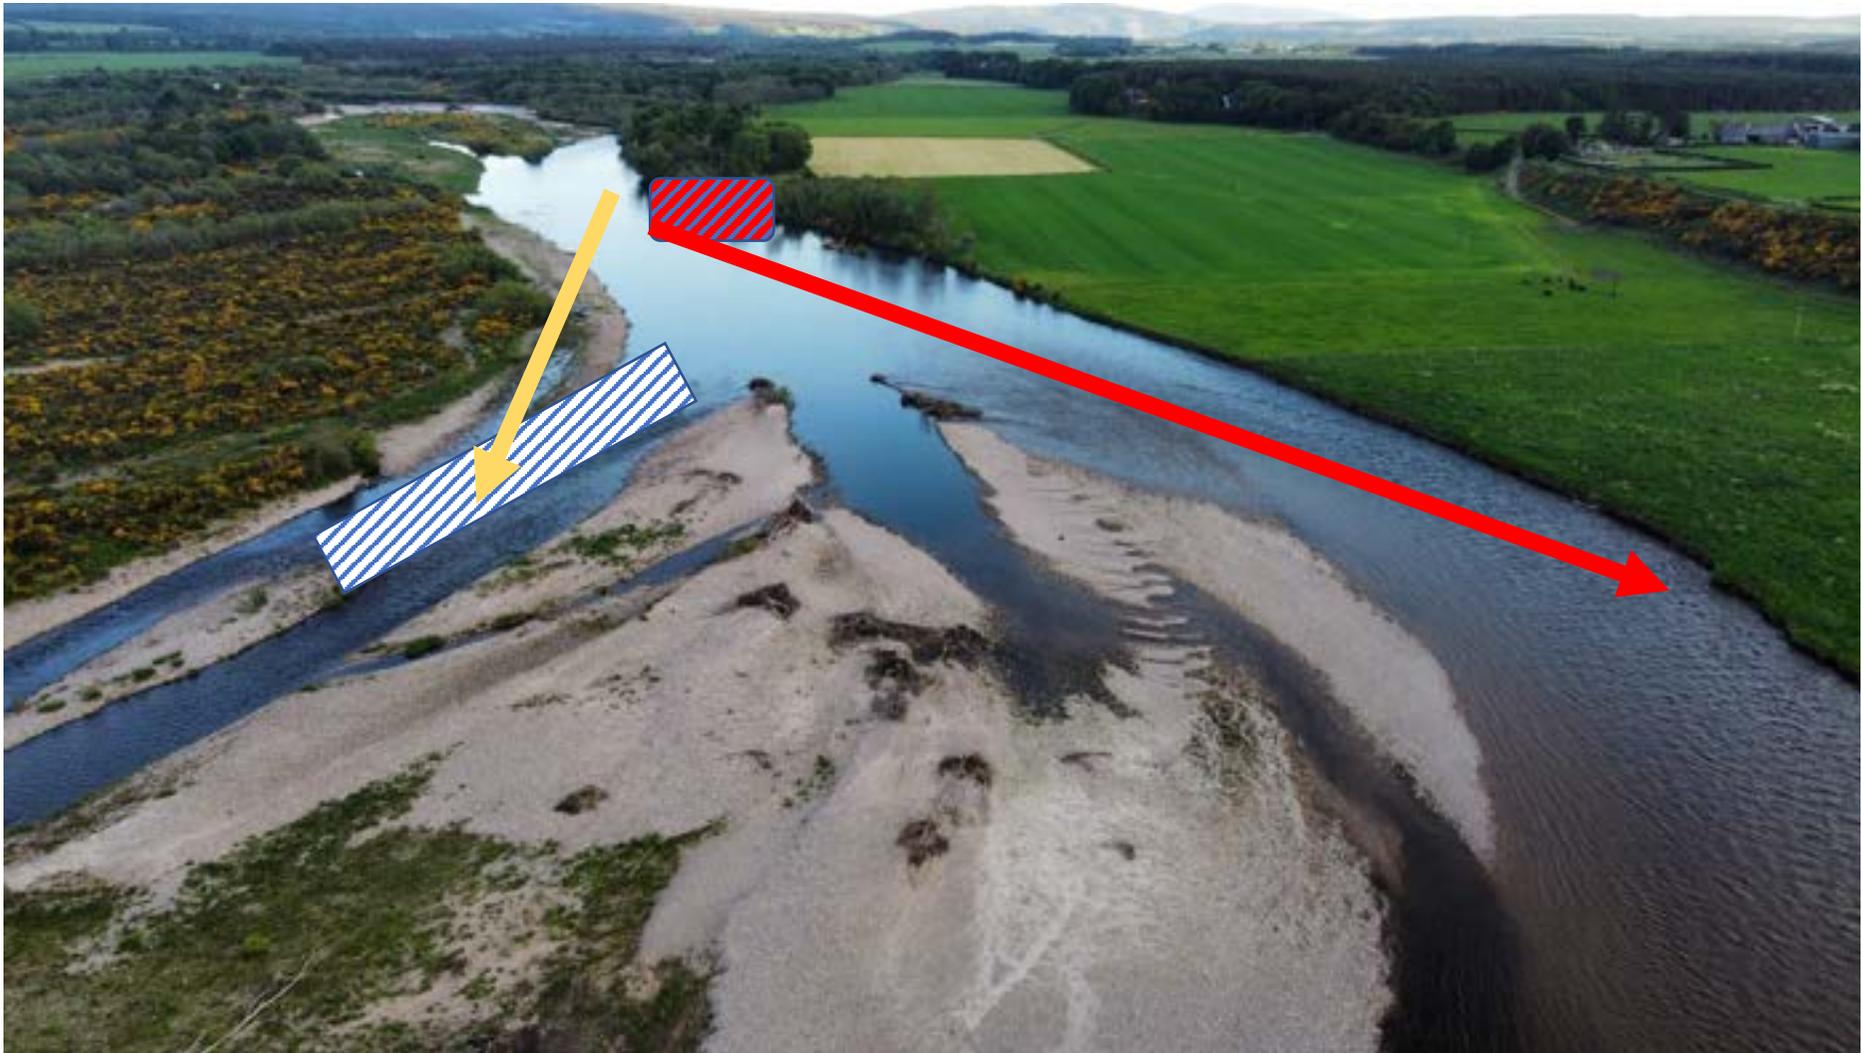
Proposed engineering works for River Spey at Queenshaugh, August, 2021

Red line current main flow of river directly into lands of Queenshaugh

Red box represents proposed tree construction to guide river eastwards. Yellow line direction that river will be guided.

Blue hash box. Channel to be deepened and widened to encourage river eastwards away from Queenshaugh land.
