# **Inspection and Assessment Report**

## **Cloddach Bridge, Elgin**

**March 2022**

REPORT TITLE: Inspection for Assessment Report

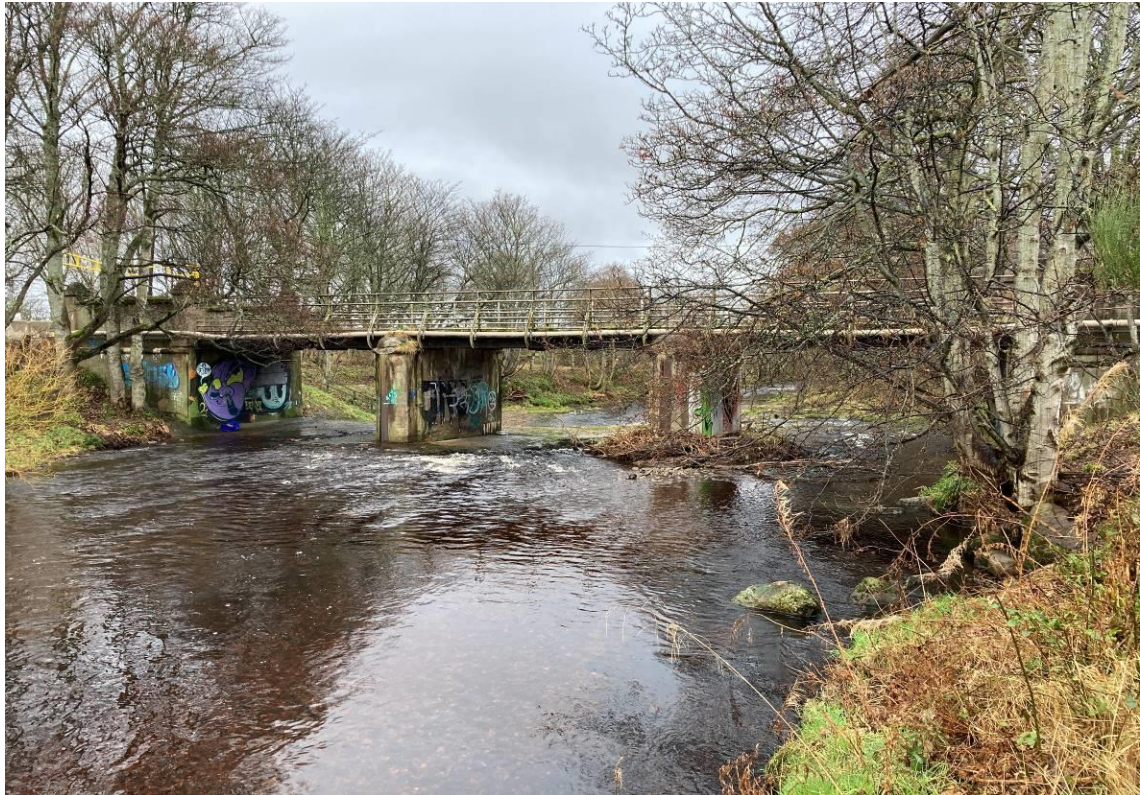
**Photograph 54: Upstream elevation.**

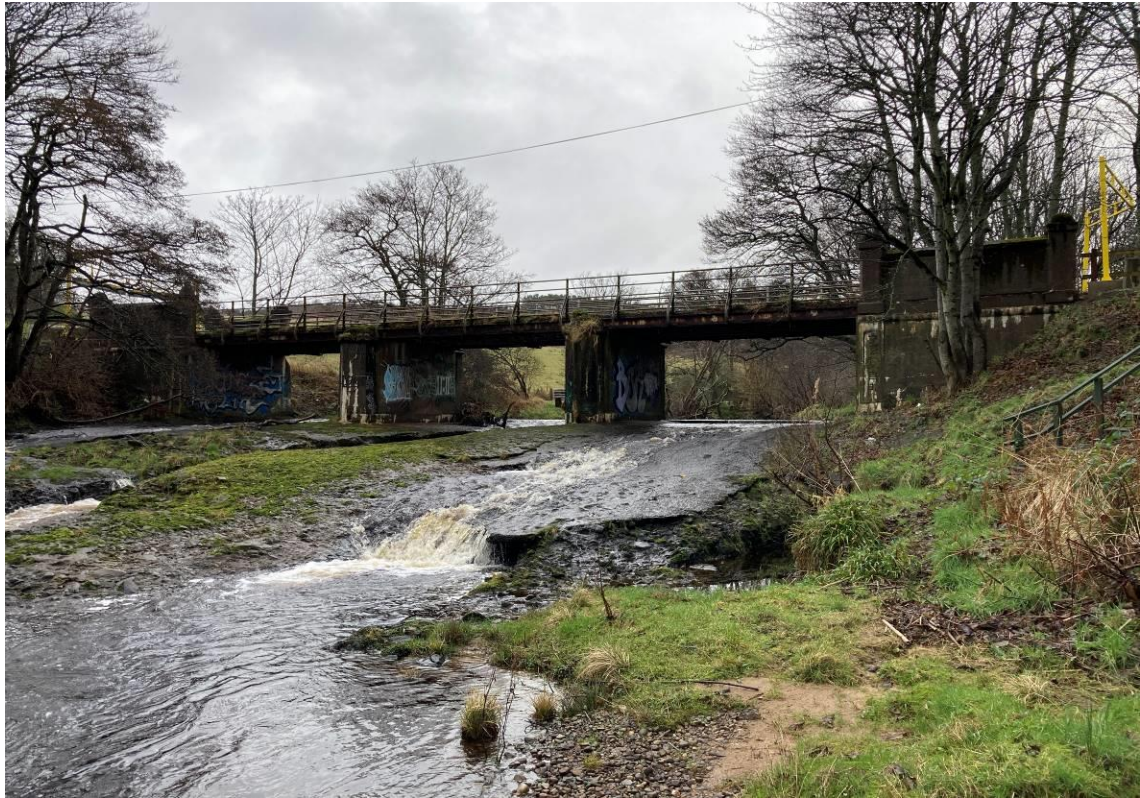
**Photograph 55: Downstream elevation.**

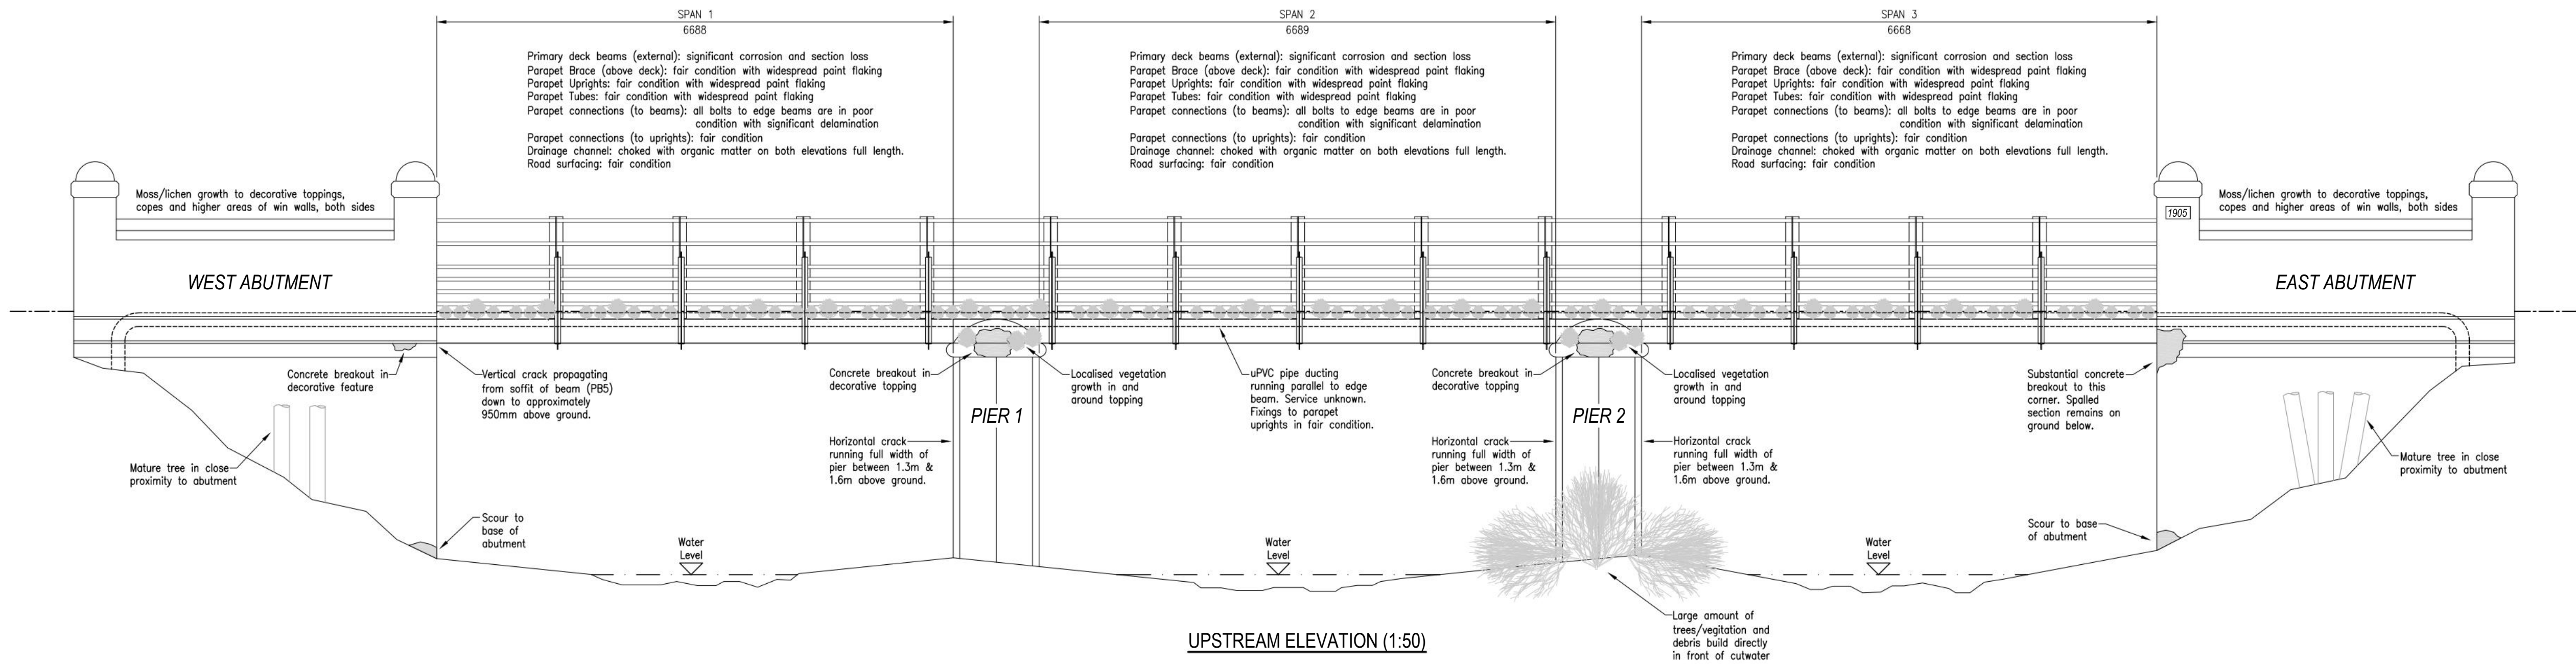
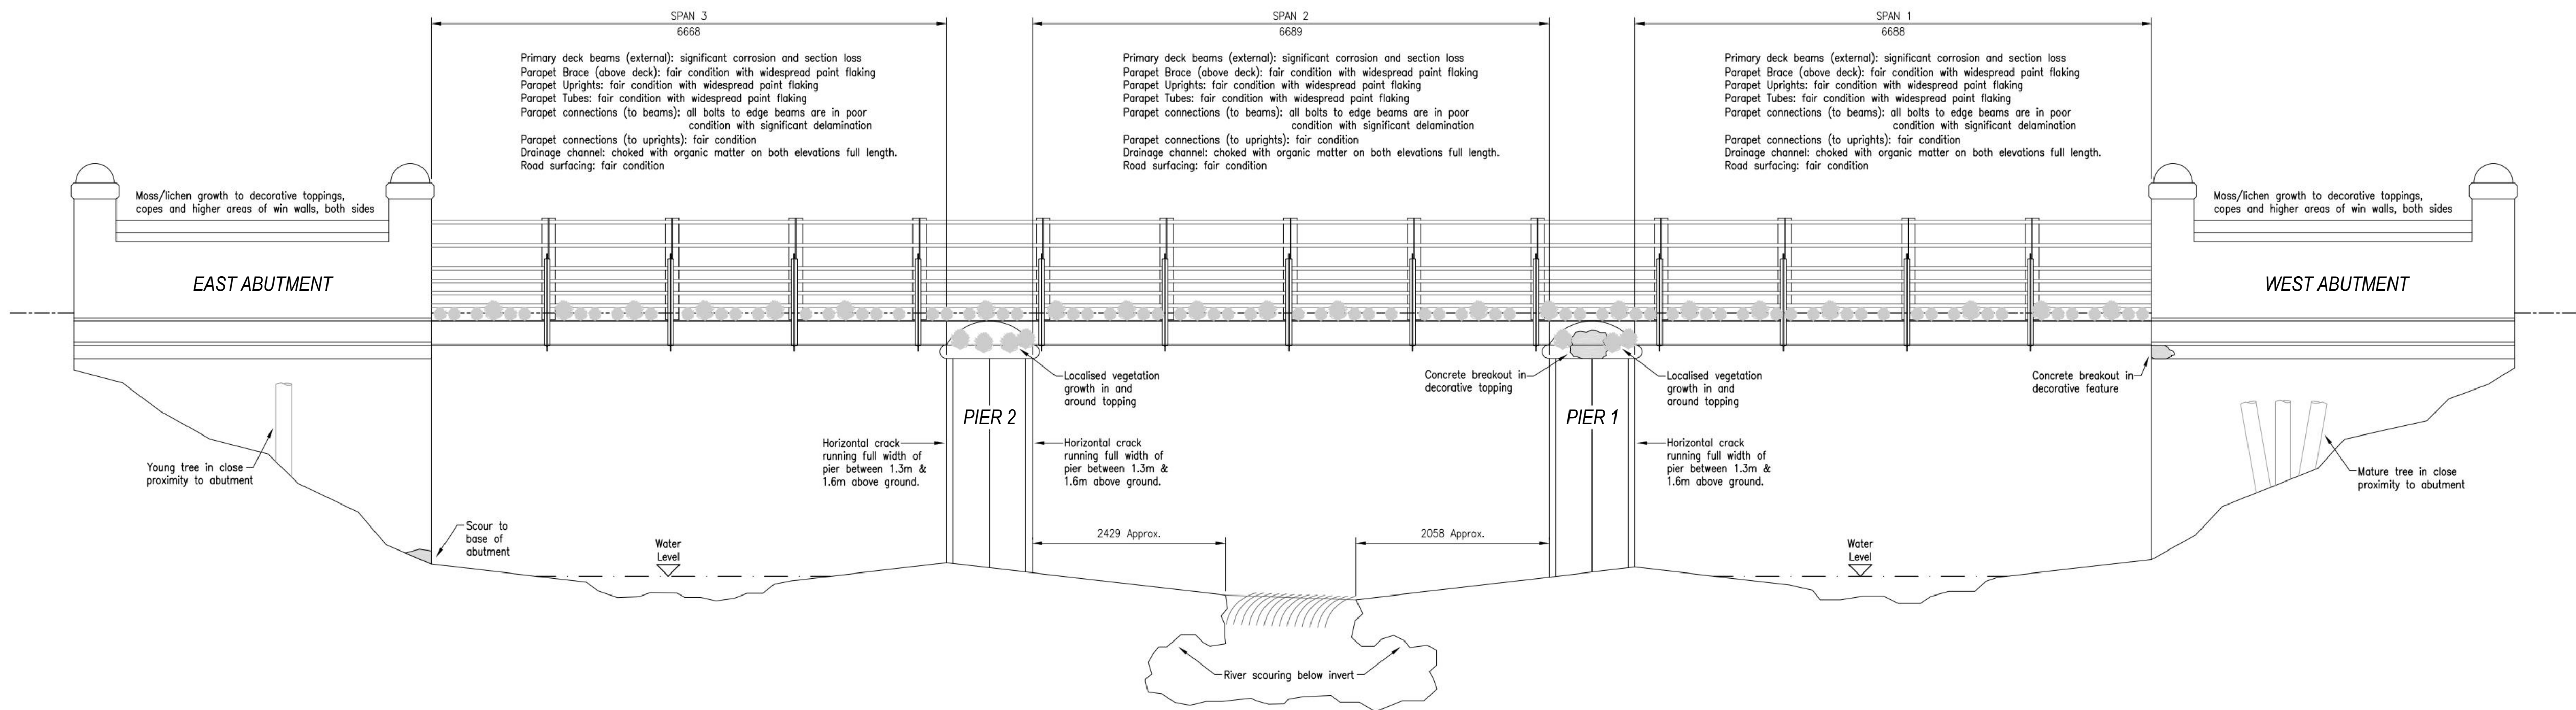
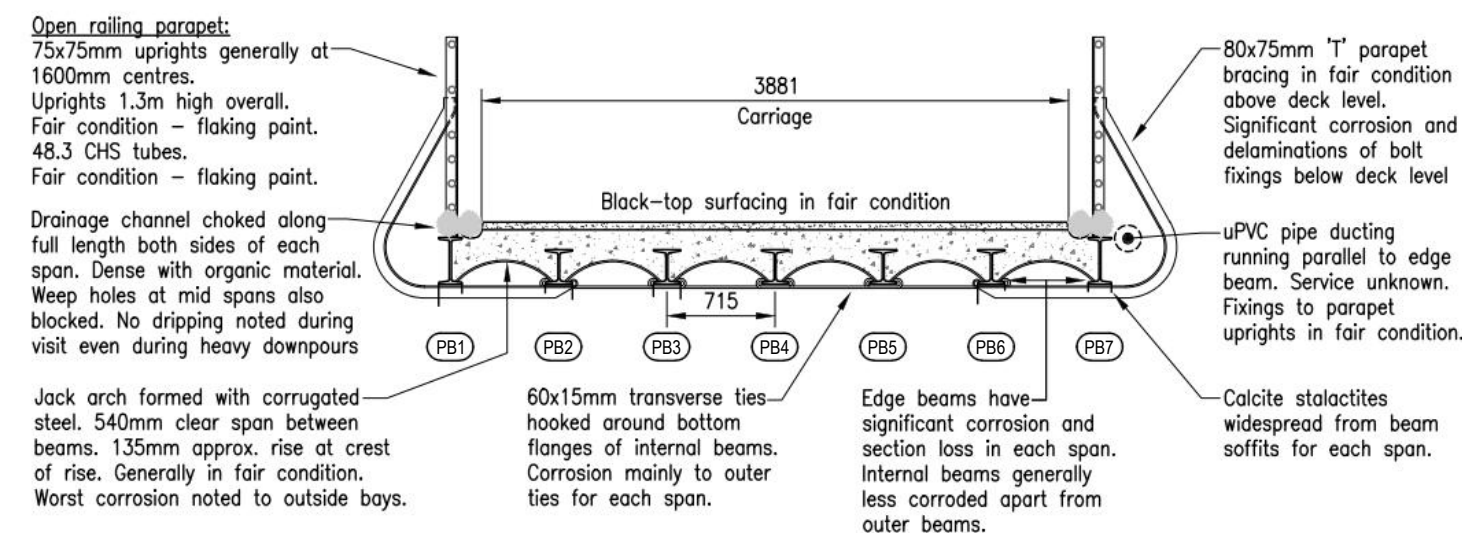
140163F/01 | —

The following paragraphs will provide a summary of the defects to the main structural elements of the bridge structure following the Inspection for Assessment. The more detailed defects schedule can be found on drawing no. 140163F/01 and 140163F/02, included in Appendix B of this report.

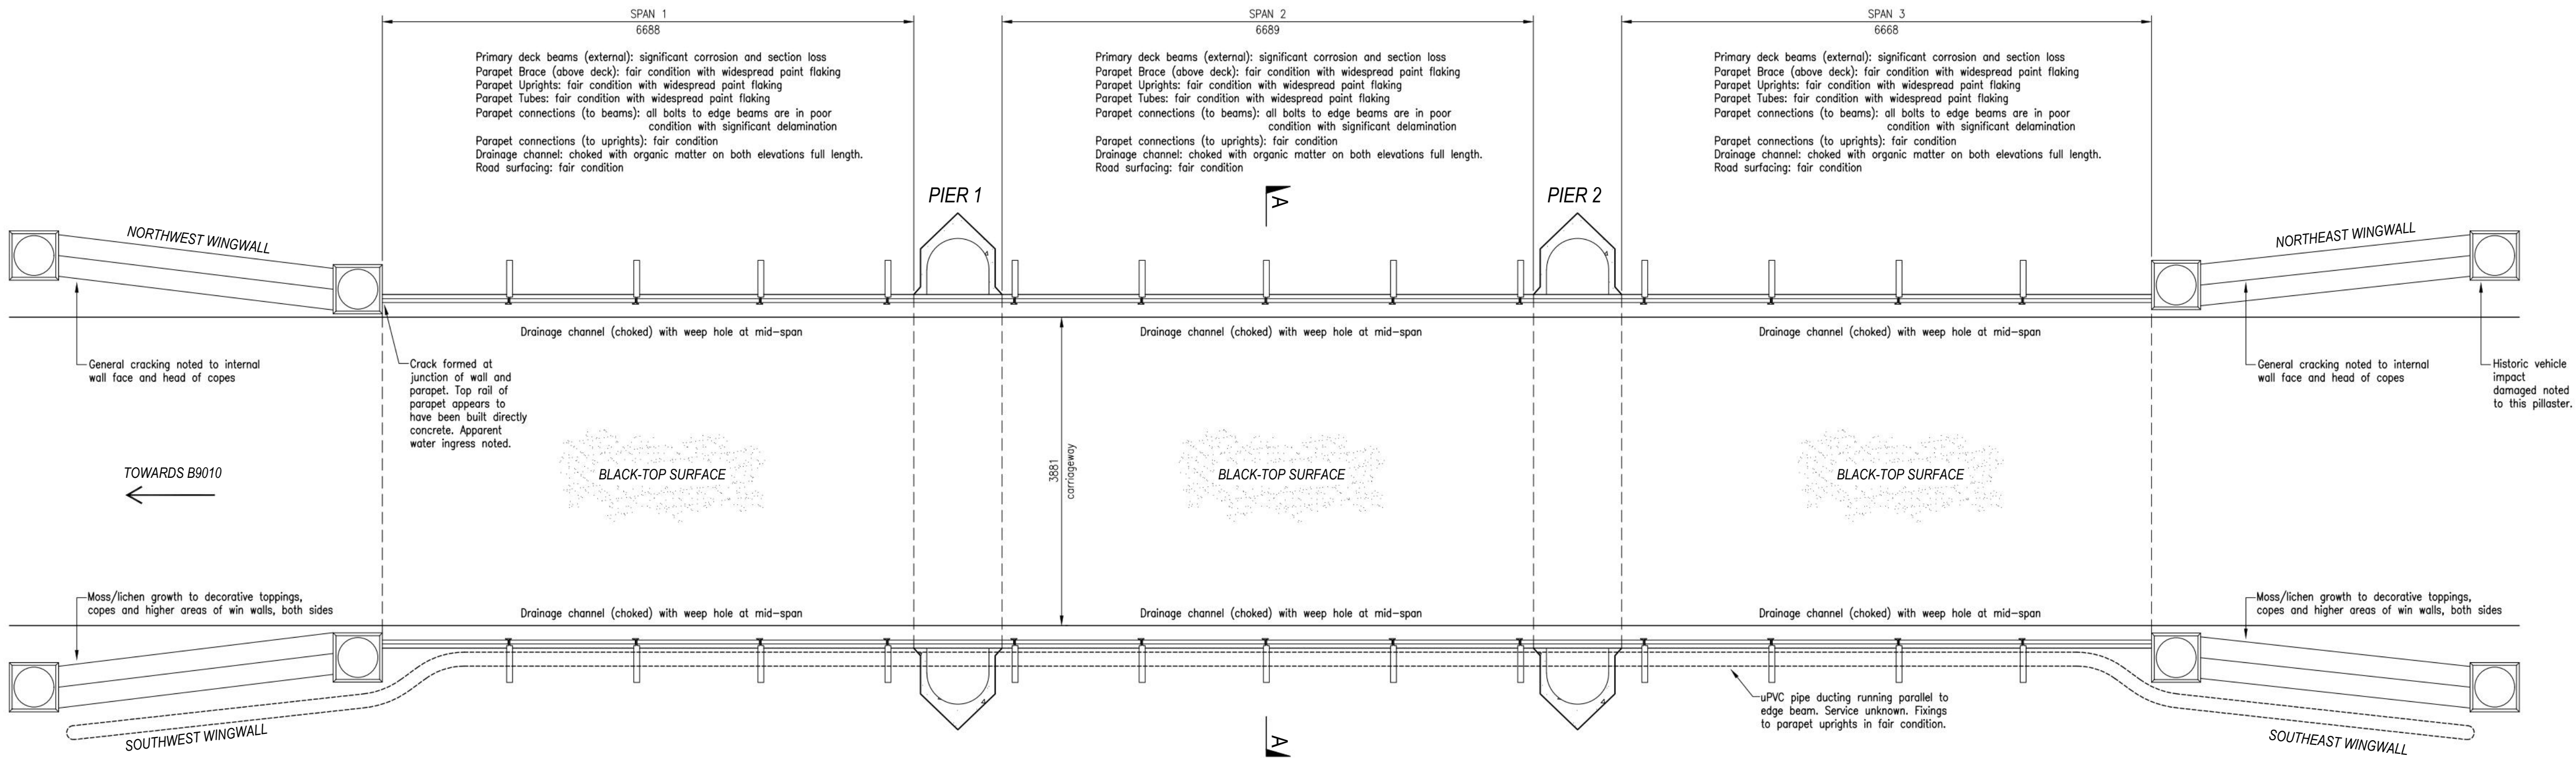
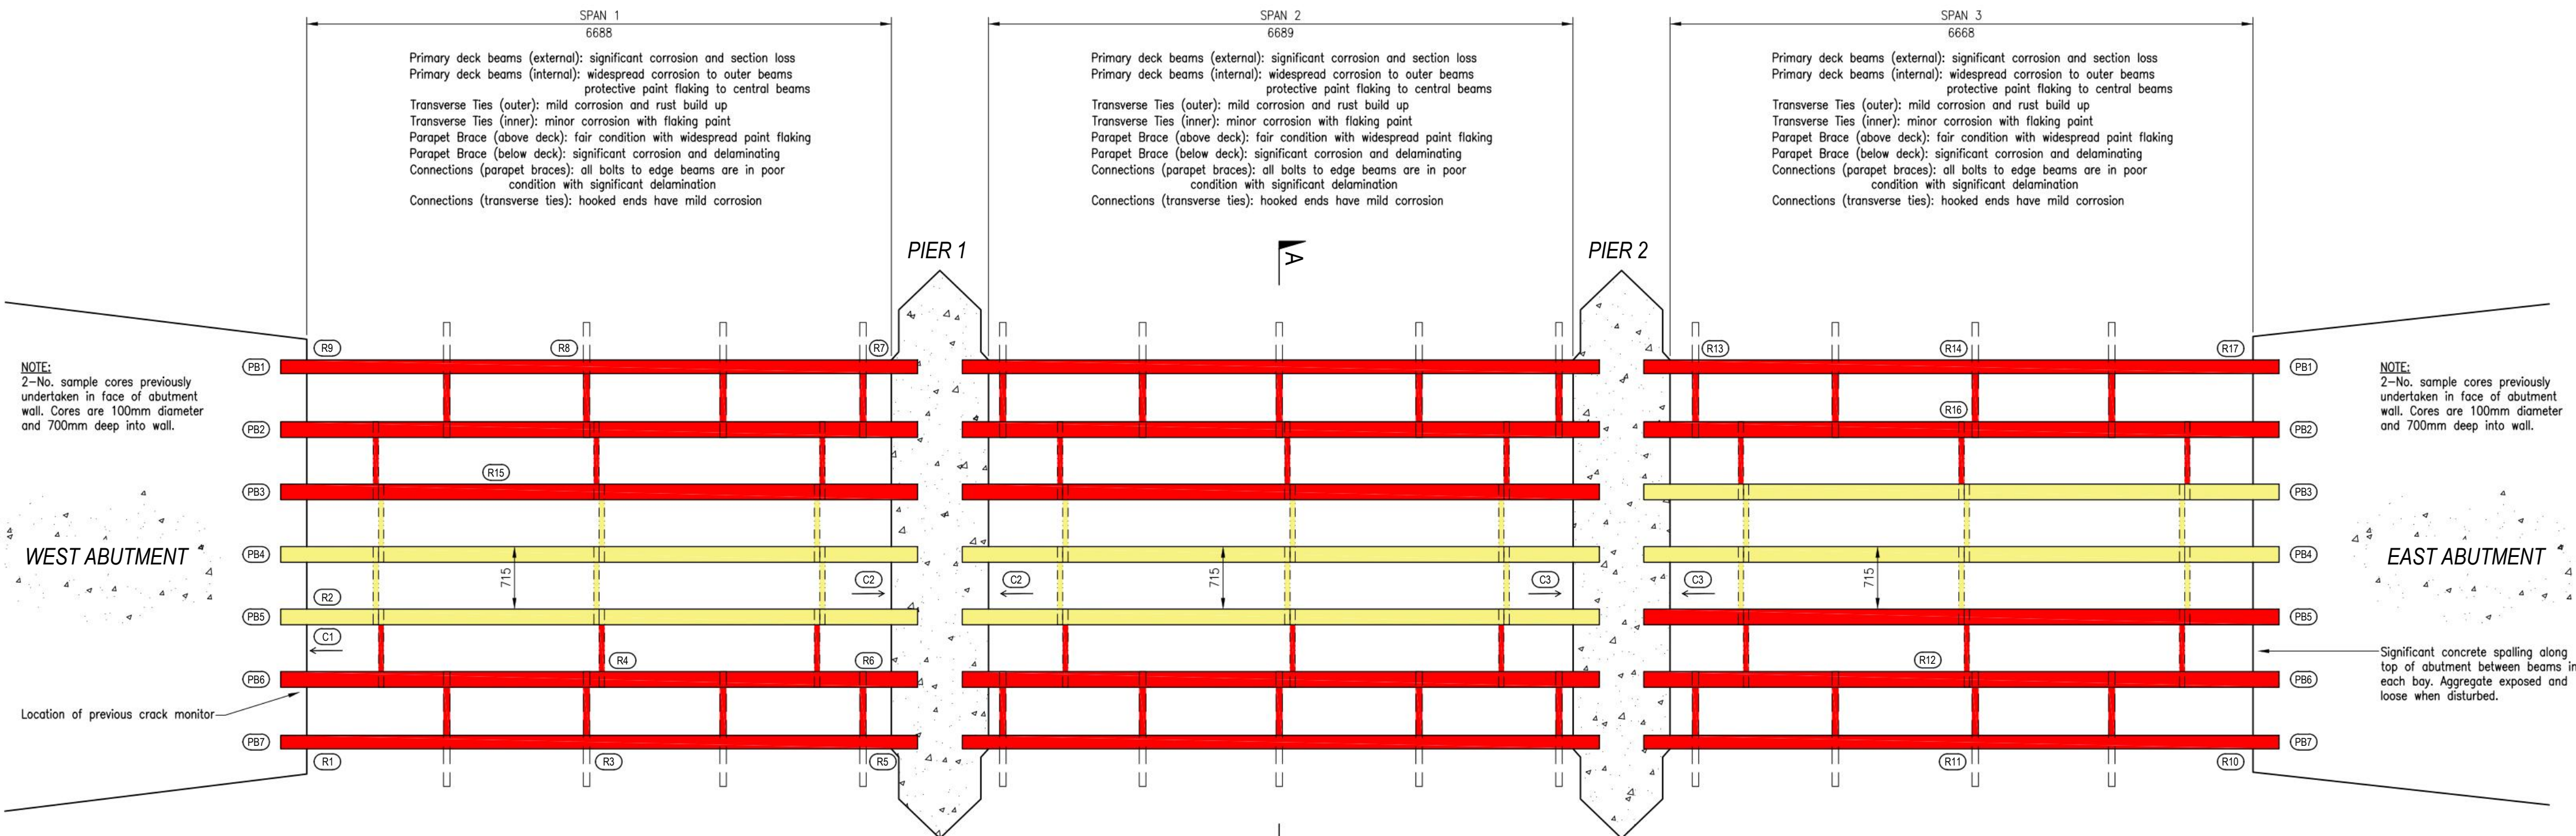
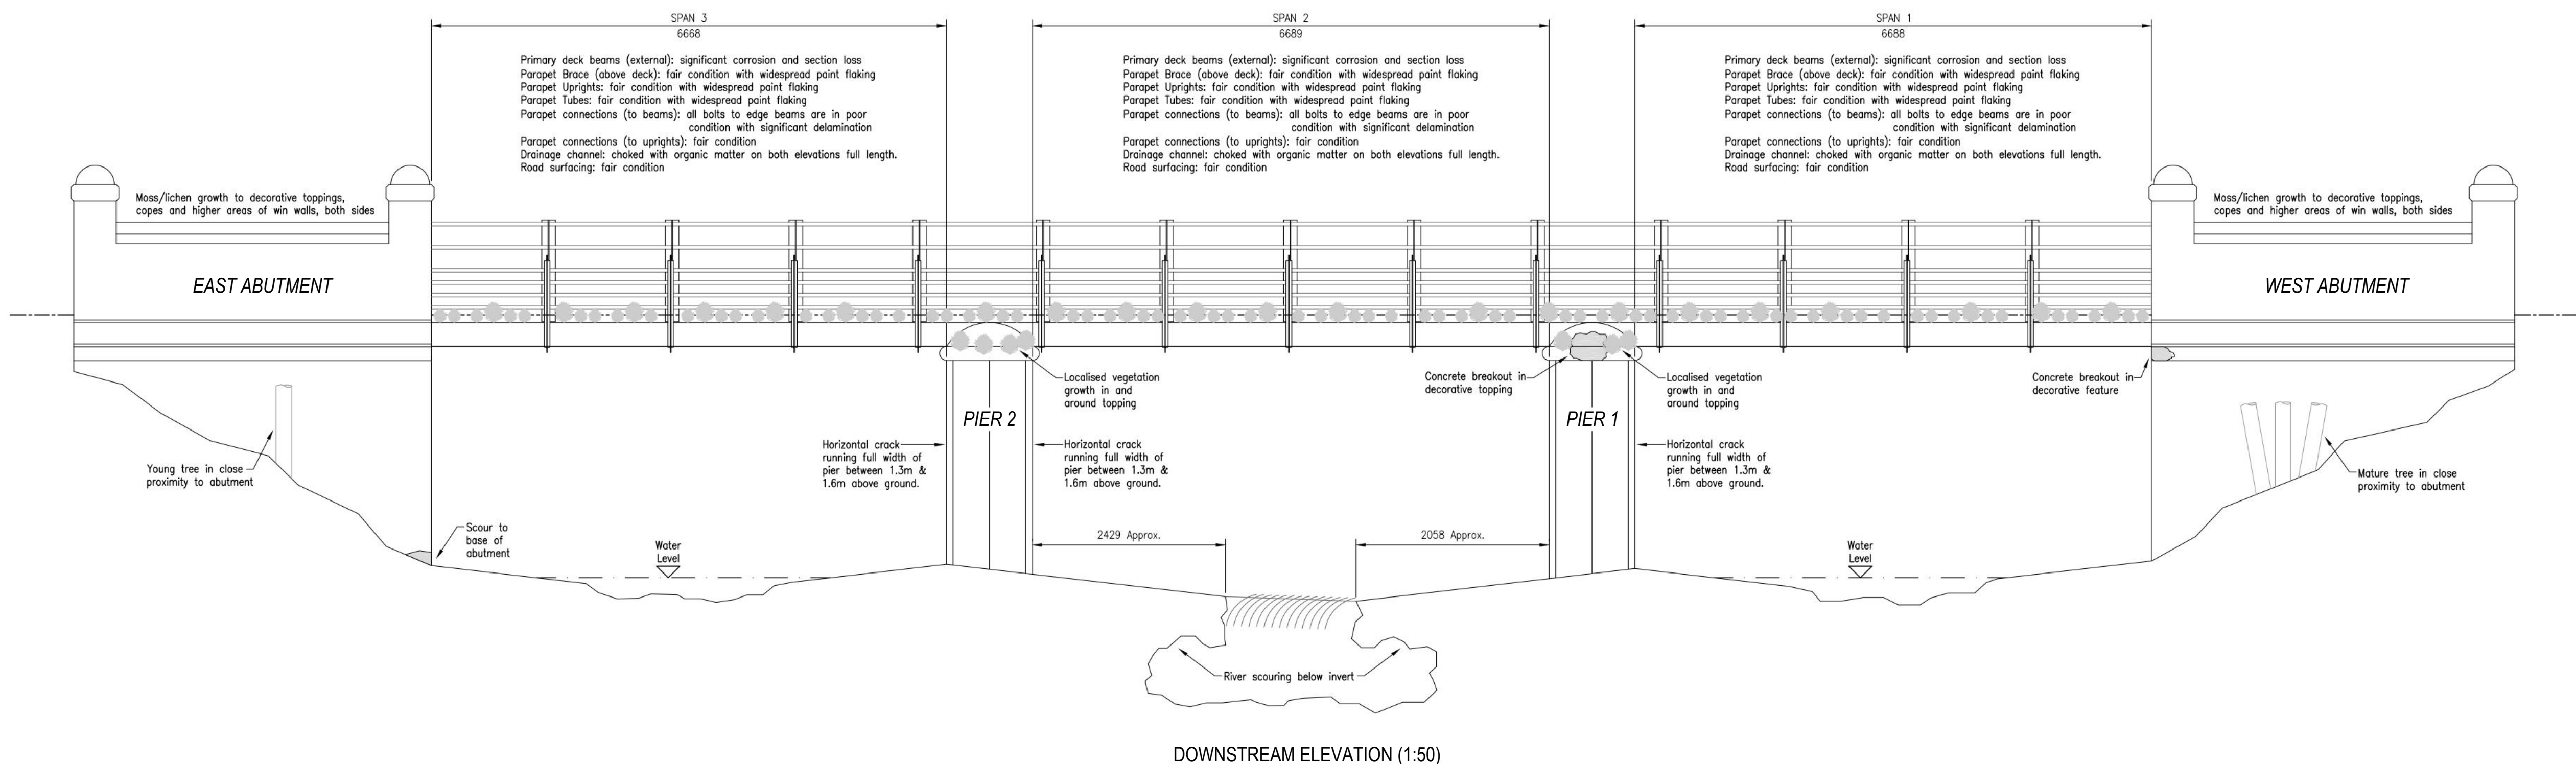
DRAWING TITLE :  
**DEFECTS SCHEDULE  
(SHEET 1 OF 2)**

Location	Reading from bottom flange (mm) taken at quarter points (u.n.o.)	Reading from web (mm)
R1	12.7	9.9
R2	11.4	Not Accessible
R3	11.5	11.5
R4	11.1	Not Accessible
R5	18.1 (mid)	5.8
R6	15.4 - 16.5 (mid)	Not Accessible
R7	12.7	13.0
R8	9.9	12.5
R9	10.6	8.9
R10	12.4	8.8 - 10.1
R11	13.0	10.9
R12	12.9	Not Accessible
R13	11.5	13.5
R14	12.0	11.4
R15	16.6	Not Accessible
R16	18.5 (mid)	Not Accessible
R17	12.1	7.1
