Inspection and Assessment Report

Cloddach Bridge, Elgin

March 2022

REPORT TITLE: Inspection for Assessment Report

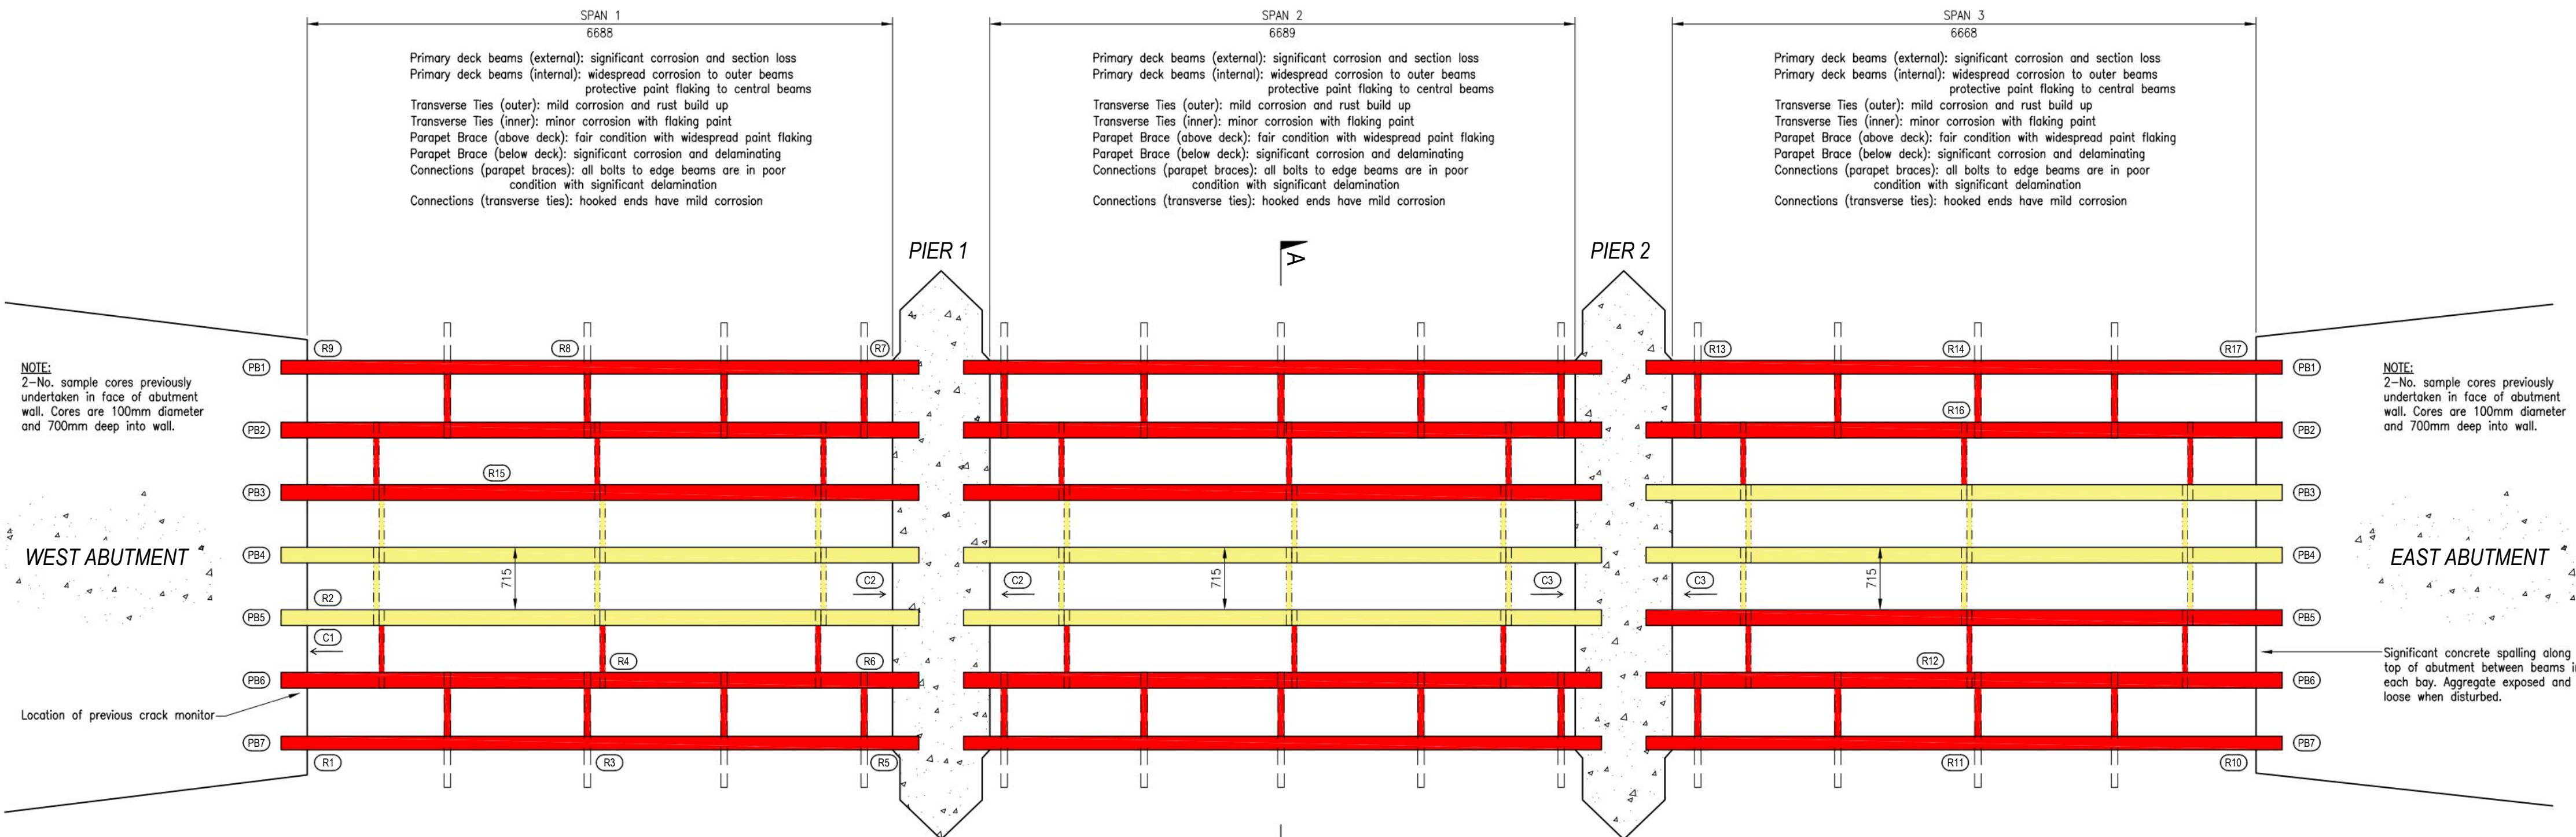
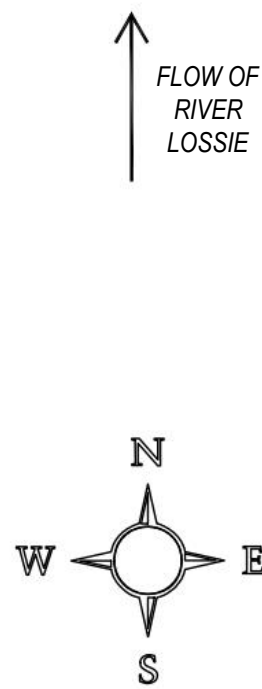
DRAWING TITLE :
**DEFECTS SCHEDULE
(SHEET 1 OF 2)**

STEELWORK MEASUREMENTS FROM MAIN DECK MEMBERS :

Location	Reading from bottom flange (mm) taken at quarter points (u.n.o.)	Reading from web (mm)
R1	12.7	9.9
R2	11.4	Not Accessible
R3	11.5	11.5
R4	11.1	Not Accessible
R5	18.1 (mid)	5.8
R6	15.4 - 16.5 (mid)	Not Accessible
R7	12.7	13.0
R8	9.9	12.5
R9	10.6	8.9
R10	12.4	8.8 - 10.1
R11	13.0	10.9
R12	12.9	Not Accessible
R13	11.5	13.5
R14	12.0	11.4
R15	16.6	Not Accessible
R16	18.5 (mid)	Not Accessible
R17	12.1	7.1
