Lossiemouth East Beach Footbridge Replacement Business Case

Lossiemouth East Beach Footbridge

Lossiemouth East Beach Bridge Replacement BB2020

Options Report For Moray Council Date: December 2020

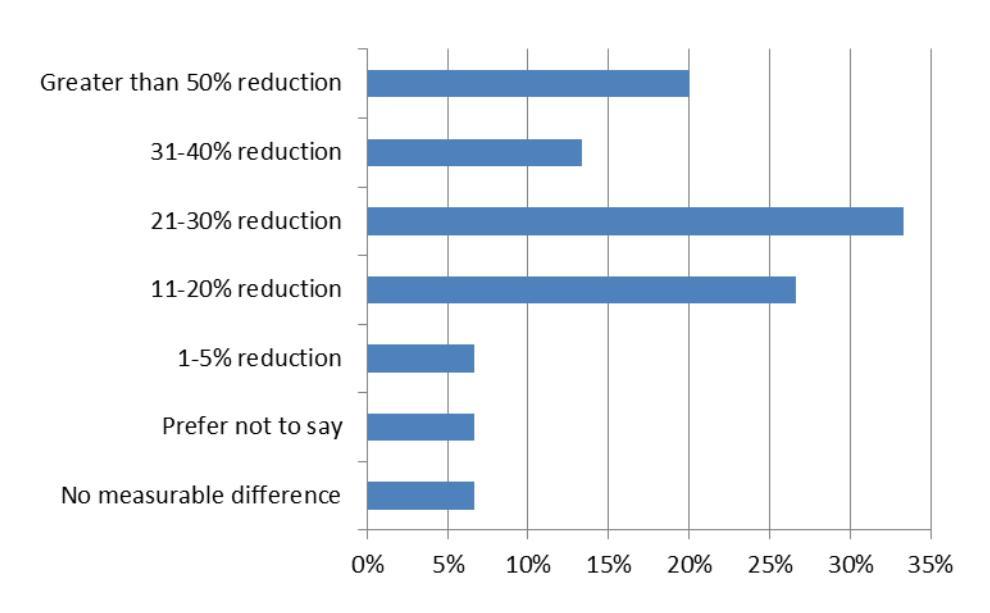
Expected change in turnover without a replacement bridge

Respondents were asked to compare what they would expect their turnover to be in 2022 without a replacement bridge (assuming that Covid-related impacts have subsided and that the bridge has been replaced) against their turnover in calendar year 2018 (net of inflation); i.e. the last full year prior to bridge closure. There was a large variance between responses, but, of the businesses that were less than 5 minutes' walk from the bridge, almost all (88%) anticipated experiencing a reduction in turnover, as shown in Figure 5 below.

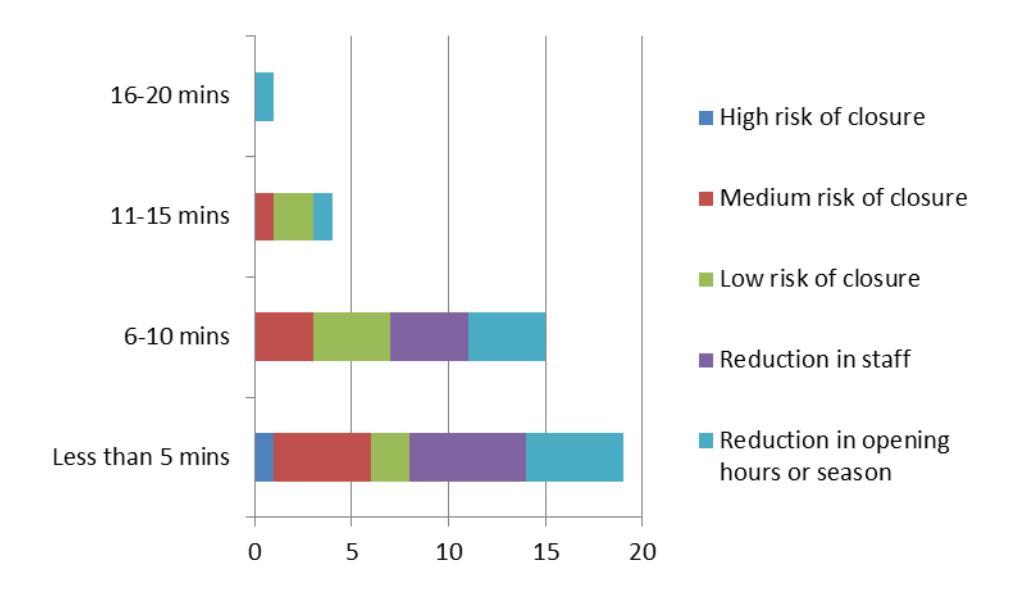
Figure 6: Risk to businesses without a replacement bridge

Figure 6 shows that the closer a business is to the existing east beach bridge, the greater their anticipated risk should there be no replacement bridge. 19 of the 21 businesses within 5 minutes' walk of the bridge expected risk of closure (high, medium or low), reduction in staffing, and/or reduction in opening hours or season.

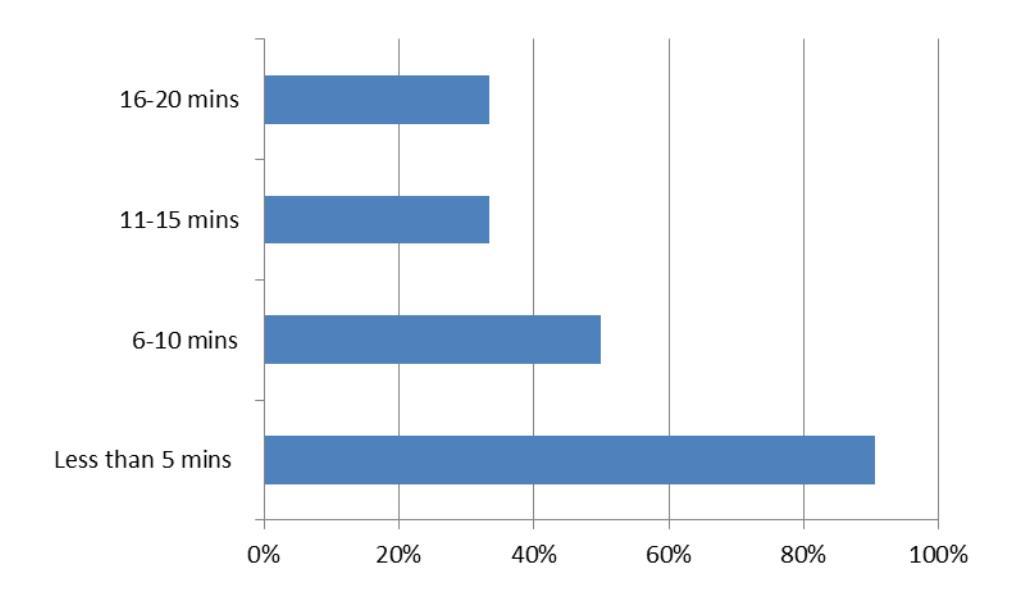
Figure 7: Percentage of businesses anticipating at least one risk

Figure 7 shows that the percentage of businesses anticipating at least one of these risks reduces the further away from the bridge they are.

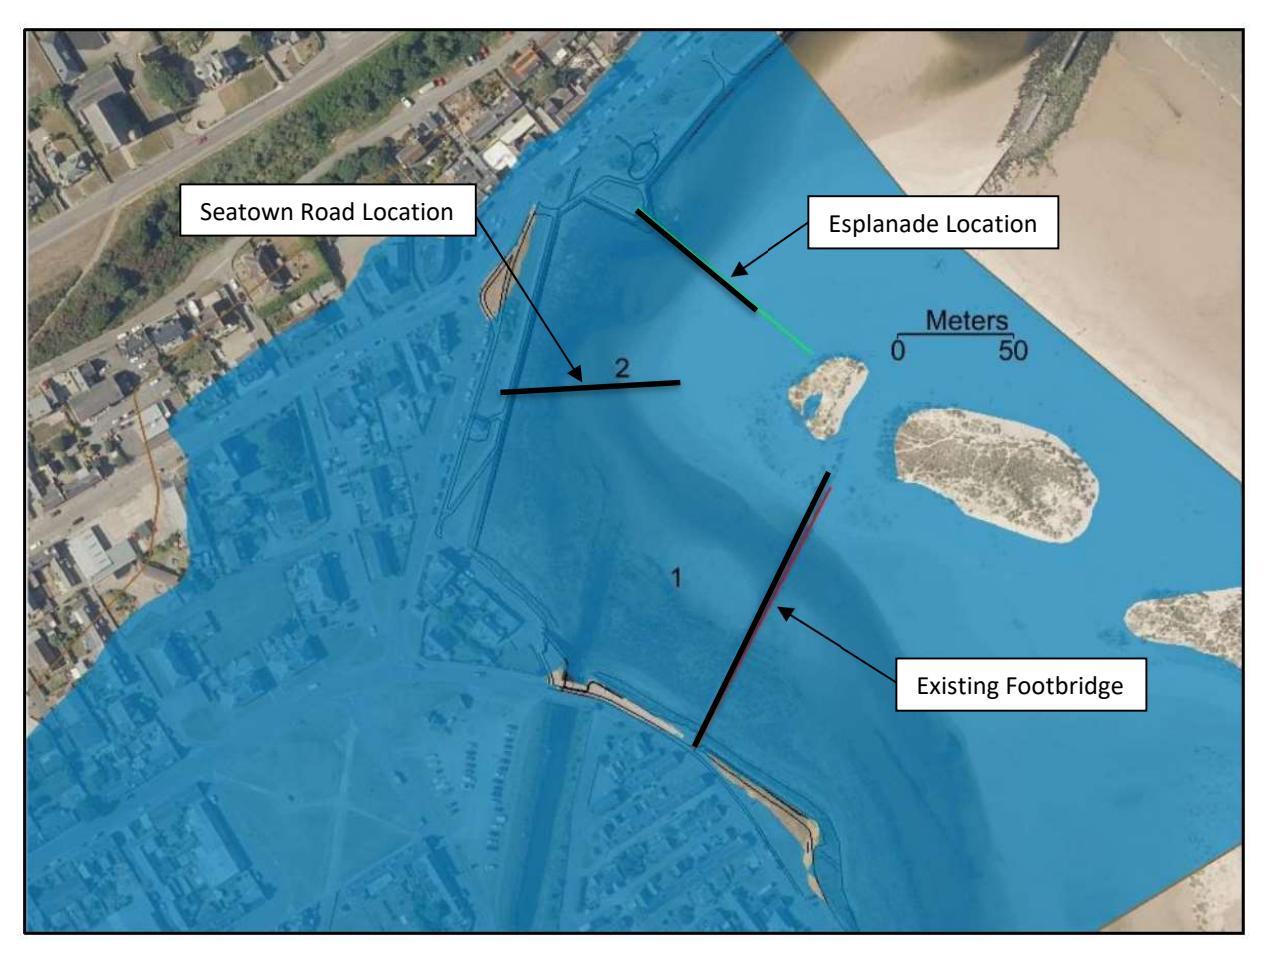
Figure 2 - 200-year Return Period tidal/storm Still Water Level plus climate uplift' flood condition (4.24mAOD)

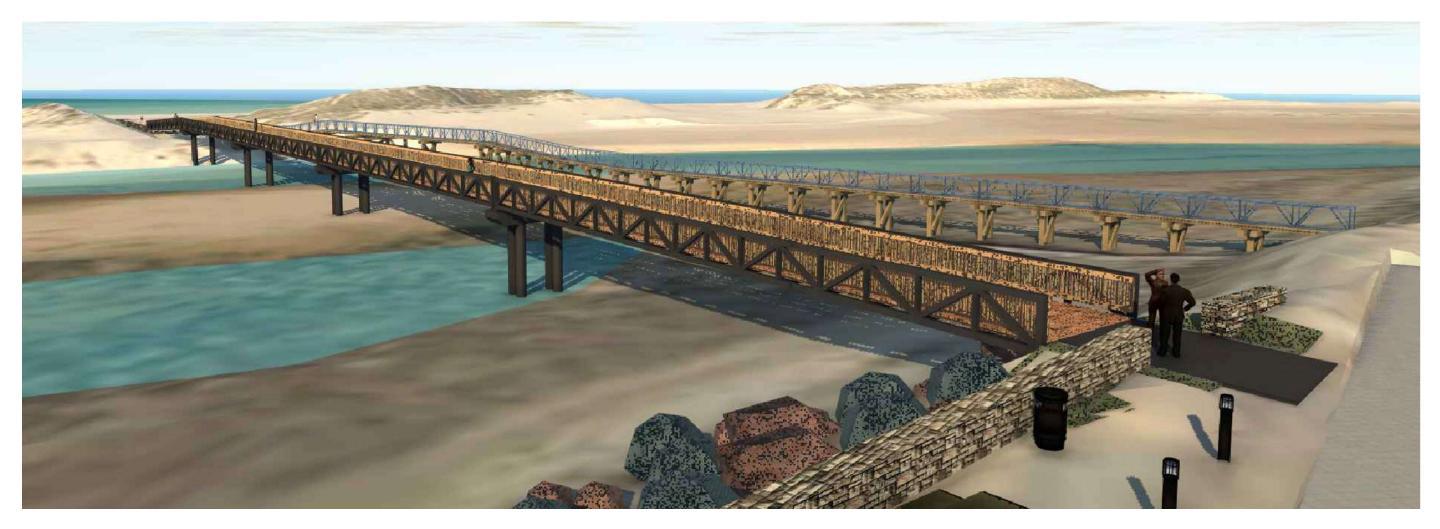
Figure 3 – Option 3 – View from Church Street

This location presents difficulties with construction as access is served from one direction only and the limited space for a works area would likely result in issues for residents east of the Spynie Canal Bridge. Sea defences are also likely to be compromised during the works hence temporary measures would be required.

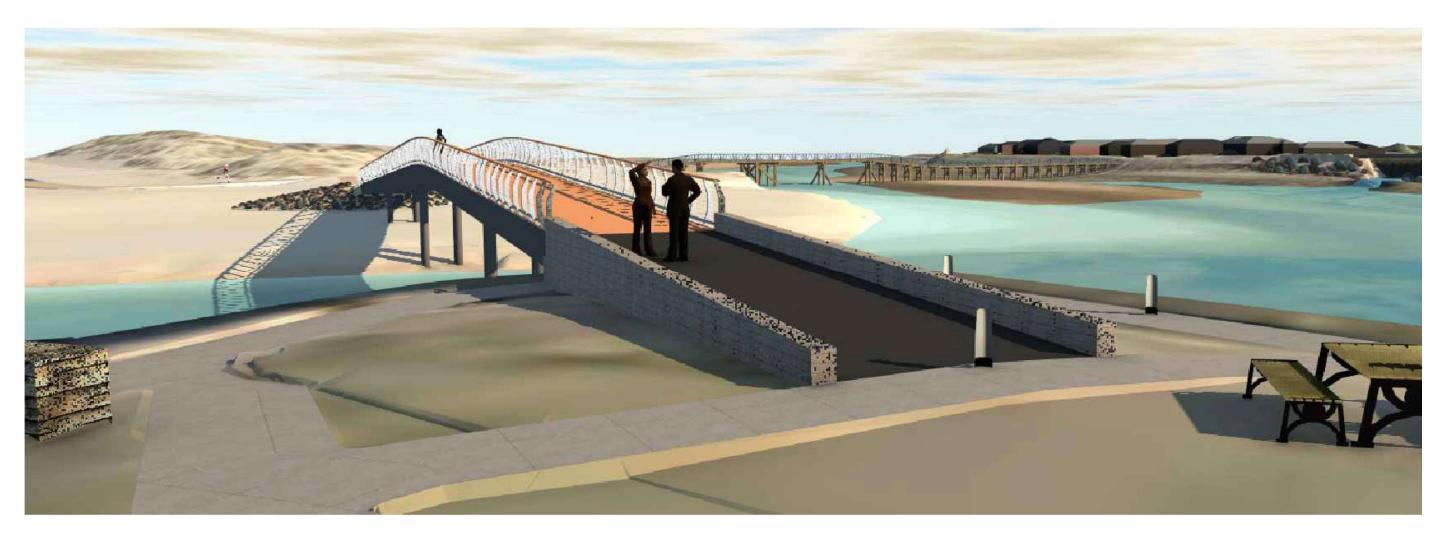
Figure 4 – Option 4 – View from The Esplanade

There are concerns that moving the crossing to this location would focus a large amount of activity into one area of Lossiemouth, creating traffic and pedestrian safety issues. Moray Council traffic engineering team have been contacted for advice on how best to facilitate the bridge at this position and their recommendations have been included in drawing BB2020-TR-002.

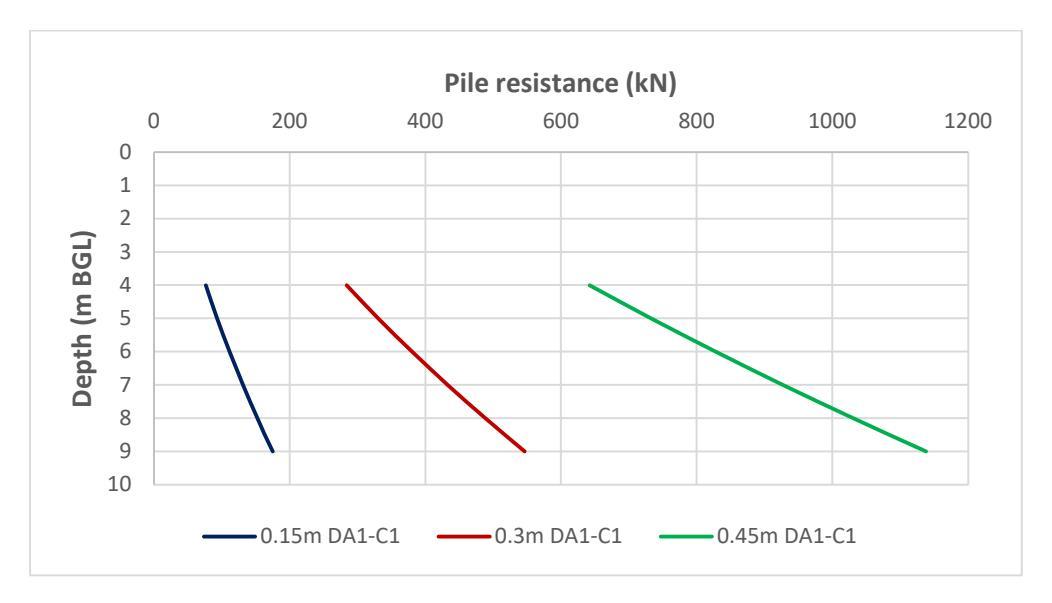
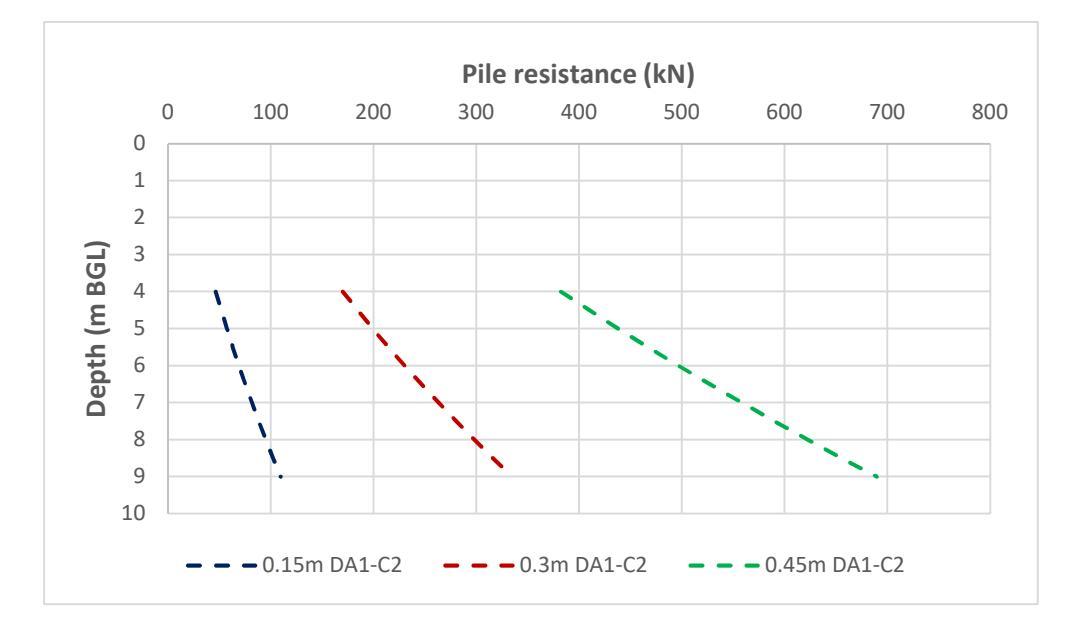
For the land side of the site, the variation of a single pile resistance in relation to pile toe depth is presented below for three different pile diameters. It should be noted that the analysis is based on the ground conditions encountered in BH03 and therefore assumes that bedrock is not present at 6.50m as conjectured in BH01. Whilst this is a conservative assumption for deriving pile capacities, such conditions would not be compatible with pile driving to lower depths. Accordingly, should these conditions be encountered then piles would need to be terminated early and cut off.

8.6.10 It should be noted that the resistance of a single pile is reduced in the vicinity of other piles. Accordingly, detailed design of the piled foundation arrangement should take into account spacing between piles and pile group effects.

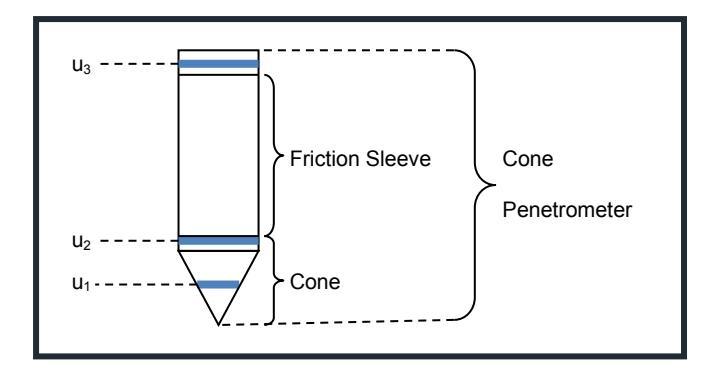
The filter element can be mounted in one of three positions. For all tests carried out in this project the filter was mounted in the u_2 position (see *Figure 3.1*).

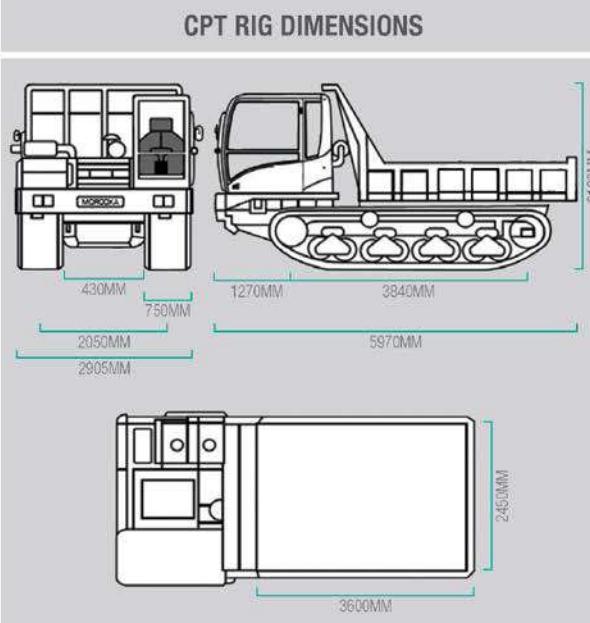
GPT RIG DETAILS
DRIVE SYSTEM	RUBBER TRACKED
OTAL WEIGHT	20 TONNES
ROUND BEARING Pressure	35kPA
PT RAM THRUST CAPACITY	20 TONNES
MAXIMUM PENETRATION	30-40M DEPENDING ON THE GROUND CONDITIONS,
PERFORMANCE RATES	100-150M OF TESTING A DAY, DEPENDING ON ACCESS TO POSITIONS.
TYPICAL SITES FOR This rig	SOFT, BOGGY SITES. THE RIG HAS LOW GROUND BEARING PRESSURE.

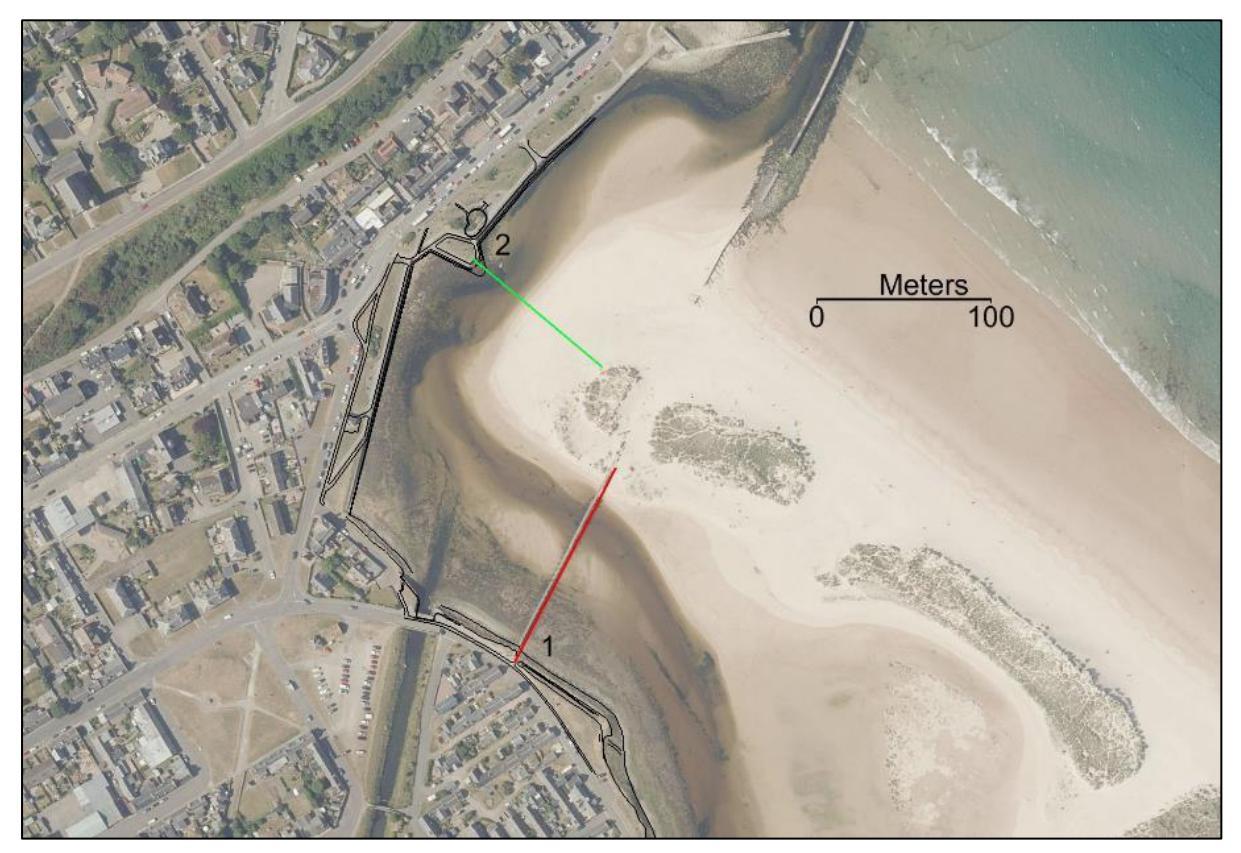
Figure 1.1: Aerial view of Lossiemouth showing the River Lossie, East beach and the two proposed access bridges.

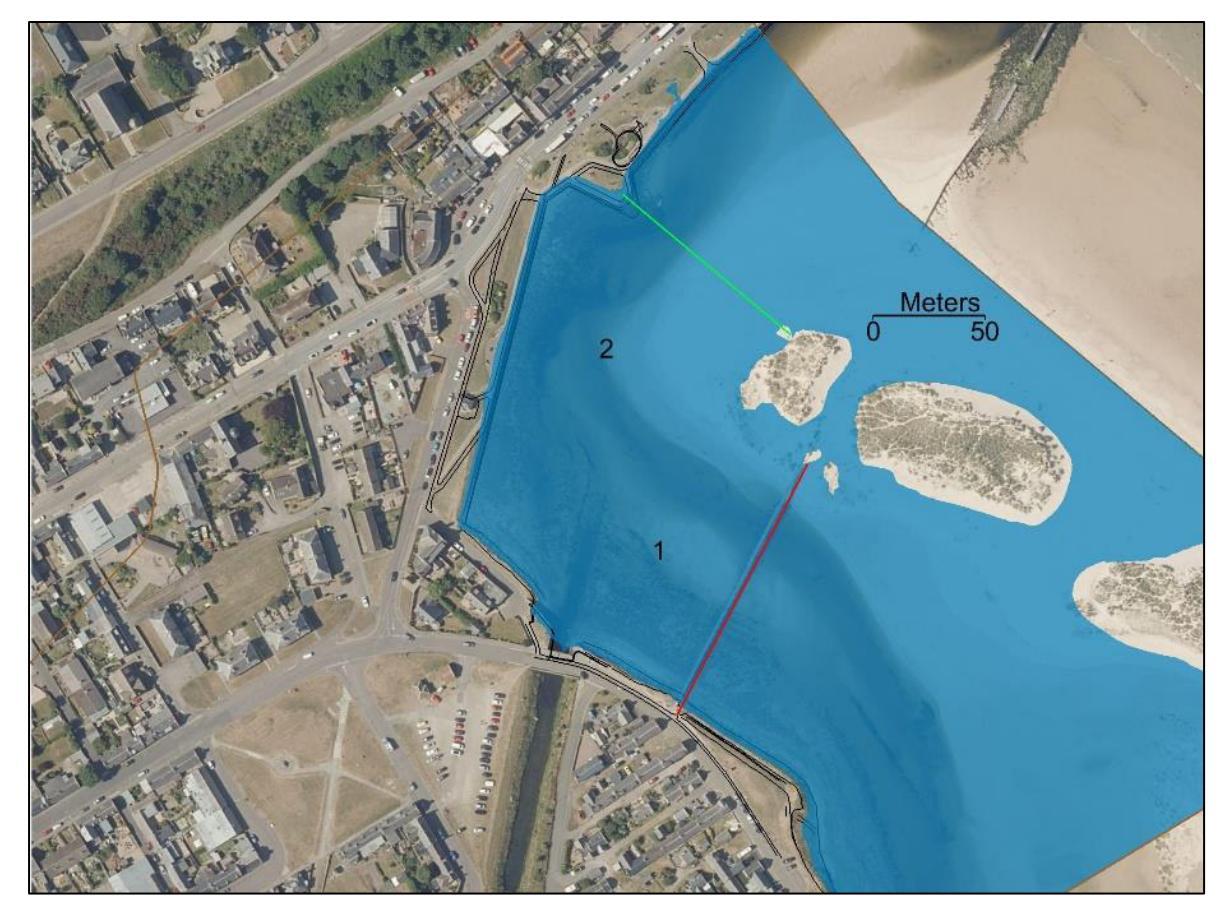
Figure 2.1: Water level at 200 year tidal/surge SWL

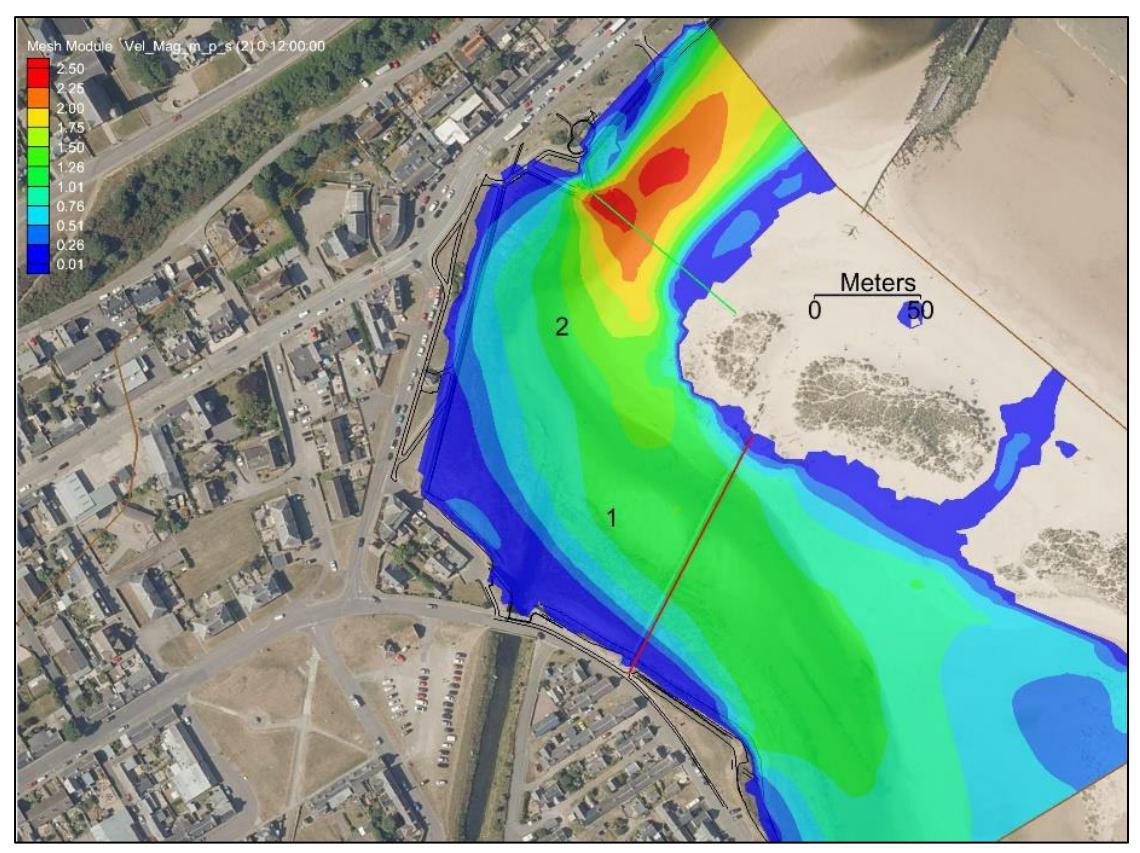
Figure 2.5: Critical velocity condition of 200 year plus climate change fluvial flood in Lossie combined with low tide (normal depth). Peak at existing bridge location (red line) is 1.10 m/s; peak at second bridge location (green line) is 2.50 m/s.

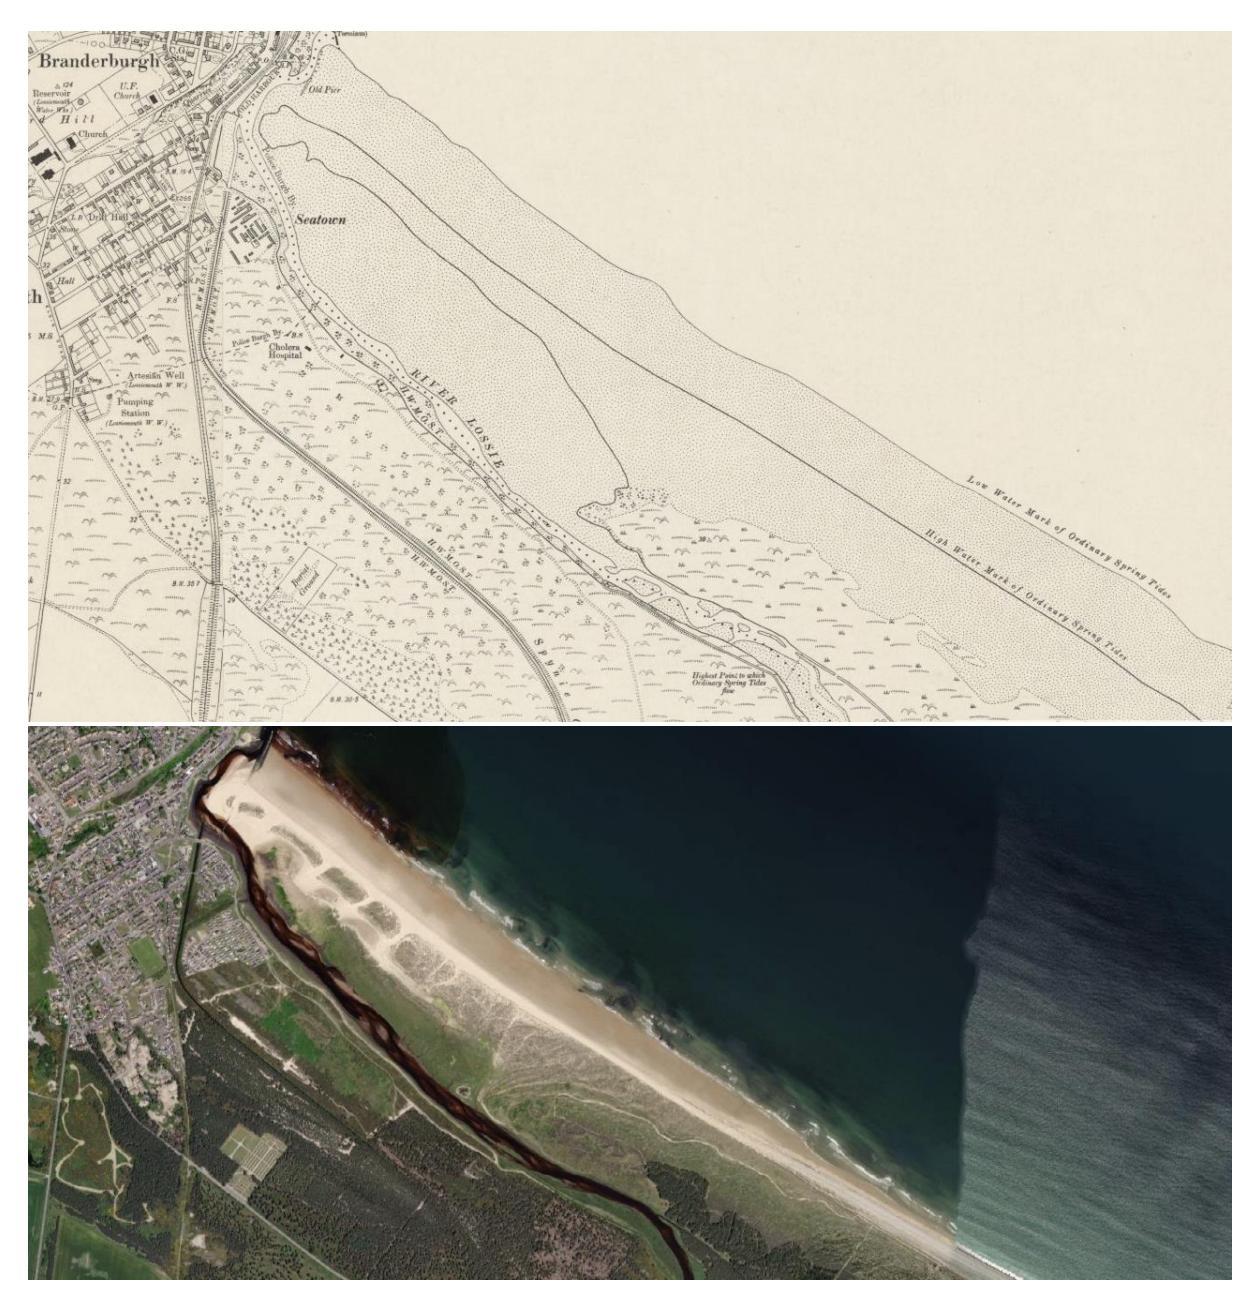
Figure A2: Downstream reach where the river flows to the NW. Note the river changes near the old harbour (last fluvial area near the sea) and in sandbars along the channel. The first map is an OS map surveyed in 1865-1870 (published in 1905), and the second map is an aerial image of Maxar from 2020.

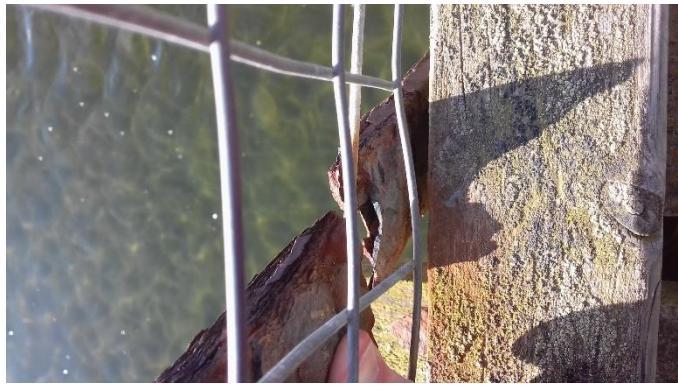
Broken tie, ends out of alignment due to distortion

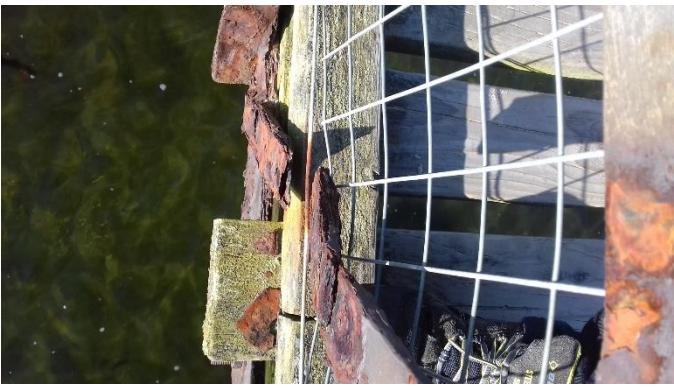
Broken tie, with missing central section

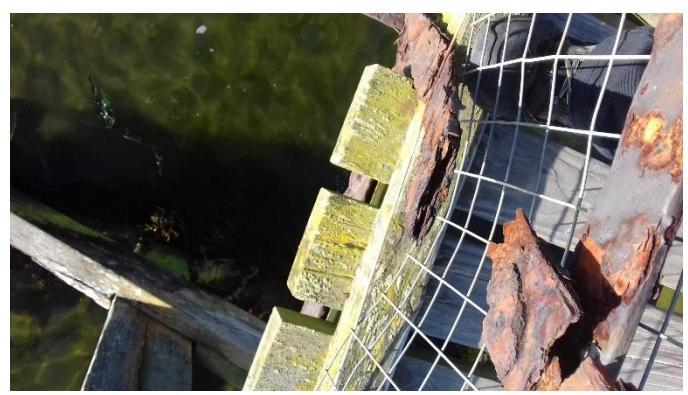
Broken tie, with missing central section

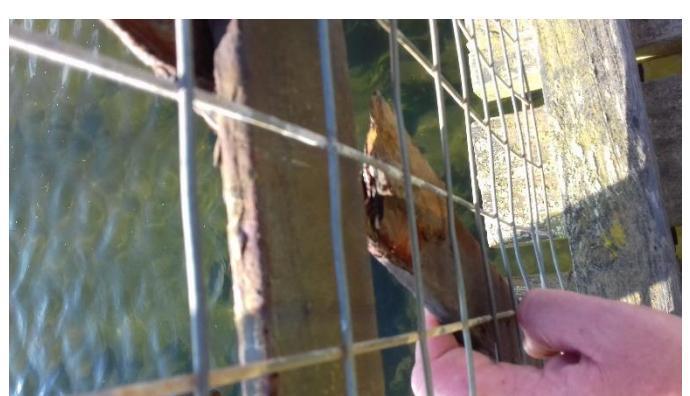
Broken tie, with dark area, failed in last few days

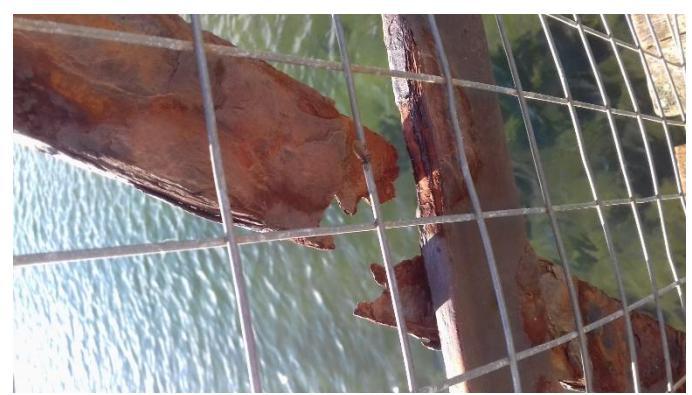
Broken tie, ends out of alignment due to distortion Broken tie, ends out of alignment due to distortion

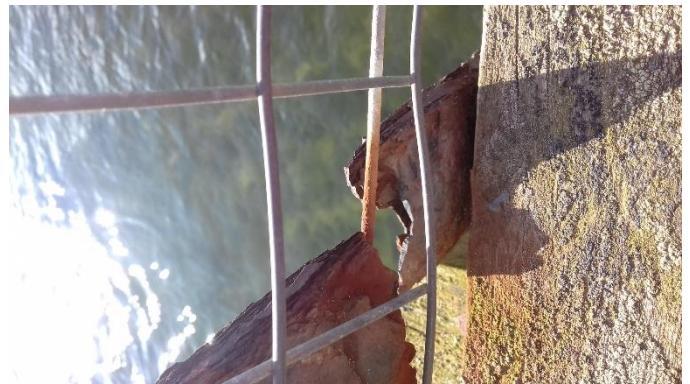
Broken tie, ends out of alignment due to distortion Broken tie, ends out of alignment due to distortion
