## **Garmouth Flood Alleviation Scheme Pre-Feasibility Study**

The Moray Council

November 2007

Final Report

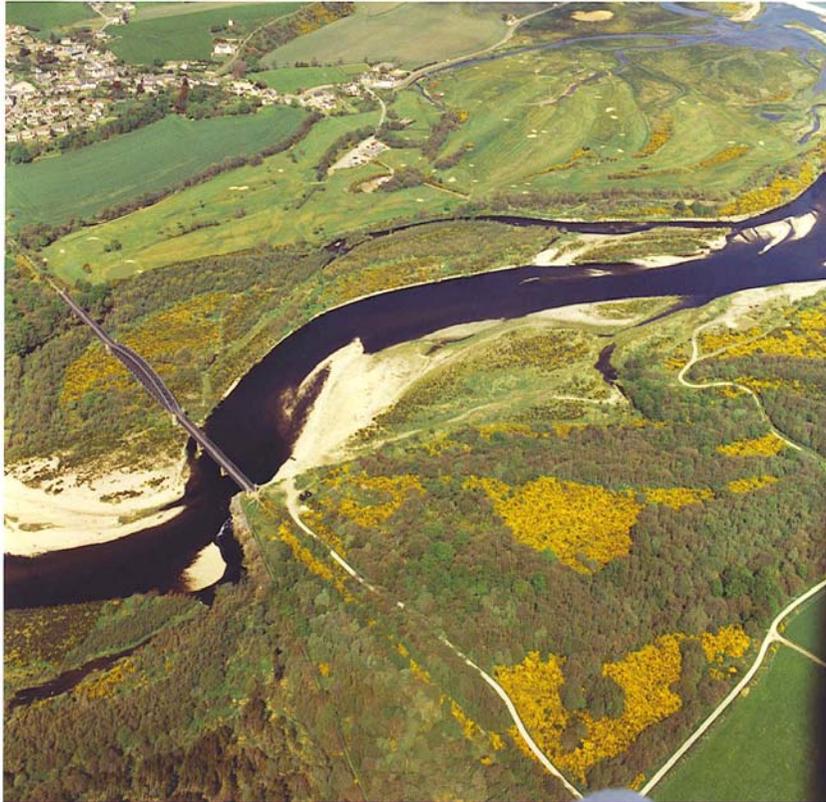
Plate 1 Main channel flowing through eastern span of the Railway Bridge (1991)

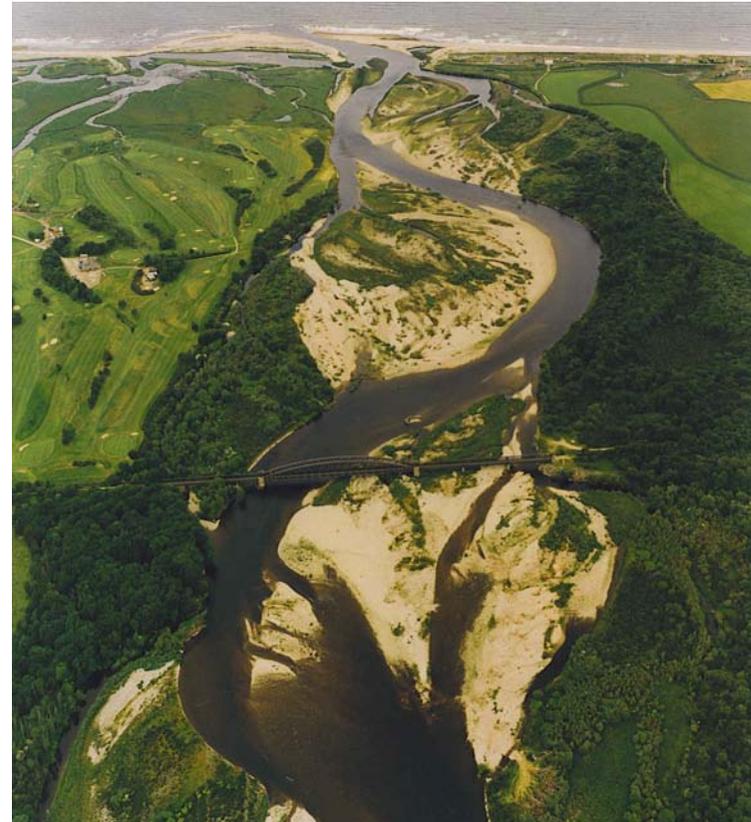
Plate 2 Main channel flowing through western span of Railway Viaduct (1998)

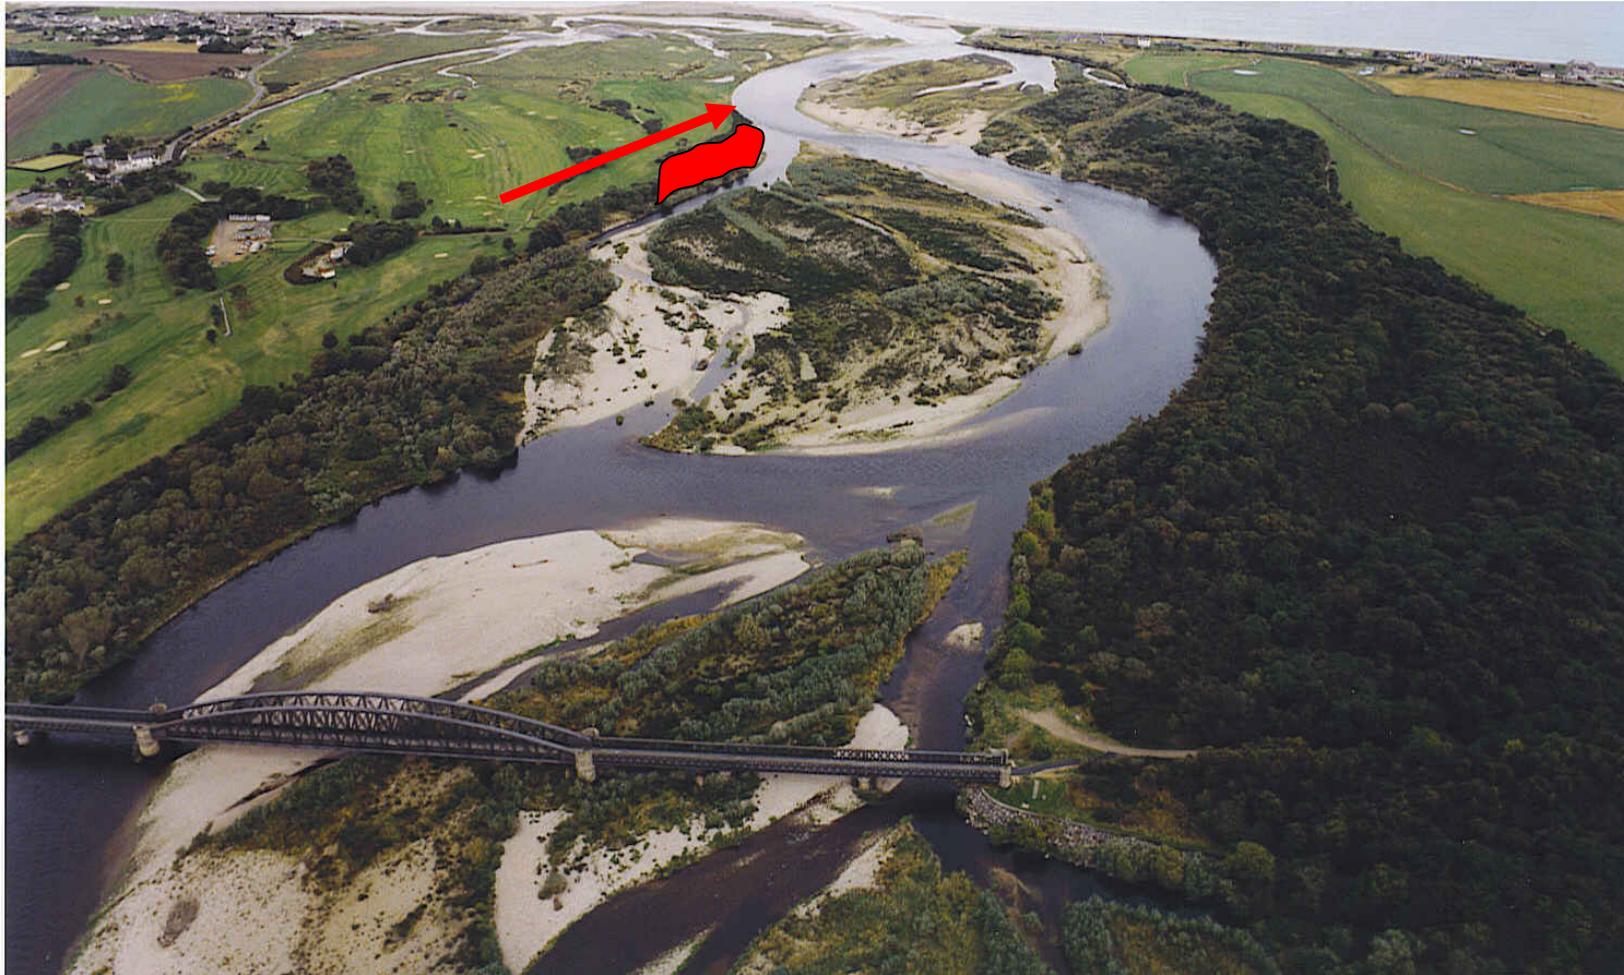
**Plate 3** Arrow marks the area where Garmouth Golf Club is currently experiencing major bank erosion and the loss of their 17<sup>th</sup>/18<sup>th</sup> hole. The area highlighted in red is the approximate area lost since this photo was taken in 2000, due to development of meander loop through bank erosion coupled with the active back channel.

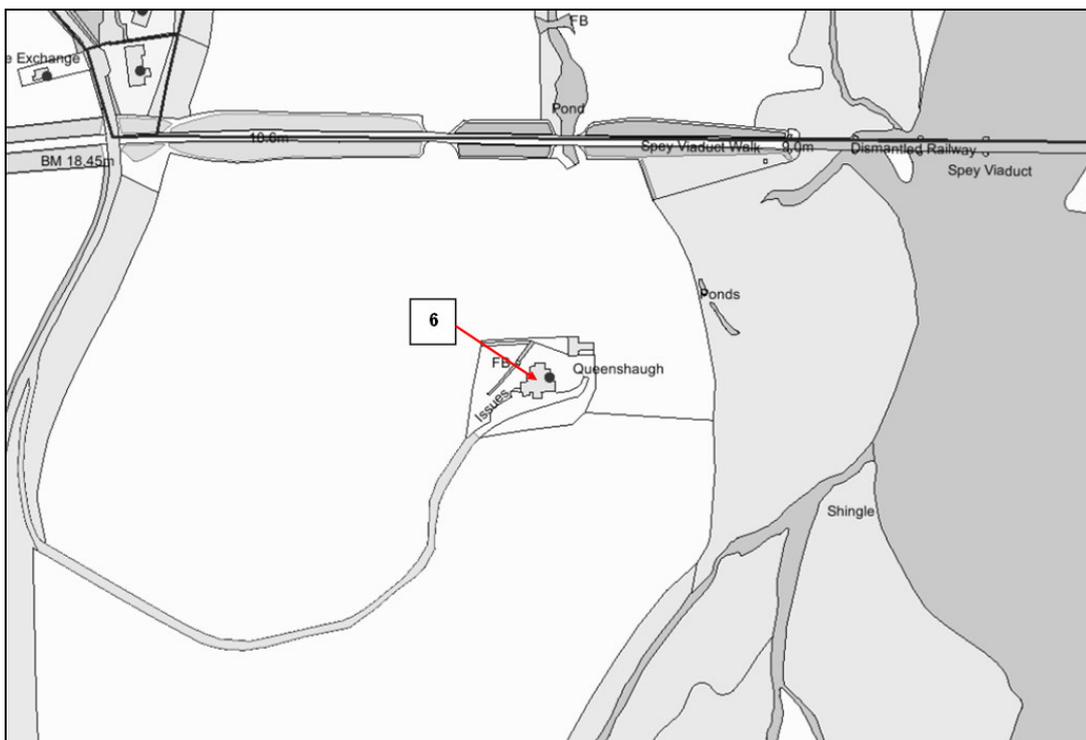
**Figure E.2: Properties at Flood Risk in Garmouth**
